# NEMSA INSPECTION REPORT

Azura Edo Independent Power Plant

**Date of Inspection: 1<sup>st</sup> May 2018**

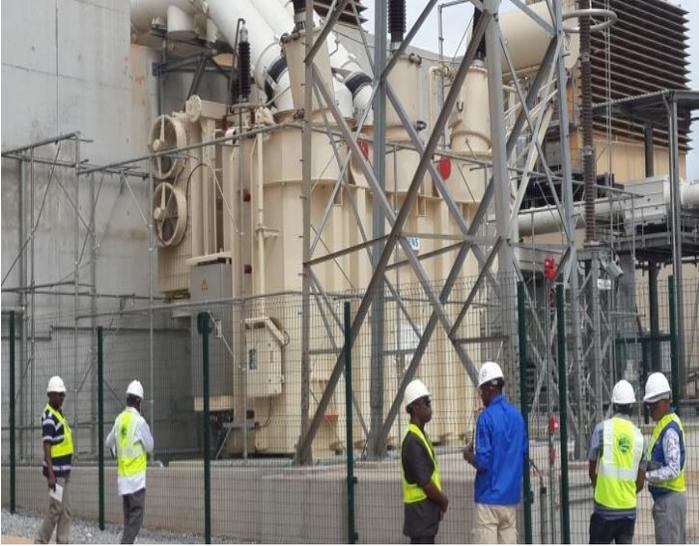
S/No	POWER PLANT AREA	OBSERVATIONS	PICTURES	RECOMMENDATIONS
1.	Station Transformer	<p>i. Transformers were well installed on solid plinths.</p> <p>ii. No oil leakages were seen.</p> <p>iii. Danger signs on surrounding fence need to be standard type as some of these were not conventional.</p> <p>iv. Paint seen covering points where the earthing terminals are connected.</p> <p>v. Also, paint seen where sections of the JP fence are joined. These may cause discontinuity of their conductive path.</p>

<p>i. All Paint marks should be scraped off at the connections to ensure better conductivity and earth continuity.</p>

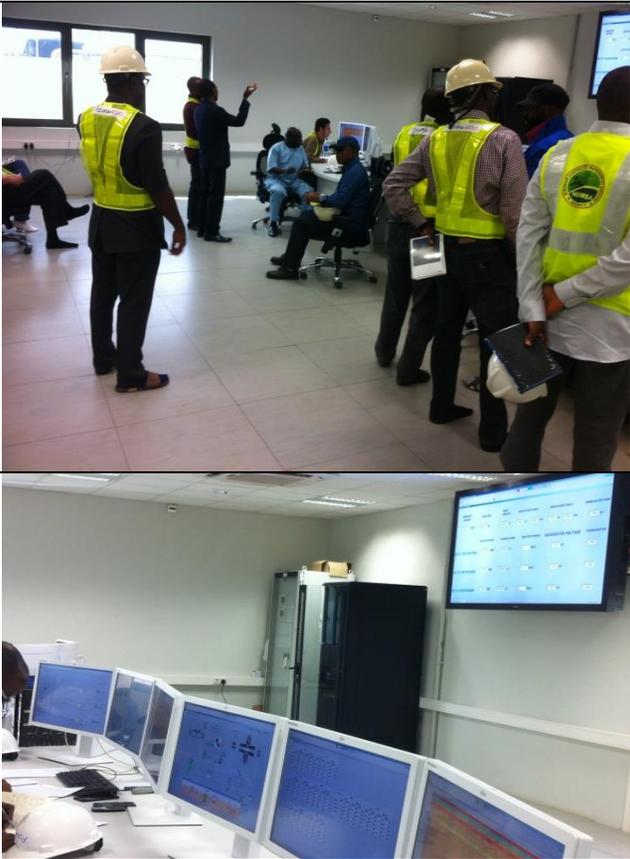
<p>2.</p>	<p><b>Control Room</b></p>	<ul style="list-style-type: none"> <li>• Control room is spacious, clean and conducive for operators.</li> <li>• No footwear from outside is allowed here thereby making it free from static, dirt, etc.</li> <li>• HMI and displays are adequate.</li> <li>• Illumination is very satisfactory.</li> <li>• No fire extinguishers seen, and could not confirm there was automatic fire extinguishing system.</li> <li>• No artificial respiration chart seen.</li> </ul>

<ul style="list-style-type: none"> <li>• Provision of fire extinguishers or automatic fire protection system recommended.</li> <li>• Artificial respiration chart should be conspicuously displayed in the control room</li> <li>• Staff should be well trained on all safety operational procedures.</li> </ul>
-----------	----------------------------	--	---	--

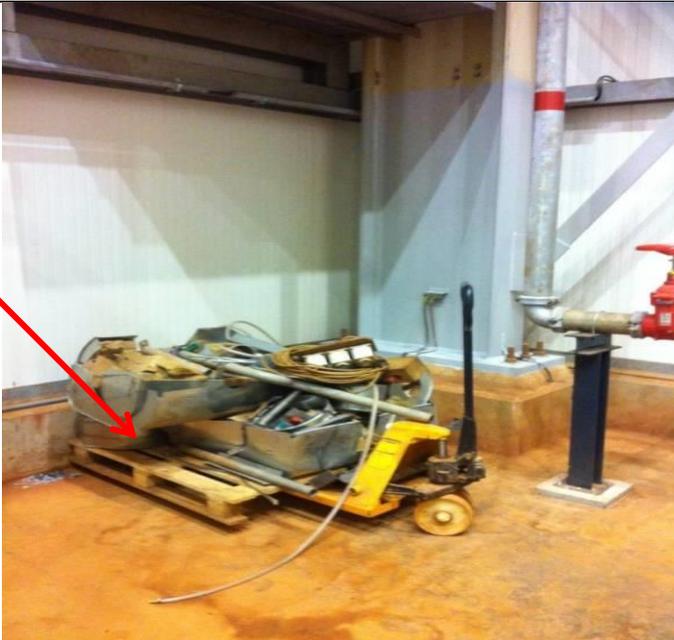
3.	Turbine Building	<ul style="list-style-type: none"> <li>• Scrap heap of materials found on a pallet by the corner of Turbine 3 floor.</li> <li>• This is unacceptable especially as it is in the path of the fire hydrant.</li> </ul>

<ul style="list-style-type: none"> <li>• The turbine floor should be kept clear of all scrap materials.</li> </ul>

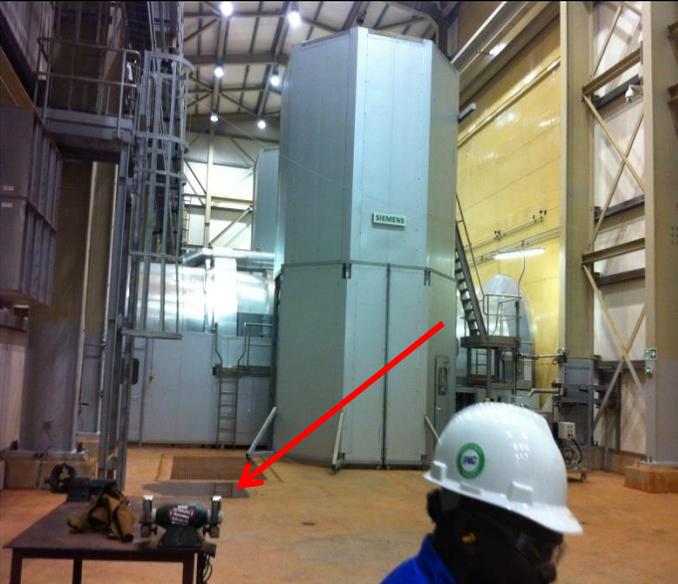
4.	Turbine Building	<ul style="list-style-type: none"> <li>• Pool of water on floor of Turbine building between GT2 and GT3. This could be an indication of roof leakage or from poor sealing on the roof fan.</li> <li>• The turbines were observed not conspicuously labeled.</li> </ul>

<ul style="list-style-type: none"> <li>• Source of water leakage should be identified and rectified.</li> <li>• The turbines should be labeled (TURBINE 1, 2 and 3/GT1, GT2, GT3) apart from the equipments code labeling.</li> </ul>

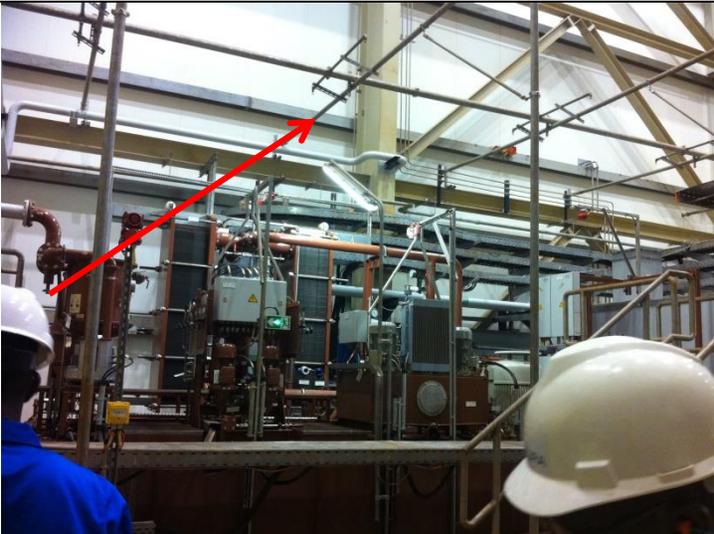
5.	Turbine	Extensive network of		ok

<p><b>Building</b></p>	<p>automatic fire foam tender seen in the turbine building. This indicates adequate fire-fighting preparedness.</p>

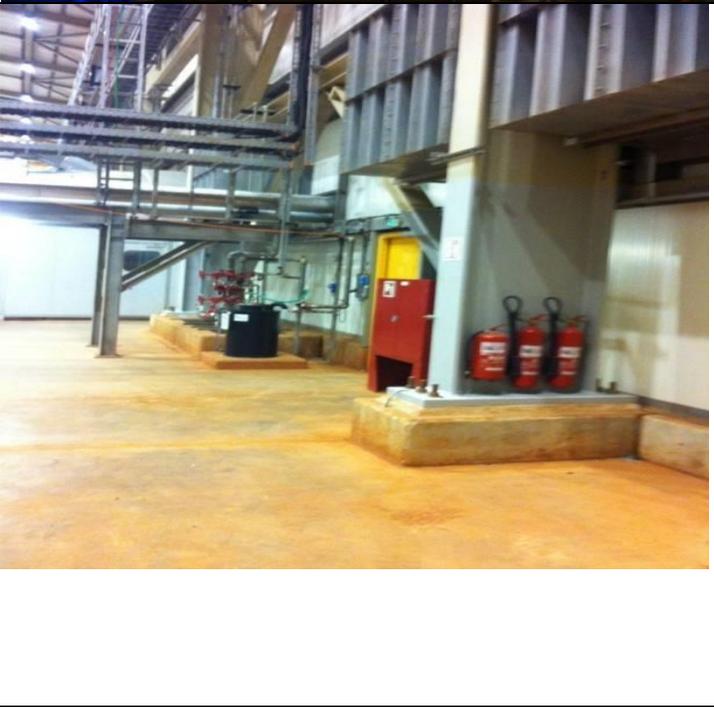
<p>6.</p>	<p><b>Turbine Building</b></p>	<p>Adequate provision of fire extinguishers and of appropriate different types and sizes.</p>

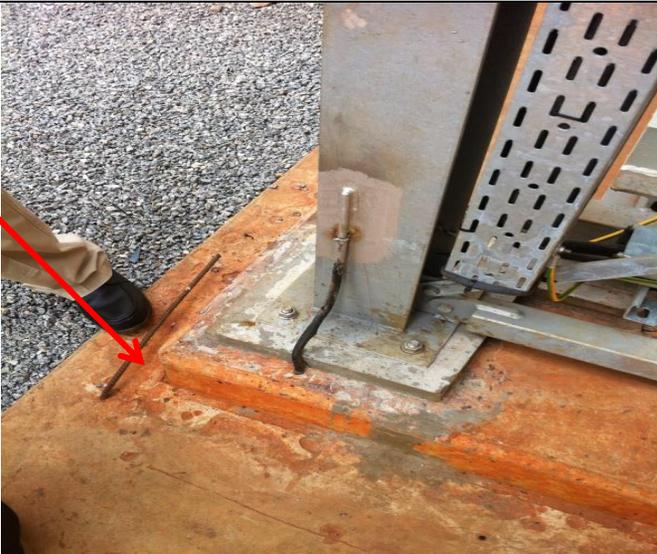
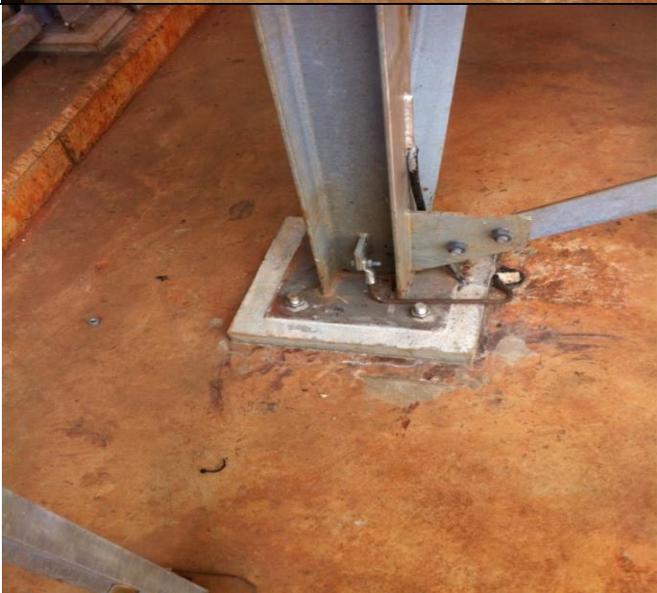
<p>7.</p>	<p><b>Turbine Building (Auxiliaries)</b></p>	<ul style="list-style-type: none"> <li>• Mild steel rods welded to the steel structure as earth continuity.</li> <li>• Unused reinforcement rods seen jutting out of the concrete base at different locations around the plant. Someone could trip on these rods.</li> </ul>

<ul style="list-style-type: none"> <li>• Earth continuity conductors of appropriate size should be used and properly terminated with cable lugs.</li> <li>• All unused reinforced steel rods should be cut off.</li> </ul>
		<ul style="list-style-type: none"> <li>• Where welded rods were used for earthing, proper earthing terminations were also used. This has been done for redundancy and as a failsafe installation.</li> </ul>

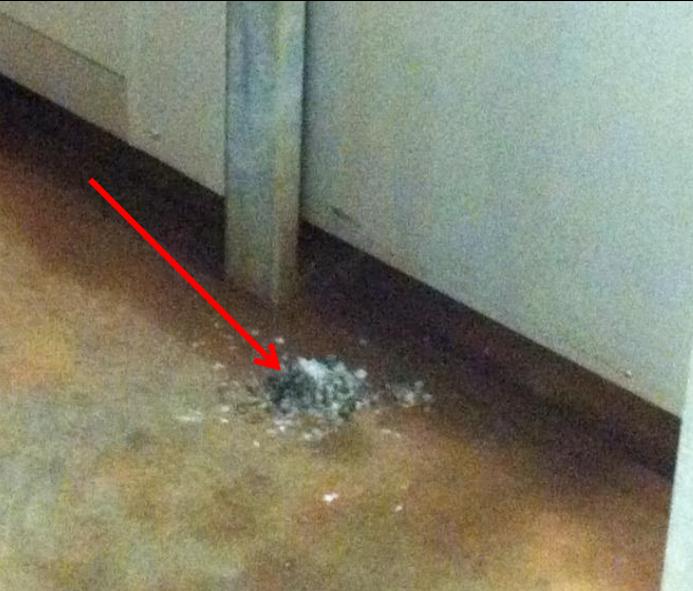
9.	<p><b>Turbine building</b></p>	<ul style="list-style-type: none"> <li>• Bird droppings were seen at many parts of the turbine building.</li> <li>• This is an indication that there was inadequate prevention of birds entering inside the building.</li> <li>• Bird droppings are corrosive to cables especially</li> </ul>

<ul style="list-style-type: none"> <li>• All possible access to birds should be blocked and birds prevented from entering into the building to deposit corrosive waste that could degrade cables.</li> </ul>

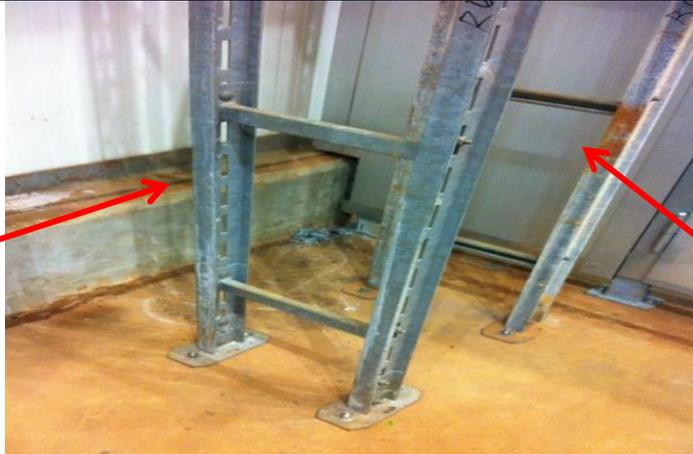
10.	Turbine building	<ul style="list-style-type: none"> <li>• Signs of rust seen on some metallic structures. This could be coming water ingress into the building</li> </ul>

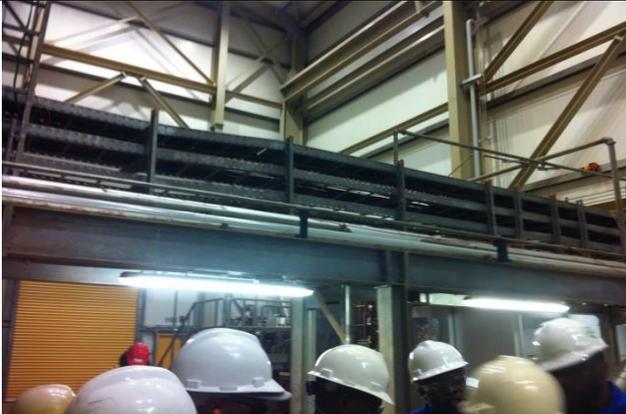
12.		<ul style="list-style-type: none"> <li>• Cables were seen well laid out on cable trays.</li> <li>• Different levels define the voltages of the cables on each tray</li> <li>• However, the trays were not labeled according to the voltage levels.</li> </ul>

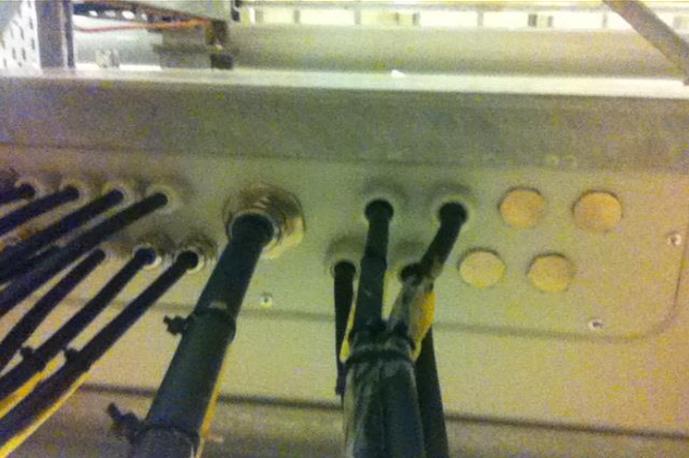
14.	Turbine building	<ul style="list-style-type: none"> <li>• All panels had adequate glanding</li> <li>• Unused points were seen sealed</li> <li>• Cable entry into the ground were all sealed with bituminous foam</li> </ul>

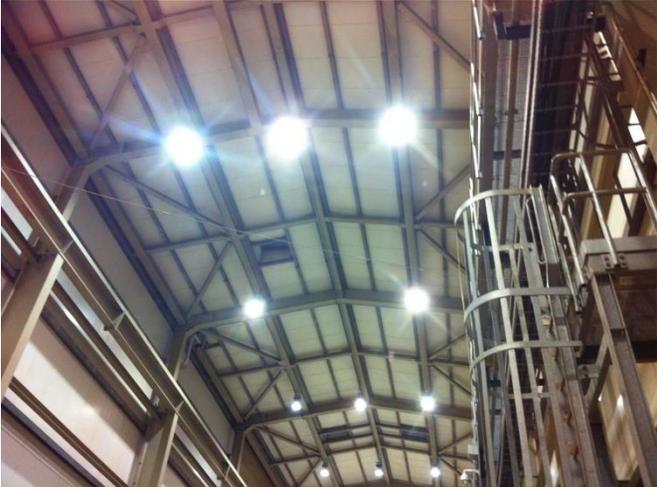
16.	Turbine building	<ul style="list-style-type: none"> <li>• Adequate illumination seen inside the turbine building</li> </ul>

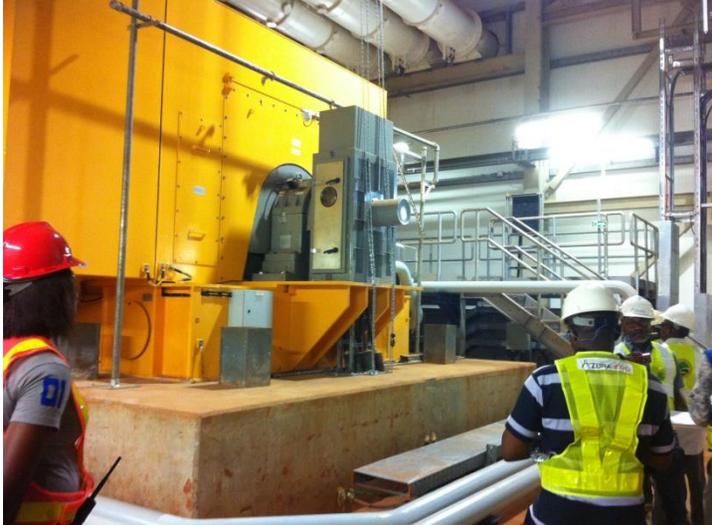
18.	<b>Turbine building</b>	<ul style="list-style-type: none"> <li>• Alternator seen properly installed and aligned.</li> <li>• Side door to the alternator room observed opened. This will reduce the efficiency of the roof heat extractor fans.</li> </ul>

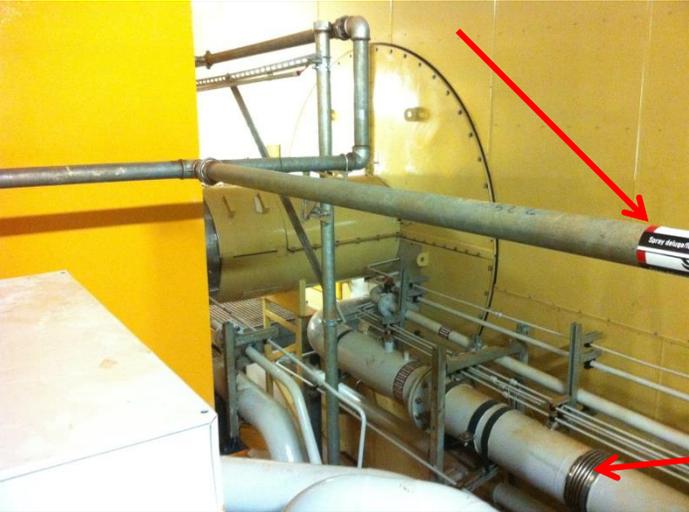
20.	Turbine building	<ul style="list-style-type: none"> <li>• Some form of colour coding on pipes seen.</li> </ul>

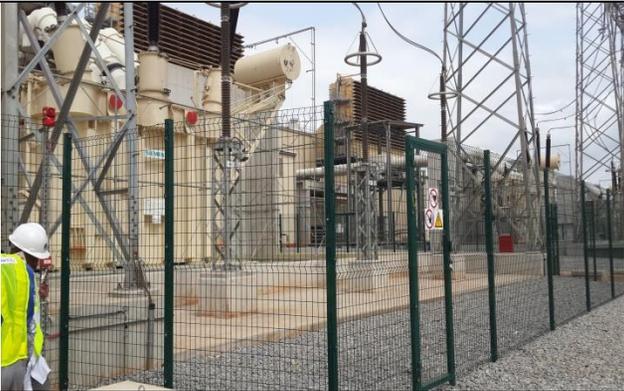
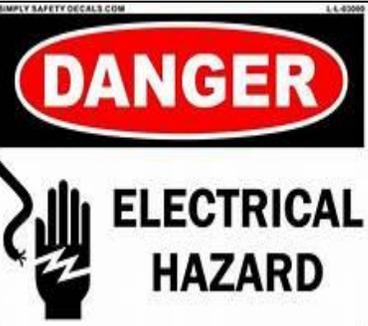
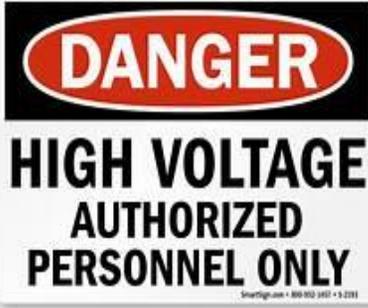
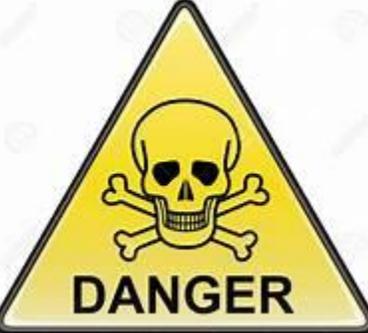
22.	Safety Signs	<ul style="list-style-type: none"> <li>• There were not elaborate safety warning and danger signs in the entire premises.</li> <li>• Some of the safety signs are inadequate as they can be understood only by professionals</li> </ul>

<ul style="list-style-type: none"> <li>• Non-technical people may not be able to interpret the safety signs used in the power plant.</li> </ul>

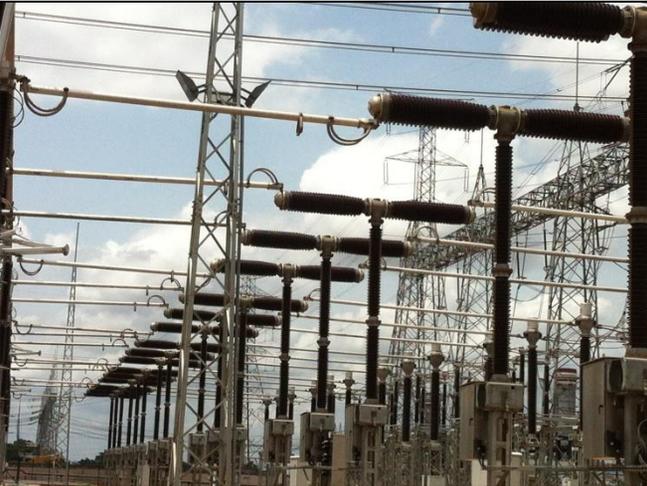
<p>23.</p>	<p><b>330kV Transmission Switchyard</b></p>	<ul style="list-style-type: none"> <li>• The construction of the switchyard is largely adequate.</li> <li>• The switch yard phase indication too tiny to be seen clearly.</li> </ul>
