INSPECTION REPORT OF 330KV SWITCHING STATION AT IKOT EKPENE, AKWA IBOM STATE

INSPECTION REPORT: 330KV SWITCHING STATION

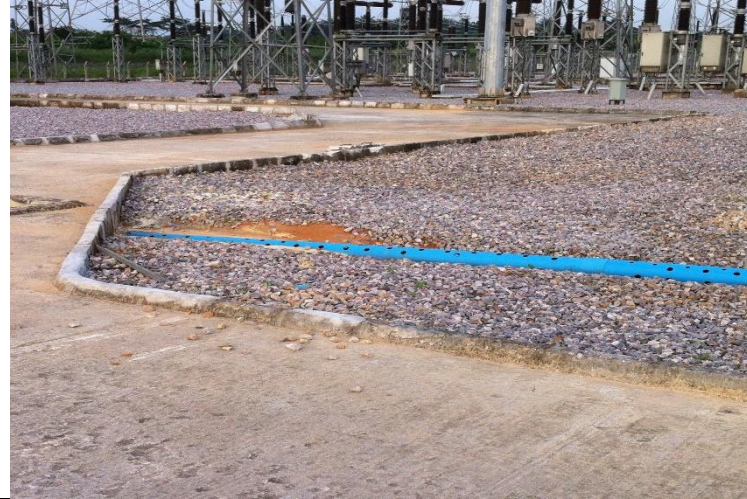
S/No	PROJECT AREA	OBSERVATIONS	PICTURES	RECOMMENDATIONS
1.	SWITCHYARD	<p>1. The Switch Yard has perimeter fencing with wire mesh adequately earthed at different points.</p> <p>2. The switchyard was well graveled and leveled.</p> <p>3. Drainage system was provided to discharge water outside the switchyard, but some drain pipes not yet covered completely with granite.</p> <p>4. The cable trench slabs were not designed uniformly (unsafe), and there are portions of the trenches not covered.</p> <p>5. The CCTV poles in the switchyard were not earthed.</p> <p>6. Flood lights were provided.</p> <p>7. Water retention observed on the walkway.</p>	<div data-bbox="954 252 1507 691" data-label="Image"> </div> <p data-bbox="1529 288 1671 475">Switch Yard Perimeter wire mesh fencing</p> <div data-bbox="954 691 1507 1114" data-label="Image"> </div> <p data-bbox="1529 735 1648 963">Well levelled and graveled switch yard</p>	<p>1. The cable trench slabs should be uniformly designed and arranged for safety. Handles should be flattened to prevent operation personnel tripping over them.</p> <p>2. 36 missing cable trench covers should be provided</p> <p>3. The CCTV poles in the switchyard should be earthed.</p> <p>4. Passage should be made/provided for the water retained on the walkway.</p> <p>5. Granite should cover all drain pipes</p> <p>6. Broken/cracked concrete slabs should be replaced.</p> <p>6. The unfinished areas of wire mesh fencing should be completed.</p>

Uncovered drain pipes

7. The metal gates leading into the switchyard should both be earthed.
8. The surroundings of the switchyard should be kept tidy to avoid reptiles.
9. All pvc pipes through which cables are run into the ground and cable trenches should be sealed.

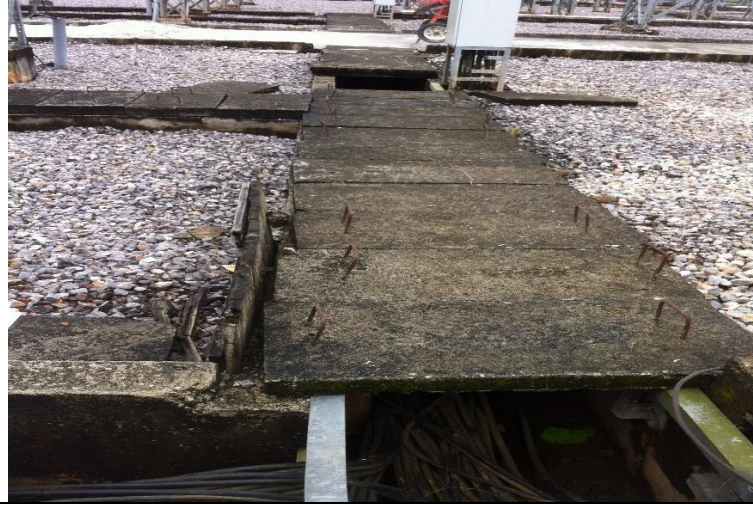
8. Adequate lightning protection seen; both spikes and sky wire lattice.
9. Some pvc pipes through which cables are run into the ground and cable trenches were seen not sealed.

Exposed cable trenches

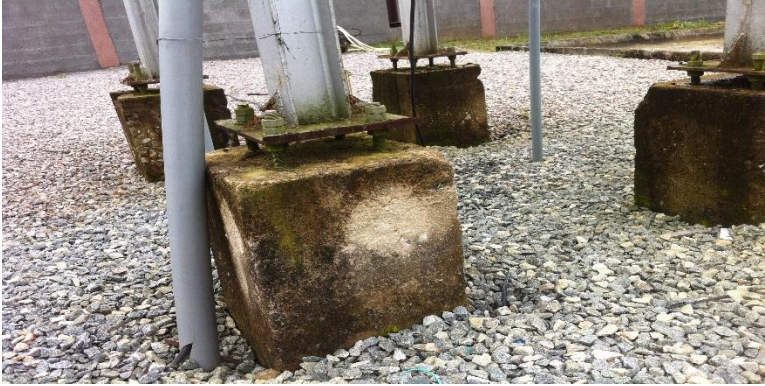
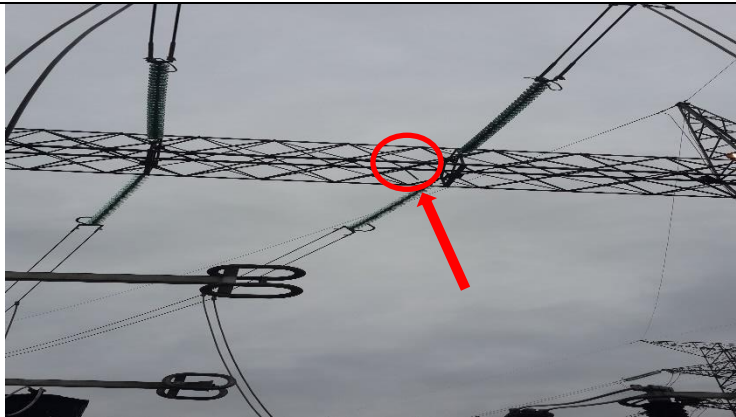
<p>2.</p>	<p>GANTRIES AND FOUNDATION</p>	<p>1. Gantries members were galvanized type; although rusting base plates for some of the equipment were observed on some gantries.</p> <p>2. Missing bracings/members, bolts and nuts were observed at:</p> <ul style="list-style-type: none"> ▪ D01 + Q11DS, D01 + Q22C, ▪ D02+T12C, D02+Q11C ▪ D05+Q12C, <p>3. Hanging/missing members, loose bolts and nuts, rusted bolts and nuts observed on :</p> <ul style="list-style-type: none"> ▪ D02+Q12C, D02+Q11C, D02+Q11B, D02+Q21B, ▪ D06+Q22A, D06+Q32A, ▪ D04+Q11B, D06+Q25C, D04+Q21C, D04+Q21, D06+Q21A <p>4. Poor grating foundation was observed at D02+Q12A.</p>	<p style="text-align: center;">Rusting gantry bases; No grouting.</p>

<p style="text-align: center;">Missing gantry member</p>	<ol style="list-style-type: none"> 1. The contractor should painstakingly go through all the gantries and replace missing members, bolts& nuts, rusted connecting plates and. 2. He should also tighten all loose bolts and nuts and members. 3. The foundations with grating defects should be corrected. 4. All rusted bolts and nuts must be replaced with galvanized types to ensure integrity of the structures and connections.

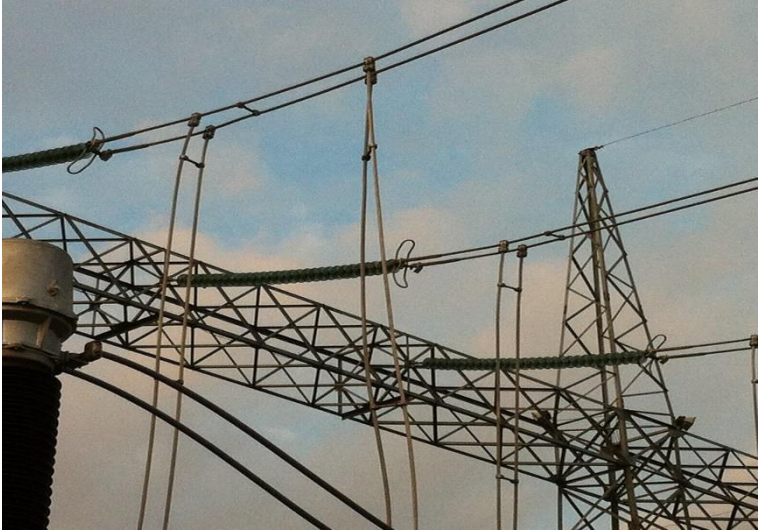
<p>3.</p>	<p>INSULATORS/ ARCING HORNS</p>	<p>1. Only single string of insulators seen used unlike other stations where two are specified and used.</p> <p>2. All the insulators used were of glass type with 20 nos on the line side and 30 nos on the gantry side.</p> <p>3. No broken/cracked insulator was observed. However, we saw:</p> <ul style="list-style-type: none"> - Rusted insulator plate at D04+Q11B, line insulator D06+Q32A <p>4. ALL the arcing horns in the switchyard were not aligned with each other</p> <p>5. No arcing horn (inner) at DO2+F11A</p>

<p>1. The contractor is advised to thoroughly check the insulator plates and replace all rusted/non-galvanized types.</p> <p>2. The arcing horns should be aligned properly to guarantee safety of the insulators and the entire installation.</p> <p>3. All missing arcing horns should be fixed.</p>
------------------	--	--	--	---

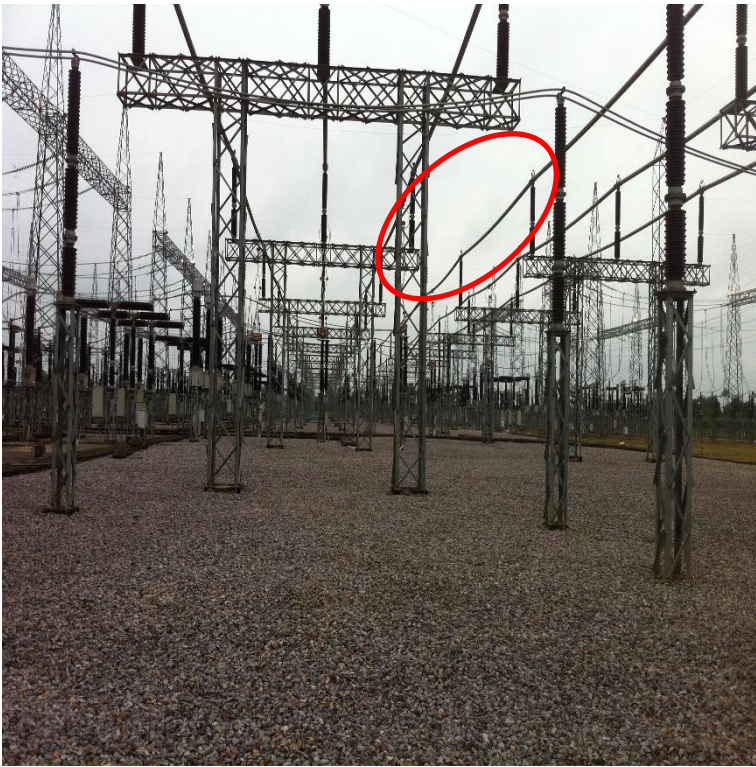
4.	BUS BARS	<p>1. The busbars sections/tubes were seen to be too long and already sagging even without carrying current. They may further sag with current and high ambient temperatures. The contractor explained that vibration dampers cables have been installed inside the bus bars and the weight may have caused the sag. This arrangement is said to be as per design.</p>

<p style="text-align: center;">Sagging busbars</p>	<p>1. Ideally, use of shorter tube lengths or inserting intermediate supports will eliminate the obvious sag seen on the bus bars.</p>
----	-----------------	--	--	--

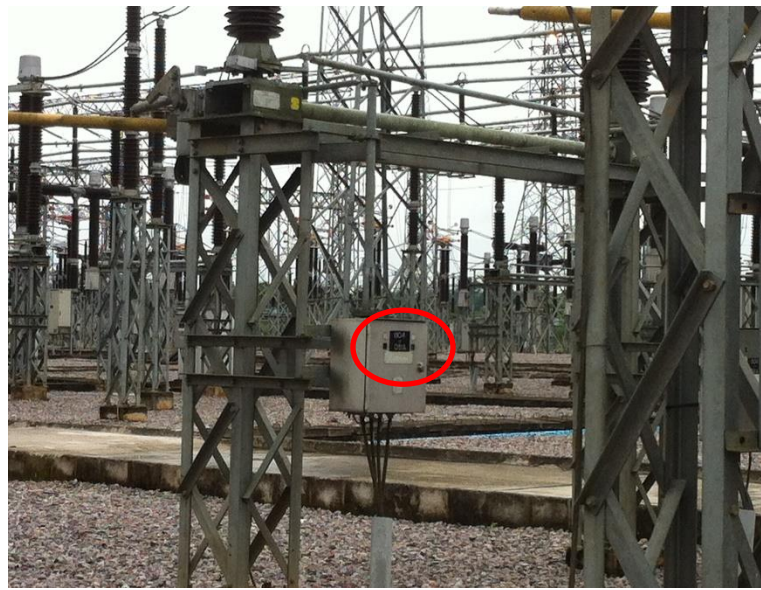
5.	EQUIPMENT LABELLING	<p>1. The equipment in the switchyard were well labeled for easy identification. However detached identification plate was observed at D03+Q22C. Also the labeling of the buses earthing switch did not tally with the one on the control panel.</p> <p>2. No phase identification plates/markers on all the lines, both incoming and outgoing.</p>

<p style="text-align: center;">Equipment labels</p>	<p>1. Phase sequence identification plates/markers should be fixed visibly on all the lines, at both incoming and outgoing gantries/bays for easy identification. Likewise, at the Buses.</p> <p>2. Identification of the various lines should also be done to know easily which is Afam, Alaoji, Calabar, Ikot Abasi and Ugwuaji.</p> <p>3. The labeling of Equipment in the switch yard should tally with the labeling on the control panels.</p>

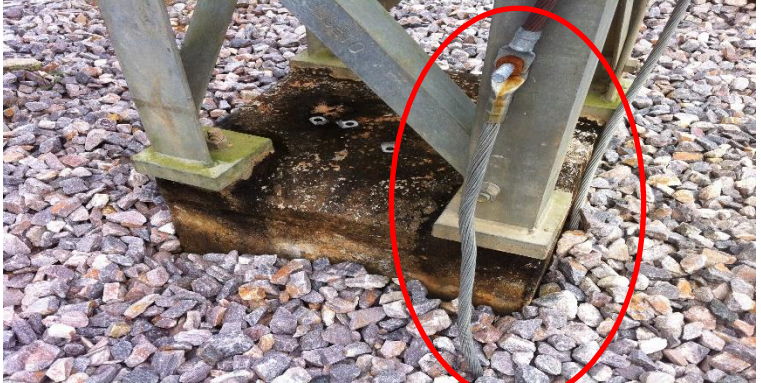
6.	EARTHING SYSTEM	<p>1. All the gantry legs were earthed at 2 points with 70mm² earth wire while hanging earth conductors were observed at D04 incoming Bay gantries (both legs) and D06 outgoing gantry.</p> <p>2. The earth readings obtained were between 0.10 and 2.01 Ohms. This is commendable. Full details of the earth readings are attached in</p>

<p style="text-align: center;">Gantry leg earthing wire</p>	<p>1. The hanging earth conductors should be clamped properly to the gantries leg.</p> <p>2. All open earth pits should be covered with appropriate concrete slabs.</p>

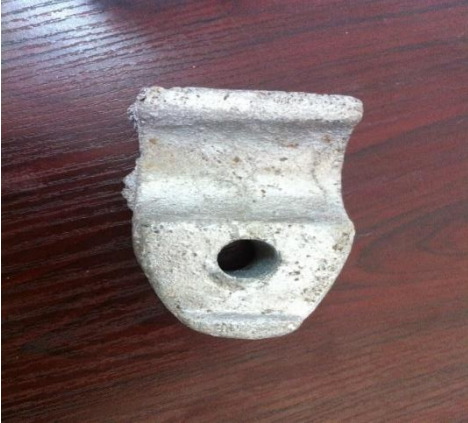
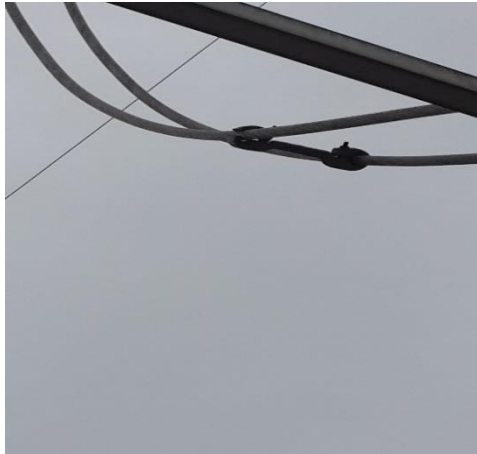
<p>Appendix I. 3. The earth pit points were not covered.</p>		
<p>7.</p>	<p>CONDUCTORS /SPACERS</p>	<p>1. The conductor used observed to be ACSR. 2. Some protruding conductors were observed at various termination points 3. Some of the spacers and accompanying clamps were observed to be improvised, not well clamped/tightened around the conductors, and rusted bolts and nuts were seen used on the spacers. This has serious potential danger for arcing, melting of the conductors and eventual failure of the installation. 4. The conductor down-drops from the incoming lines to the lightning arrestors were seen not aligned properly and some seen were under strain</p>	<p style="text-align: center;">Improvised spacer</p>

<p>1. The protruding conductors should be trimmed to flush at all termination points/ends. 2. The improvised spacers and clamps should be replaced with standard /specified type. 3. All the spacers not well clamped should be properly clamped and well tightened. 4. All conductors and terminations should not be under strain.</p>

1. The improvised spacers and clamps must be replaced to guarantee the safe operations of the switching station.
2. All the arcing horns must be properly aligned to ensure safety of the insulators and the entire switching station.
3. EPC Contractor should carry out a general re-greasing of all disconnecting switches, elbows of pantographs, and contact points of isolators. The hooking points for the insulators on the gantries should be strengthened.
4. The non-functioning energy meters on the control panels should be reactivated or replaced.
5. The CCTV system should be activated.
6. The access road to the station should be properly attended to and tarred.

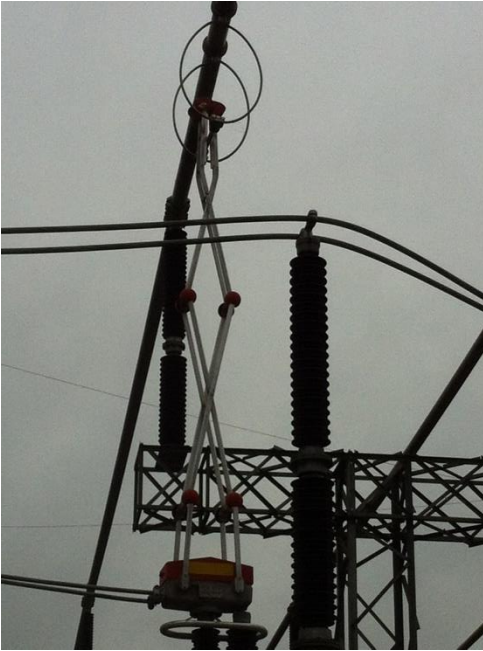
<p>8.</p>	<p>FUNCTIONAL TESTS ON EQUIPMENT</p>	<p>The switchyard equipment operations were observed using:</p> <ol style="list-style-type: none"> 1. Local command test 2. Command via control panel 3. Earthing switches/mechanism operations 4. BCU command test. 5. Some of the equipment were not responding as expected e.g. <ul style="list-style-type: none"> • D02+Q01CB (Circuit Breaker), • D02+Q21 Isolator Switch, • D02+Q02CB, D02+Q03CB, D02+Q81&82 ES (Earth Switch) not aligned properly. 6. All equipment on D03 not responding 7. D04+Q01C SF6 gauges (phase A & B) were observed to be below 0.7bar mark 8. Isolator D05+Q91 (phase C) needs adjustment and earth switches D05+Q81 (phases B&C) not closing well. 	<p>Functional operation of the pantograph disconnectors</p>

<p>9. Circuit breakers D06+Q01CB, Q02CB, Q03CB not responding locally.</p> <p>10. Some cable glands on SF6 circuit breakers not properly fixed.</p>

<ol style="list-style-type: none"> 1. The contractor should painstakingly go through ALL the equipment to ensure that they work properly as intended. 2. All isolator contacts should be greased with petroleum jelly. 3. All commutators of motors installed in control kiosks for the isolators should be cleaned to avoid arcing. 4. All cable glands to be fully secured.

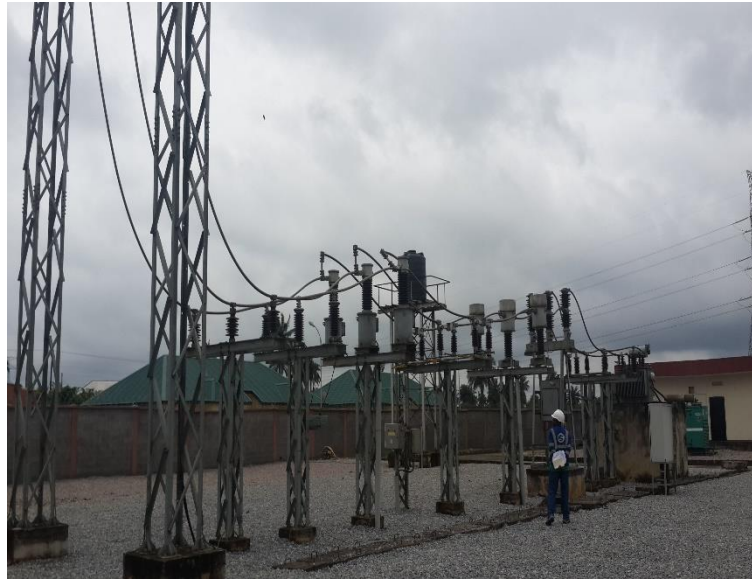
9.	<p>STATION TRANSFORMER (300KVA, 33/0.415KV) AND STATION GENERATOR (125KVA)</p>	<p>1. The 300KVA, 33/0.415KV is fed from an unreliable public utility line</p> <p>2. Undersized cables were used for the connection of the Secondary terminals of the transformer to the energy meter and from the energy meter directly to the control room and to the staff housing quarters.</p> <p>3. All the cross arm channel irons were not earthed.</p> <p>4. The Silica gel was saturated.</p> <p>5. The line isolators were not properly aligned.</p> <p>6. The earth resistance reading is very high (17.2 Ohms)</p> <p>7. The generator was not earthed (358Ω)</p> <p>8. The overhead water reservoir steel support close to</p>

<p>300KVA, 33/0.415KV station transformer supplied from unreliable public power supply.</p>	<p>1. Reliable station power supply should be provided in the form of either a dedicated station transformer, or a dedicated 33KV public supply, or two synchronized station generators, each genset being capable of carrying the load of the station.</p> <p>2. Appropriately sized cables should be used for the auxiliary transformer connections to the control room and staff quarters. Protection circuit breakers should be provided on the transformer secondary.</p> <p>3. All the cross arm channel irons should be properly earthed</p> <p>4. The saturated silica gel</p>

<p>the transformer was not earthed.</p> <p>9. The water tank stand/foundation bolts not grouted.</p>		<p>should be replaced</p> <p>5. The line insulator should be realigned to prevent arcing</p> <p>6. The earth resistance should be improved upon</p> <p>7. The generator and water reservoir tank should be earthed</p> <p>8. The water tank stand should be properly grouted.</p>
10.	BATTERY ROOM	<p>1. Wash hand basin was installed, extractor fan installed, smoke detector installed</p> <p>2. Hanging lightning point wire seen.</p> <p>3. Lighting fittings not working</p> <p>4. Metallic door not earthed</p>

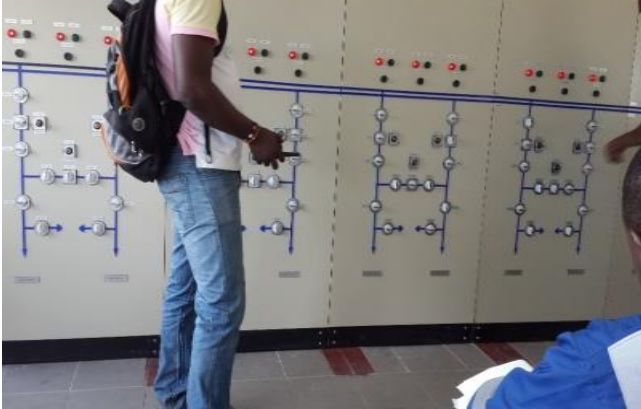
<p>11.</p>	<p>CONTROL ROOM</p>	<ol style="list-style-type: none"> 1. TCN trained operators were seen and demonstrated familiarity with the operations of the switching station. 2. Outside security light not working 3. Some inner lighting points were not working 4. All the metallic doors were not earthed 5. Insulation rubber mat was not provided for the control panels. 6. Electric shock treatment chart was not provided in the control room. 7. Cable trench metallic covers not earthed 8. Control panel labeling was in line with the labeling at the switch yard. 9. Air-conditioning in BCU room not functioning. 10. Ceramic tiles in corridor between control room and offices broken and constitutes danger of people tripping. 11. Cable trench behind 	<p style="text-align: center;">Front view of the control panels</p>

<ol style="list-style-type: none"> 1. All the security lights should be fixed. 2. The inner lighting points should be made functional. 3. All the metallic doors should be earthed 4. Insulation rubber mat should be provided and laid around the control panels. 5. Electric shock treatment chart should be provided. 6. Cable trench metallic covers should be earthed. 7. The air-conditioners in the BCU room should be repaired and made functional. 8. Replace all missing /broken floor tiles. 9. Cover the cable trench and seal entry ducts to the control with appropriate compound. 10. SCADA communication with National Control Centre should be made operational.

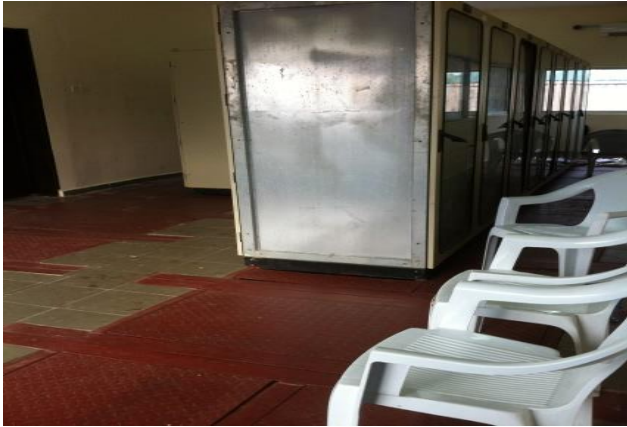
<p style="text-align: center;">Rear view of the control panel</p>

<p>control room not covered and the entry points not seal. This could be a source of rodents entering the control room.</p> <p>12. SCADA panel installed but not demonstrated as working.</p>
