ELECTRICITY MANAGEMENT SERVICES LIMITED

RE: CONSTRUCTION OF 132KV LINE AND 2 x 30 MVA, 132/33KV SUBSTATION AT OGHARA, DELTA STATE

SUMMARY OF OBSERVATIONS AND RECOMMENDATION

Dates of Inspection: 13th & 14th FEBRUARY, 2015

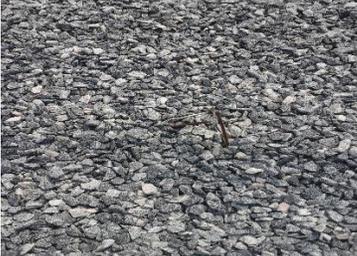
2.	The entire Sub-station equipment were well laid and graveled with adequate drainage for total drainage of water due to rainfall.	The protruding iron rods around Transformer B area should be cut/ removed to avoid possible injuries to personnel/operators.

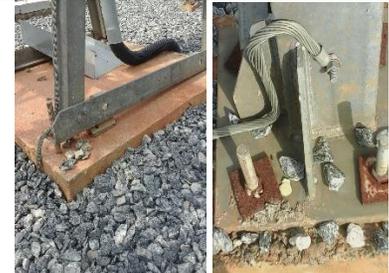
3.	The gantries support foundation were properly cast with adequate ground clearances, however, usage of non-galvanised foundation bolts and nuts had been observed. Other observation are non-grouting of foundation bolts and loosening/absence of nuts on some gantries foundations.	The non-galvanised gantries foundation bolts and nuts should be replaced with galvanized ones or adequately treated to prevent rusting/corroding. The missing nuts should be replaced while the loosening bolts should be re-tightened.

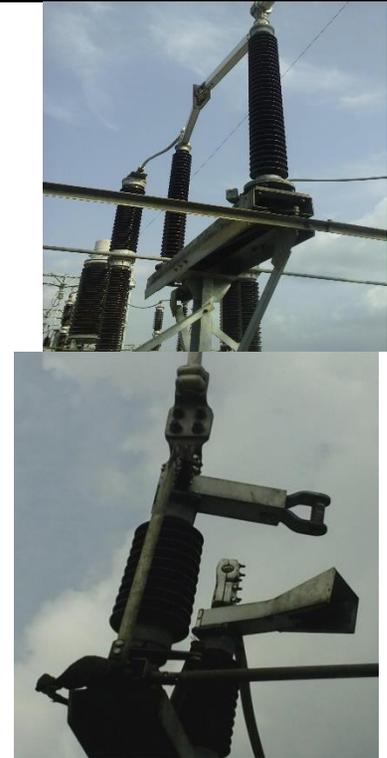
4. During the substation equipment functional test demonstration, the following were observed:

- The switching/controlling equipment in the switching yard were not labelled at all for easy identification in relation to the labelling of the control panel.
- Some isolator were not opening fully on both remote and manual operation
- The circuit breakers for the 33kV outgoing feeders' Bus bar B were not operating remotely.
- Some earthing switches were not making proper contact on closing as a result of improper opening of the respective isolators.
- Isolators' mechanism for the 132kV side shook vigorously while in operation due to unfirm/solid gantries.

- The switching/controlling equipment in the substation should be properly labeled in line with the control room labeling.
- The affected isolators should be re-aligned/adjusted to open fully on both remote and manual operations.
- The wiring of the affected circuit breakers should be reviewed to ensure that they operate smoothly on both remote and manual operation.
- While re-aligning/adjusting the affected isolators, it should be ensured that the earthing switches are making proper contact.
- The support gantries for the isolator mechanism should be re-enforced for firmness/solid enough to withstand the switching/operations of the Isolator.

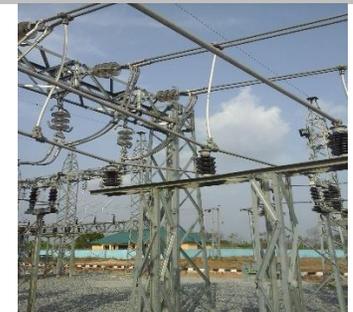
5. The arcing horns on the 132kV and 33kV sides of the substation gantries were not properly aligned.

All the arcing horns should be properly aligned in order to achieve its usefulness.

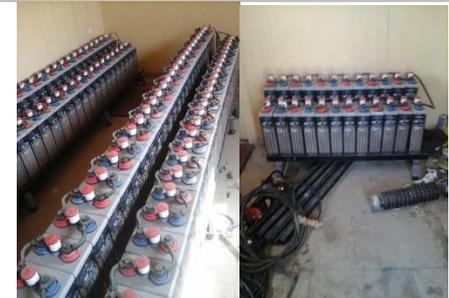
9. The 110V and 48V batteries band rooms were spacious and have been provided with extractor fans. However, eyewash basin has not been installed in the battery rooms. Eyewash basin should be installed in both battery rooms.

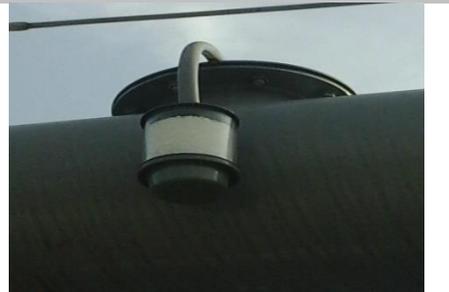
10. The silica jell provided for the transformers were not the conventional types (blue) that turns brown upon saturation; that is when it has performed its function. The silica jell should be changed to the conventional type which is more familiar to our operators.

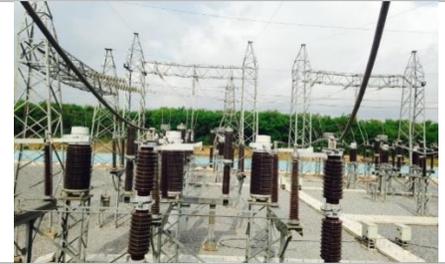
11. They were no phase identification marks at the turn-in-turn-out connecting bays.

Phase identification marks should be provided/fixed on the turn-in-turn-out connecting bays for easier phase identification.

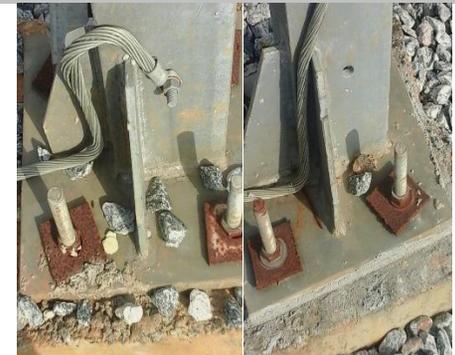
12. Rusted/corroded gantries foundation bolts and nuts were observed within the substation yard.

All bolts and nuts used for the gantries should be galvanized.
