REPORT ON INSPECTION AND TESTING OF THE PARAS ENERGY 90MW POWER
STATION AT OGIJO, OGUN STATE
26TH AND 27TH FEBRUARY 2015.

INSPECTION OF PARAS ENERGY 90 MW GENERATION POWER PLANT AND 33KV/132KV SUBSTATION IN OGIJO, OGUN STATE

ON 26TH AND 27TH FEBRUARY 2015

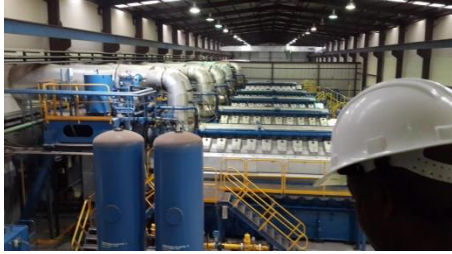
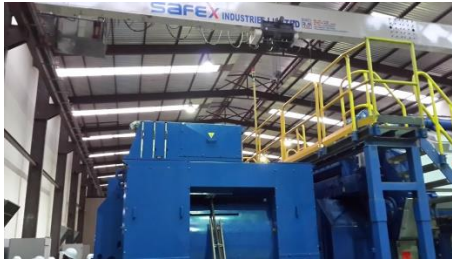
S/NO.	PROJECT AREA	OBSERVATIONS	PICTORIAL VIEW OF ITEM	RECOMMENDATION
1.	GENERATING STATION	<p>There are nine gas-fired 20-cylinder Wortsila Type 20V34SG gas-fired fuel efficient reciprocating engines. The 20V-engines are coupled to 11KV ABB alternators with details as below:</p> <ol style="list-style-type: none"> 1. GEN-1: 8.73MW 2. GEN-2: 8.73MW 3. GEN-3: 9.73MW 4. GEN-4: 9.73MW 5. GEN-5: 9.73MW 6. GEN-6: 9.73MW 7. GEN-7: 9.73MW 8. GEN-8: 9.73MW 9. GEN-9: 9.73MW

<p>It is recommended that the numbering of Generators 6 to 9 [GEN-6, GEN-7, GEN-8, GEN-9] should be completed as done for Generators 1 to 5.</p>
		<p>The Power Plant is well laid out with adequate provision for maintenance space. Floor of generator areas was treated with Dipox epoxy coating for prevention of ingress of oils and solvents onto the generators bases; also for ease of cleaning and generally for good housekeeping.</p>

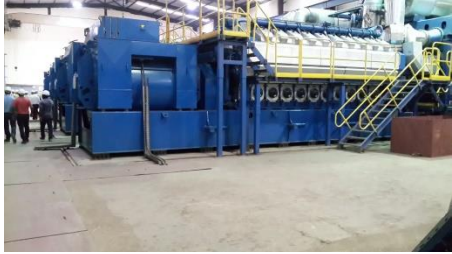
<p>Commendable Layout and installation.</p>

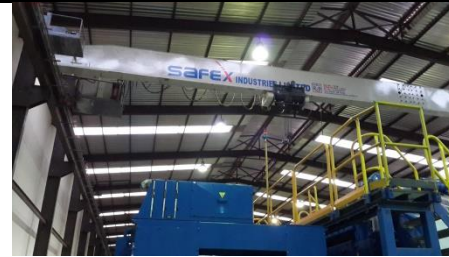
Two overhead cranes of 2-tonnes were provided and were found well maintained. Regular safety tests are carried out on them.

SOP for the cranes should be provided.

Regular Safe Working Load Test should be carried out and documented.

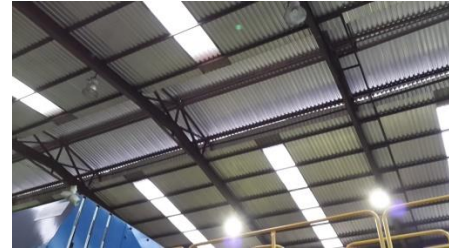
The generator area is well lit with both natural lighting and flood lights. However three of the flood lights bulbs were found not functioning.

The faulty lighting units should be repaired and burnt bulbs replaced.

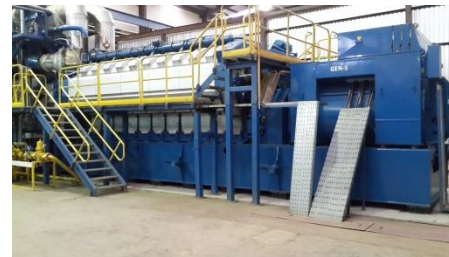
The hand rails and other stand-alone barriers were seen painted with yellow, same colour as the gas lines.

The handrails and other stand-alone barriers should be painted alternate black and yellow stripes.

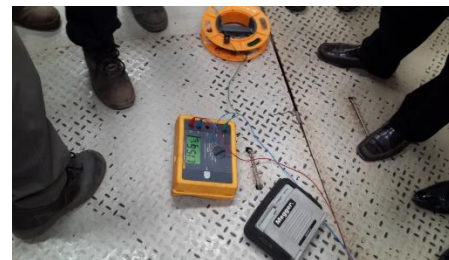
The earth resistance of all the generators were measured and found to be as in Appendix 3. However the earth resistance of the handrails and steps were high.

An improvement on the earth resistance of the handrail and steps could be achieved by connecting them to earth continuity as done in the workshop area as shown below.

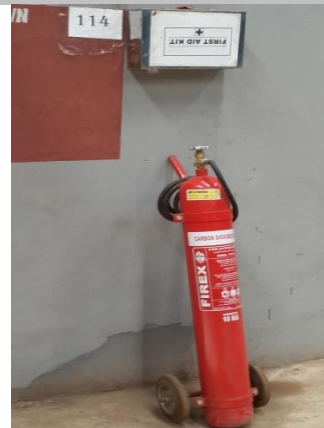
The First Aid box label in the generator area was upside down.

Please reverse this label.

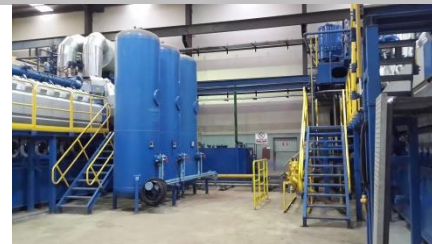
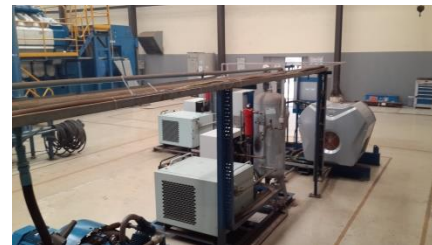
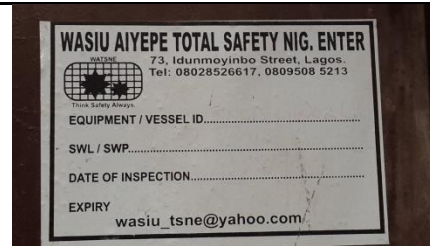
The air compressors and the compressed air receivers/surge vessels were well installed.

However, there was no evidence of SWP routine hydrostatic tests done on the body of the air vessels.

All air receivers/vessels must be hydrostatically tested with labels on the body showing SWP, Test pressure and Date of last test.

All OH cranes/hoists must be tested and labeled on the body showing SWL and Date tested.

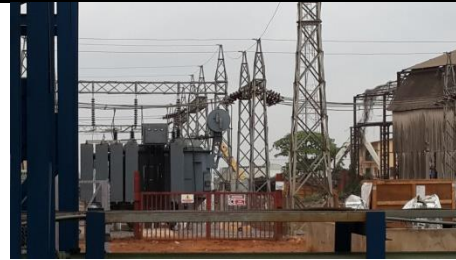
However, part of the extension of the substation to a future expansion was not enclosed in the main substation fenced-off area.

It is recommended that all equipment associated with the substation should be fenced in even though this particular portion is not energized but is structurally linked with the rest of the substation.

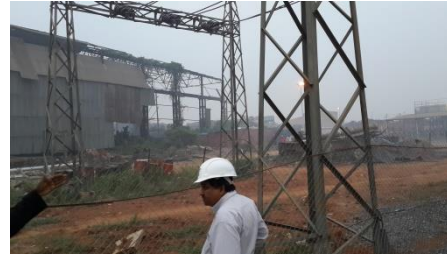
Some gantries bearing lightning protection skywires are located outside the fenced off area of the substation.

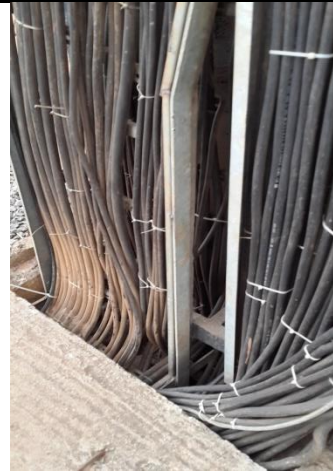
Some portions of the cable trenches leading into the main building are exposed.

The exposed portions of the cable trenches leading into the main building should be covered to avoid entry of rodents and flooding.

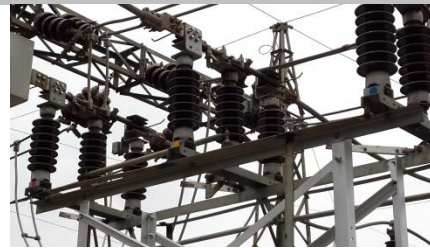
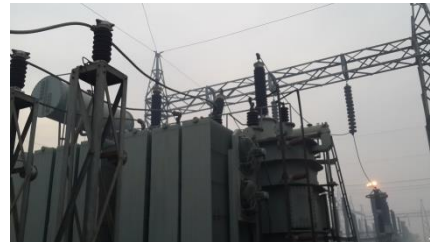
The phase indication on the 40MVA breakers and isolators was in conflict with the phase sequence, red and blue were interchanged.

It is recommended that all phase indicators be aligned with the transformers and the incoming/outgoing TCN lines.

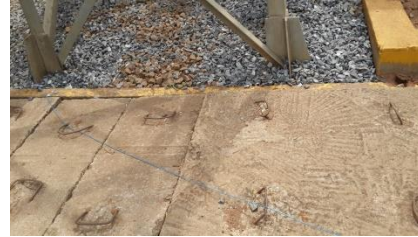
The cable trench covers had some of the lifting handles turned inwards, some turned outwards making tripping of personnel inevitable.

These should be uniformly turned outwards, thereby also providing more and unimpeded movement space.

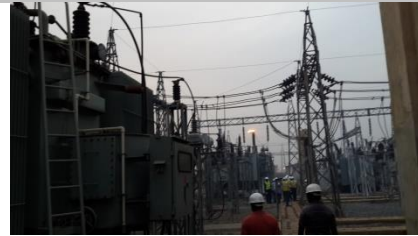
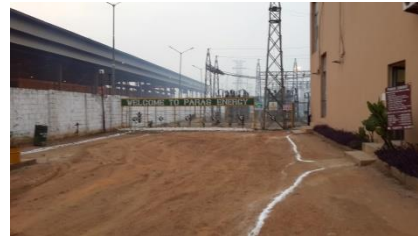
The lighting in the substation was extremely poor and in the night of day 1 of our visit the entire substation was in darkness.

It is recommended to ensure that any faulty illumination installation be rectified.

If none were really available as we observed then it is essential that the substation is adequately illuminated all round the periphery of the substation with the lights shining into the switchyard.

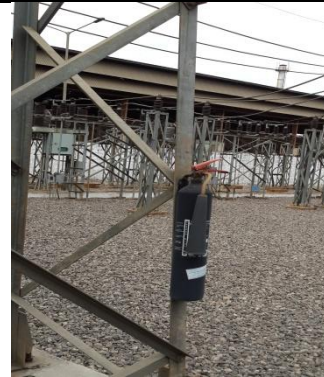
Fire extinguishers were located at strategic positions in the substation. They were standard CO₂ types. However they were exposed to weather and could malfunction as a result.

It is recommended that the top of the fire extinguishers be covered and protected particularly from rain.

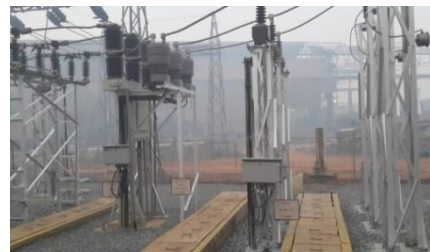
However the smoke emanating from the adjoining steel manufacturing process is inimical to the environment and workers.

It is recommended that processes be put in place to ameliorate environmental pollution and to protect the health of the workers.

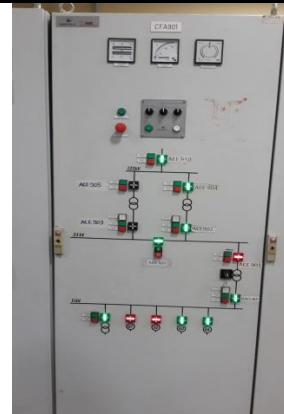
The indicators on the Generator controls are reversed, showing “Green” for breaker on and “Red” for breaker off. This is incorrect, is confusing to operators, and may be unsafe for operational and maintenance situations and personnel.

Indicators must be uniform throughout the plant in order to forestall accidents and confusion. “Red” for Breaker on, and “Green” for breaker off should be made as standard.

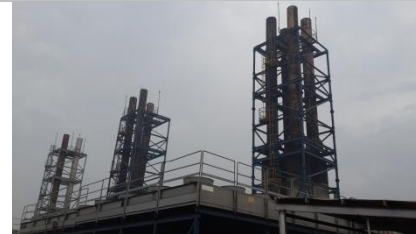
Lightning arrestors were provided at the highest points in the power station (at the exhaust stacks), main building, gas stations; and the substation proper.

Lightning protection using radial coverage type should be provided as a matter of priority for the safety of lives and installed equipment.

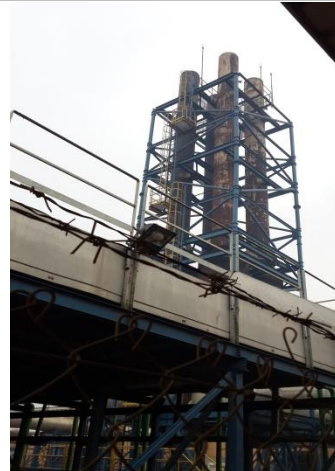
The exhaust stacks were observed rusting.

It is recommended that adequate stack surface preparation, priming with weather-proof undercoat and final coating with High Temperature Aluminium (HTA) be done to preserve these stacks.

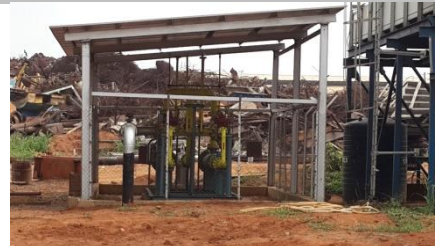
The two gas regulating stations were adequately constructed. All the metal stanchions were found adequately connected to earth. Spike lightning arrestors were installed on top of each of the sheds.

The earth resistance readings on the near side unit however were relatively high at 4.32 – 5.43 ohms

Improvement of earth resistance recommended so as to obtain values of 2 ohms and less.

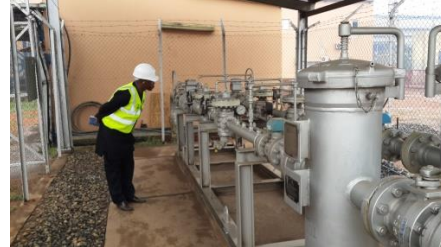
The near-side gas station pipes and equipment were still in aluminium colour.

The gas installation and equipment and should be painted yellow as has been done on the other station.
