ELECTRICITY MANAGEMENT SERVICES LIMITED

INSPECTION REPORT OF JOS-MAKURDI 330KV DC OVERHEAD TRANSMISSION LINE

Your letter No NIPP/TRX/2041/2014 dated 28th November, 2014 on the above subject matter refers. Please be informed that the Inspection/Test of Makurdi – Jos 330KV (DC) OHTL with the associated Makurdi 330/132/33KV substation and 330KV line bays extension at Jos was carried out between 8th and 14th December, 2014. The following persons were present for the exercise;

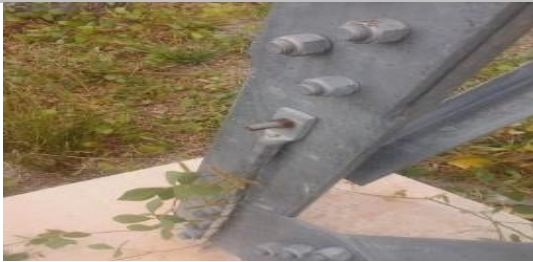
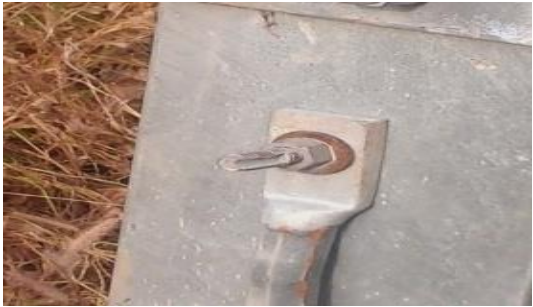
S/NO.	PROJECT AREA	OBSERVATION	PICTORIAL ILLUSTRATIONS	RECOMMENDATIONS
1.	Tower structures and Foundations	<p>The 330KV DC Makurdi – Jos OHTL were seen supported on towers made of galvanized steel lattice construction. Each of the tower legs were firmly erected on rectangular concrete foundation (bases). Anti-vandals (specially made) bolts and nuts were used for fixing the tower members. Also the step bolts used for the erection of the tower were still in position at the time of our inspection visit</p> <p>The following were also observed;</p> <p>i. The integrity of the</p>

anti-vandals bolts and nuts used were not adequately demonstrated by the contractors.

<p>i. In order to prevent easy climbing access by vandals, all the step bolts below the anti-climbing devices should be removed from position as advised</p> <p>ii. The contractor is expected to demonstrate the integrity of the anti-vandals bolts and nuts used in the construction of the towers</p> <p>iii. All tower location within visible erosion</p>

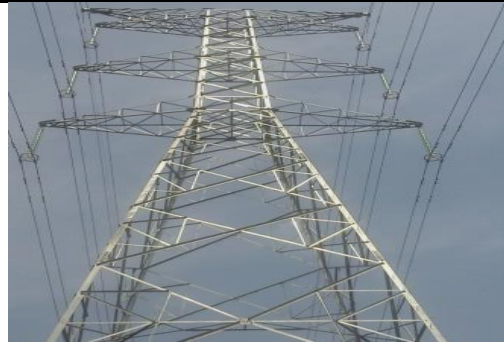
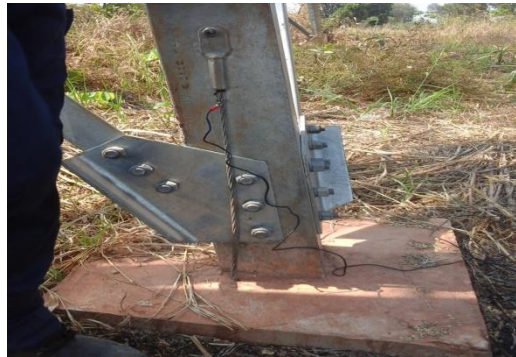
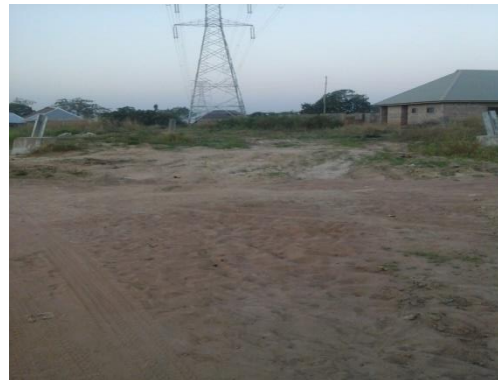
ii. Some chimneys were observed completely buried and there was also indication of water retention at the tower legs (T133, T160, T208, T288, T529)

iii. Loose nuts and bolts were observed on some towers (T217, T655 – Leg “B”)

iv. On some towers, improvised holes for fixing of anti-climbing devices were not adequately treated against rust (T246, T277)

v. Excavations for laterite observed occurring in close proximity to some towers (T20, T36, T529)

vi. Some of the bolts and nuts used for fixing the earthing conductors on the tower legs were observed rusting (T234)

prone areas along the entire transmission route length, should be provided with erosion control measures

iv. All observed loose bolts and nuts on the towers should be re-tightened

v. Improvised holes for fixing of anti-climbing devices should be treated against rust using zinc-oxide paint as supposed to the aluminum paint employed

vi. All excavation works within the vicinity of the towers should be stopped and towers already affected by excavations need to be protected by barriers/embankment

vii. All rusting/non-galvanized bolts and nuts for fixing earth wire conductors to the tower legs should be replaced

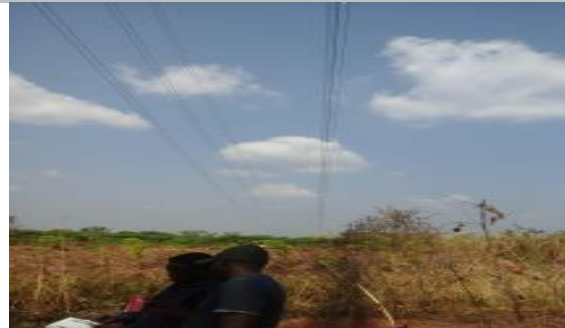
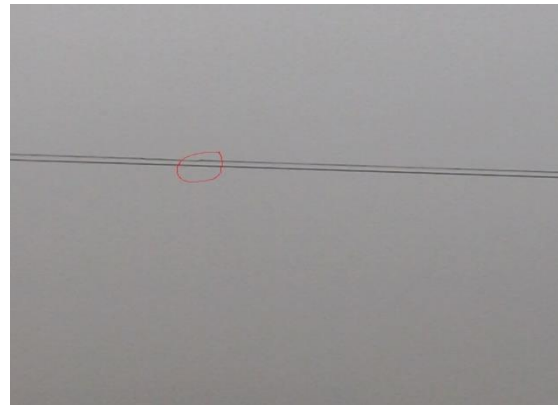
- i. The OPGW link to T8 was disconnected
- ii. All conductors of the two circuits were joined at some points between towers (T285 and T286), thereby creating a point of possible failure in the future

- i. The OPGW link to T8 tower should be reconnected to the tower
- ii. The joined points of the conductors should be carefully observed for sign of un-stranding and this should be avoided in subsequent projects. TCN should also be notified of the locations for close monitoring when the lines are put to use

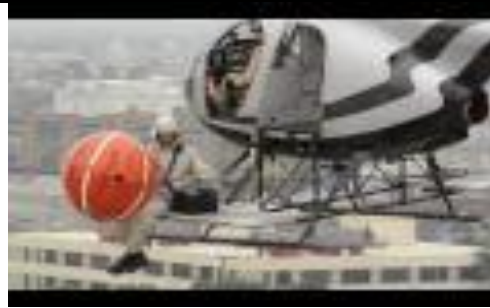
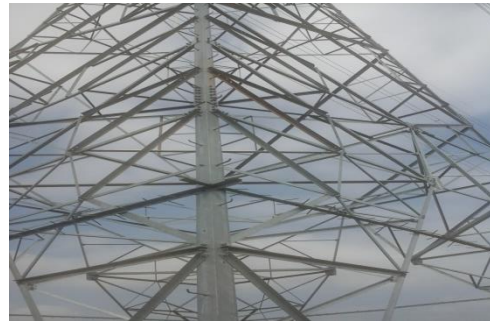
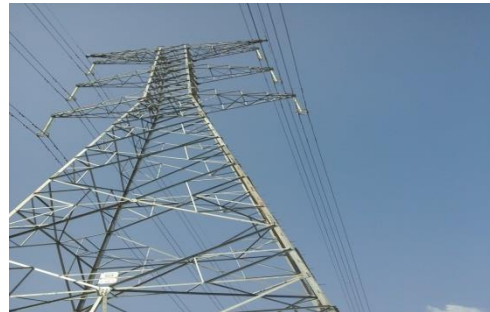
Anti-climbing devices and danger plates have been provided/fitted on all the towers from Makurdi to Jos as per design. However, it was noticed that the already fitted phase identification plates for the two circuits were done on the cross-arms and they are not readily visible. Aerial identification plates were seen provided on the overhead transmission towers at intervals of about 10 towers apart, these are also not readily visible. Other observations are;

- i. Disparity of phase identification observed on tower (T240)
- ii. Considering the existence of a major Nigerian Airforce base in Makurdi, there were no aerial marker balls on the transmission lines.

- i. The phase indication should be adjusted to ensure right sequencing/order
- ii. Aerial marker balls should be fitted on the uppermost conductors of the transmission lines
- iii. The phase identification plates should be lowered for better visibility

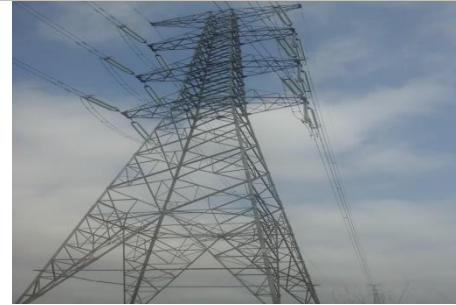
4. OHTL Stabilization Facilities From thorough inspections and checks, insulators, spacers, vibration dampers and corona rings were provided and properly erected except we noticed loose dampers on tower (T277) which may have the tendency of coming in contact with the nearest conductor spacer.

The loose dampers should be re-tightened to avoid possible archings when in contact with the spacers.

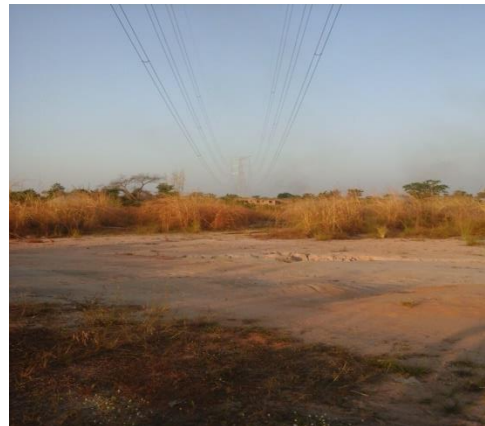
5. 330KV OHTL Status The tensioning of the 330KV OHTL at some sections were observed not uniformly executed as can be seen from conductors imbalance (mismatch) per phase at the span between towers (T248 and T249) (red phase conductors of circuit 2), also between towers (T249 and T250).

These conductors mismatch should be corrected to achieve the required tensioning uniformity.

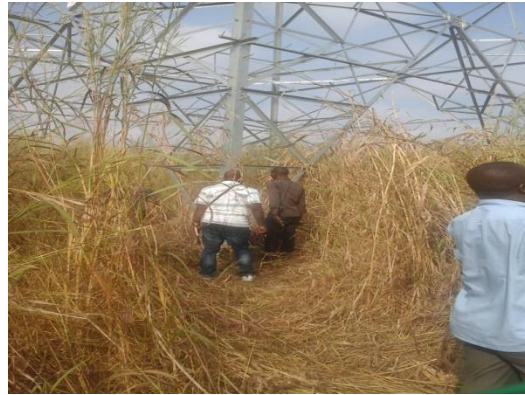
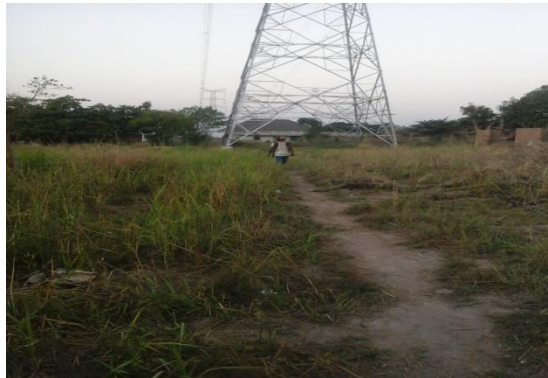
The terrain traversed by the 330KV DC OHTL is a difficult one with abundant visible gulleys, heavy vegetation, swampy areas, hills and mountains, built-up areas; refer to areas between towers (T45 and T52, T160 and T161, T173 and T174, T252 and T253, T266 and T267, T275 and T279, T554 and T555, T652 and T654, T671 and T672) etc.

Contrary to the contractors claim on provision of motorable access earth road along the OHTL route, it was discovered that the access road has been overtaken by shrubs, cultivated farm lands, vegetation encroachments etc.

The line trace should be properly and adequately maintained and secured. Appropriate procedures need to be put in place by the Contractor to ensure clear access along the entire route.

All erosion prone areas should be adequately backfilled and compacted.

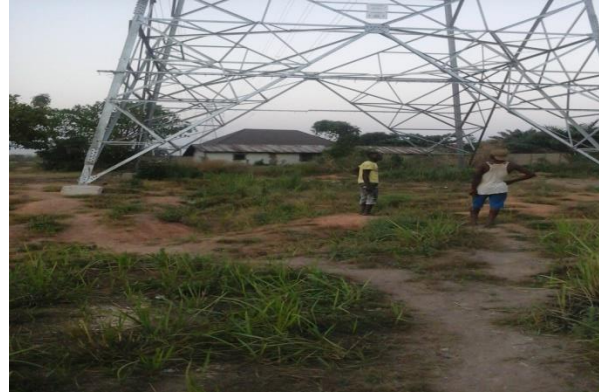
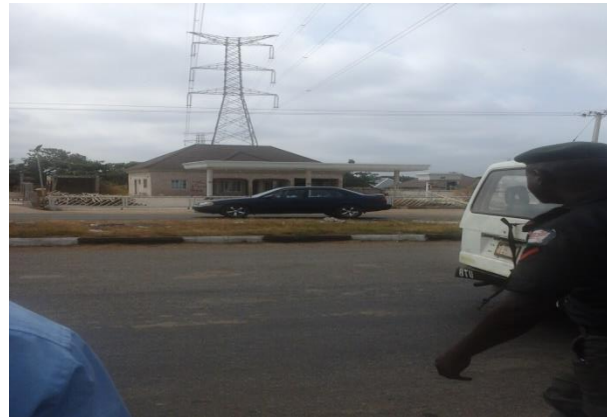
7. 330KV OHTL Crossings Observations also revealed that there were no railway lines crossings along the trace of the 330KV DC OHTL. However, the line crosses Benue river between towers (T37, T38 and T39) and it also crosses existing 33KV, 11KV and 0.415KV OH lines at many locations. It also crosses some major roads. At all these crossings, statutory safety clearances were maintained throughout the lines route. Other observations are seen as in appendix II

- i. The 330KV OHTL passes over buildings between towers (T24 – T25), (T33+1 – T34), (T231 – T232), (T232 – T233), (T263 – T264), (T653 – T654), (T671 – T672)

- i. All existing structures within the right of way of the transmission line should be demolished.
- ii. The contractor should liaise with the respective distribution companies to ensure that all channel irons of the 33/11KV lines at the crossings of the 330KV OHTL are appropriately earthed.

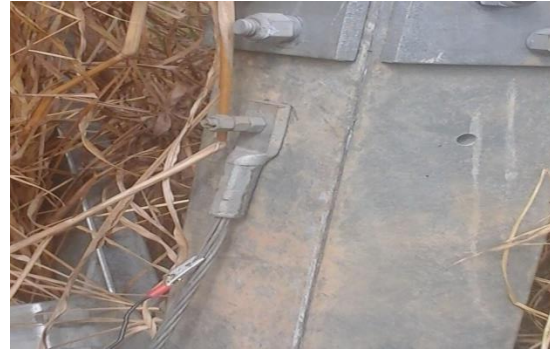
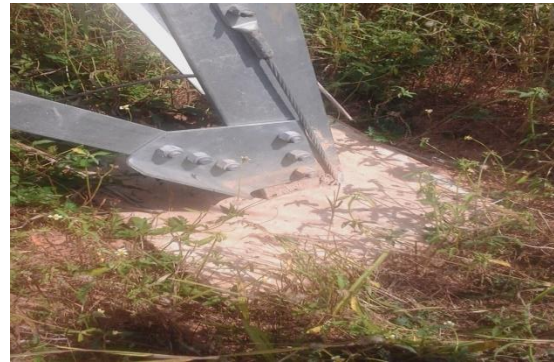
In both cases, physical earth connection to the tower legs was seen and visible. The results of the random earth resistance measurement tests for the tower legs were as recorded in appendix III

The contractor should carry out further earthing improvements for all earthing resistance above 10 Ω

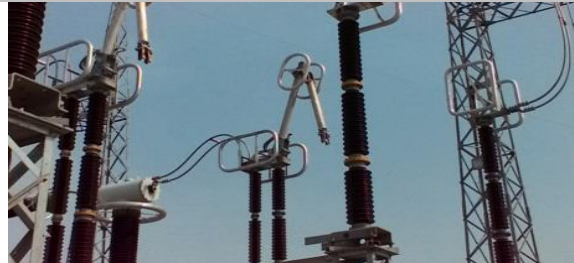
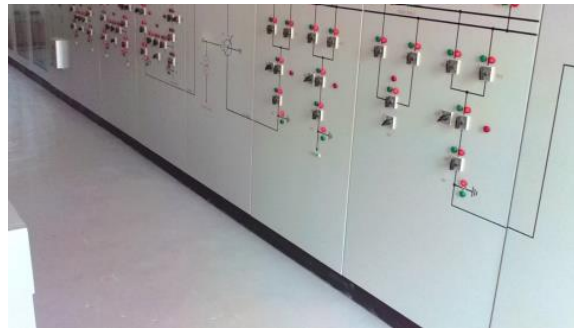
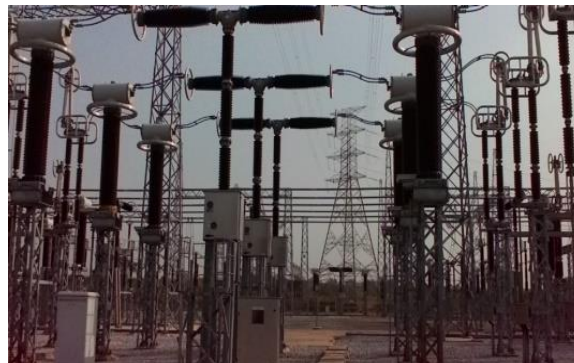
- i. Remote/manual and automatic operations of all isolators and circuit breakers
- ii. Operation of all earthing switches
- iii. Relay injection simulation test to verify differential, overcurrent and earth fault protection schemes were not demonstrated
- iv. Tripping of circuit breakers in response to actuation of Bucholz relay and

transformer
pressure release
valves were not
demonstrated

- i. The contractor should carry out relay injection simulation test to verify differential, overcurrent and earth fault protection schemes in the presence of EMSL engineers
- ii. Likewise, the tripping of circuit breaker in response to actuation of Bucholz relay and transformer pressure release valves

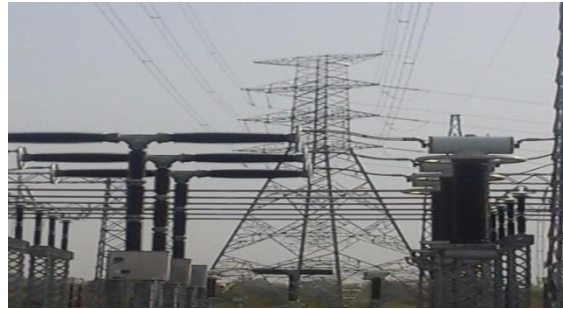
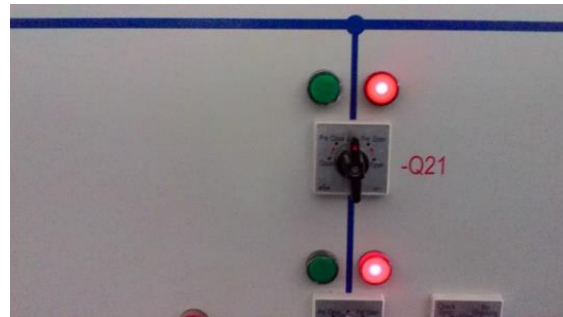
- i. The ugwuaji 330KV
DC lines run over
the substation. This
is a potentially very
dangerous design
as non-isolated live
lines will be
running over a
supposedly dead
station when the
breakers are in
open position
- ii. On the main
substation control
panel, clockwise
rotation of
operating switches
turn off the
respective
substation devices
whilst anti-
clockwise direction
turns them on. This
is against normal
practice/standard

- iii. The running of
ugwuaji 330KV DC
lines over the
substation is unsafe.
A diversion to clear
the substation is
recommended

- iv. The control panel
switches should be
re-wired to conform
to standard, which is
clockwise to "ON"
and anti-clockwise to
"OFF"

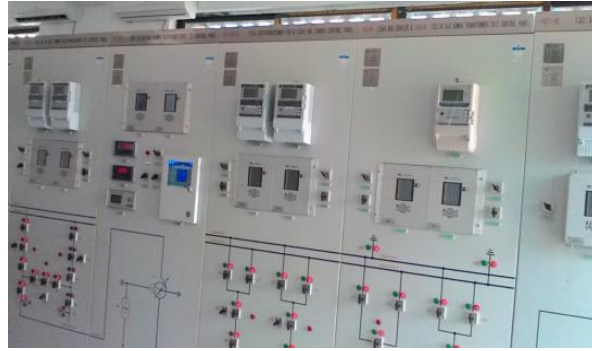
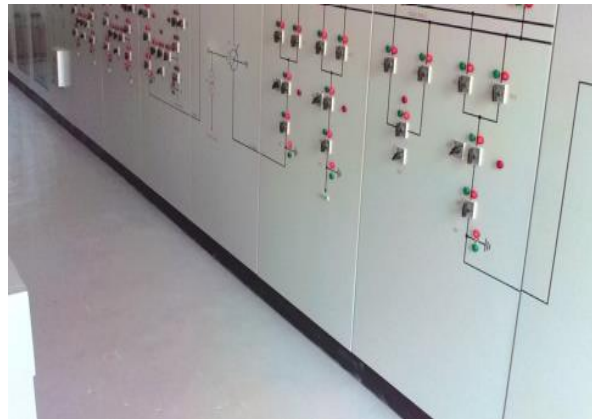
-
- of clockwise ON and anticlockwise OFF
- iii. On the main substation control panel, the indicators are Green when the substation equipment is ON and RED when the equipment is OFF. This is against standard practice and design of having indicators to be RED when the units are ON, and GREEN, when the units are OFF. It was observed that in the main substation, local indicators on the Circuit Breakers show RED on CLOSE and GREEN on OPEN, which is directly opposite to what happens in the Control room. This is confusing and unsafe

- v. The control panel indicators should also be re-wired to indicate RED when the units are ON and green when the units are OFF

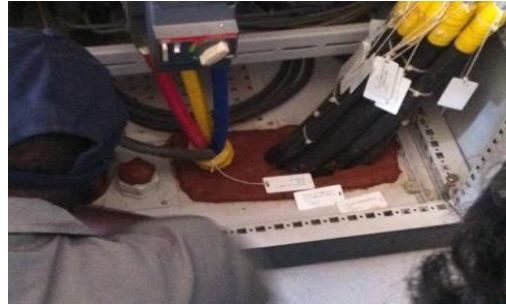
iv. No insulation rubber mats provided for all the panels in the control room

v. A lot of the cable entries into the panels do not have cable glands, and the sealing compound used may degrade over time

vi. Contractor to provide insulated rubber mats on all control panel floors

vii. Appropriate cable glands should be used, while all panel entries sealed to prevent rodents from gaining access to the panel

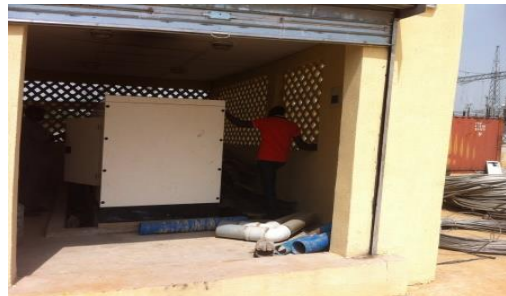
vi. The contractor could not demonstrate the operation of the changeover switch/interlock between the station's 415V supply and the standby generator supply

vii. The exhaust of the generator was within the generator room

viii. Although the main 150MVA transformer oil temperatures were being indicated on

the Control panel, there was no indication for the transformer winding temperature.

Relying on the oil temperature may not give an accurate indication of the transformer windings temperatures

viii. Generator, main supply, changeover/interlock operation should be demonstrated prior to handing over the substation

ix. The exhaust of the standby generator should be moved out of the generator room

x. Appropriate means of monitoring transformer windings temperatures should be installed in the control room

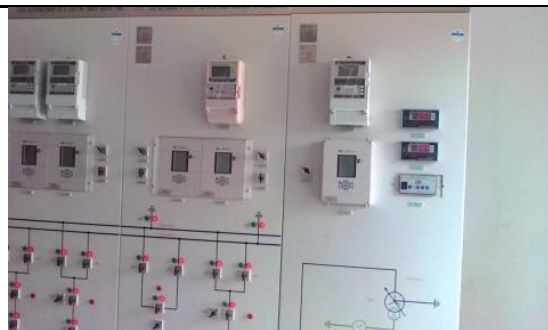
- ix. Some of the labelling on the control panel are not explicit enough. On some panels the upper label indicates Jos 2- Jos 1 whilst the line diagram below indicates Jos 1- Jos 2

- xi. The labelling in the control room should be consistent and explicit

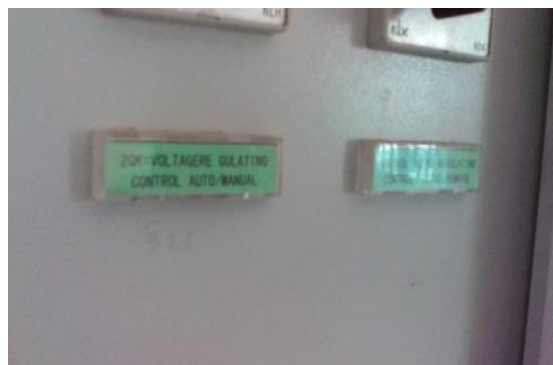
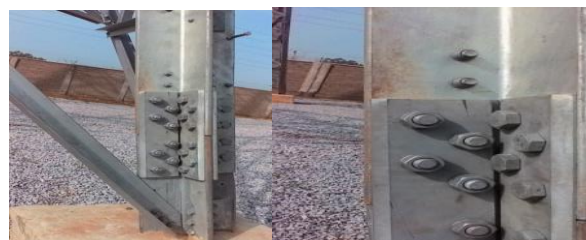
- x. Some bolts and nuts used on the substation gantries were found to have corroded.

- xii. Replace all corroded bolts and nuts with galvanized ones

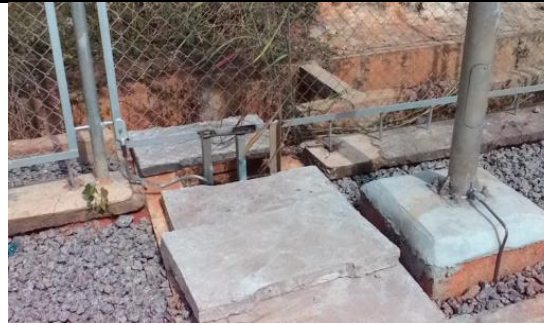
xi. Most of the earth leads of the perimeter lighting columns were not properly bolted, and some bolts, nuts and washers have rusted. A drainage bar welded to the metal fence was found rusted at the point of welding. At the Makurdi-Jos feeder 1, all the metal support bars for the CVT control panel are rusted.

xiii. Tighten all bolts and nuts and coat all exposed welded joints with zinc-oxide and thereafter with aluminum paint

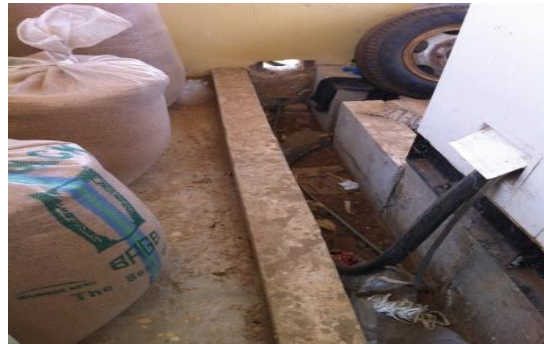
xii. The standby generator house was being used as storage for expanded metal, formwork, used tyres, clothes and other flammable materials. It was generally very dirty and cable trenches were still left open without covers. Cable entries not properly glanded

xiv. The generator room should be cleared of all items and left free of all storage items at all times

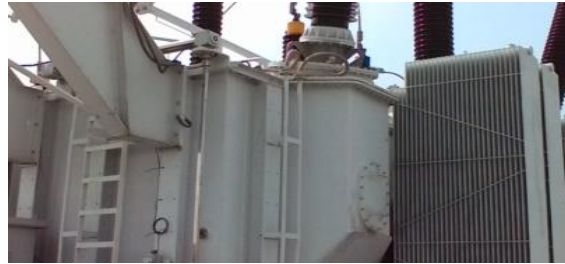
xiii. During the tap change operation on the 150MVA power transformer, there was severe noise emanating from the bevel gear mechanism

xv. The 150MVA transformer tap changer mechanism should be serviced to prevent failure whilst operational

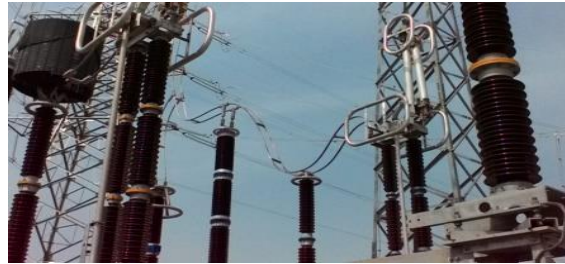
xiv. The red phase earthing switch on the Jos 2 feeder was difficult to operate in comparison with the rest earthing switches. The key lock was malfunctioning

xvi. The red phase earthing switch on the Jos 2 feeder should be rectified

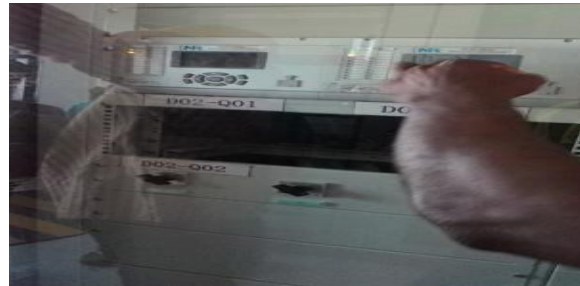
xv. A relay module on the Ugwuaji line was not available, though the Contractor stated that this unit was on its way from Lagos, having been ordered earlier

xvii. The contractor to confirm when the expected relay module is available on site

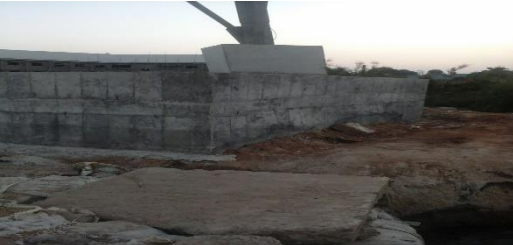
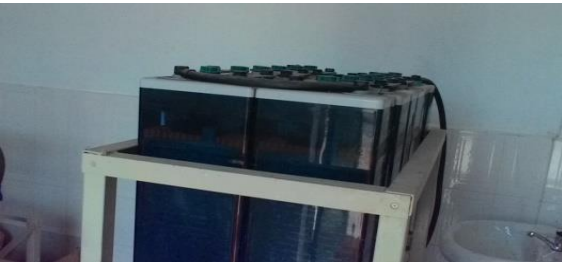
11.	General Observations	<ul style="list-style-type: none"> i. During the construction of pile foundation for tower (T33), a stream was blocked. The blockage has caused flooding around the area ii. The metal doors of the control rooms are not earthed iii. The eye wash basin installed in the battery room was not safely positioned

<ul style="list-style-type: none"> i. The blockage should be removed to enable free flow of the water since the pile foundation construction has been successfully executed ii. The frames of all metal doors of the control room should be earthed iii. The eye wash hand basin should be safely positioned to make it readily available in an emergency
------------	-------------------------	--	---	--
