INSPECTION OF 132KV MADU SUBSTATION BAY EXTENSION AT MANDO TRANSMISSION SWITCHYARD, MANDO, KADUNA

INSPECTION AND TESTING OF 132KV TRANSMISSION SUBSTATION EXTENSION BAY AT MANDO, KADUNA, KADUNA STATE BETWEEN 10TH – 12TH DECEMBER, 2018

CLIENT: Federal Ministry of Power

CONTRACTOR: SKIPPERSEIL LIMITED

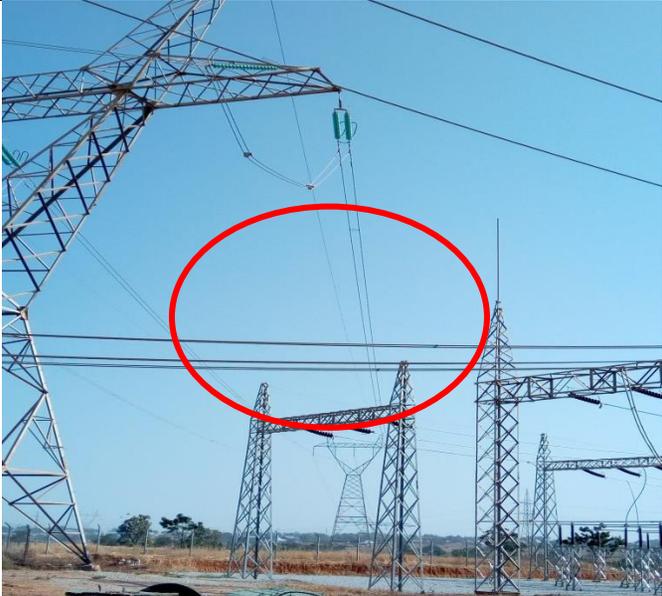
S/NO	LOCATION	OBSERVATIONS	PICTURES	RECOMMENDATIONS
1.	Substation Switchyard	Insufficient clearance between the existing High voltage 132kV O-H line and the newly constructed terminal gantry for the bay extension.

Sufficient clearance between the High voltage 132KV line and the tower

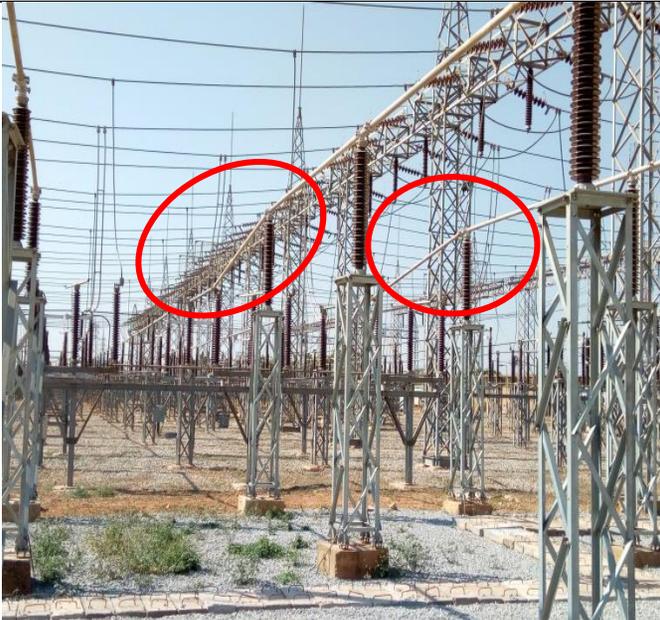
- i. The newly installed 132KV bus bar was seen not aligned with the existing bus bars. This is unsafe and could be points of arcing and early failure of the installation. Therefore, Bus bar alignment with existing bus bar should be carried accordingly.

Substation Switchyard	Busbars were observed not aligned with the existing busbars at the point of contact/joint. This is dangerous and unsafe as arcing can occur due to poor contact, with disastrous consequences.

- v. The newly installed 132KV bus bar was seen not aligned with the existing bus bars. This is unsafe and could be points of arcing and early failure of the installation. Therefore, Bus bar alignment with existing bus bar should be carried accordingly.

Busbars must be adjusted and aligned.
Substation Switchyard	Close joints were observed on the 132KV bus bar. This is a poor construction. Too many closed joints on bus bar should be avoided as they represent a source of arcing and failure of the bus bar system.

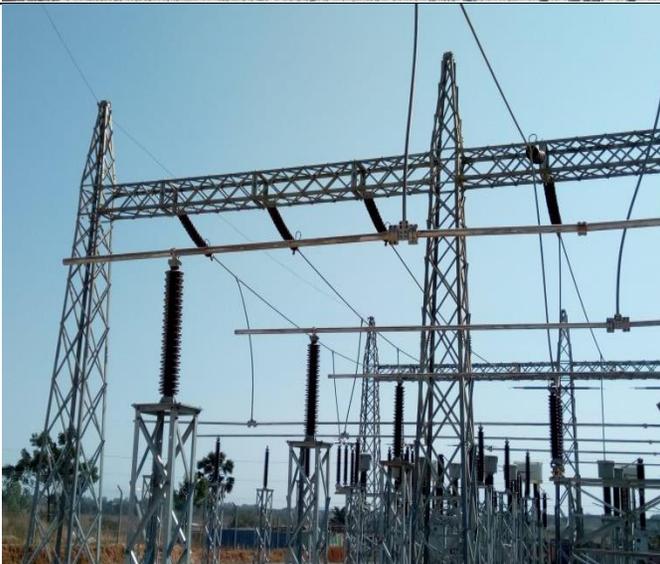
- vii. Close joints were observed on the 132KV bus bar. This is a poor construction. Too many closed joints on bus bar should be avoided as they represent a source of arcing and failure of the bus bar system.

Full length bus bars should be used. No joints.

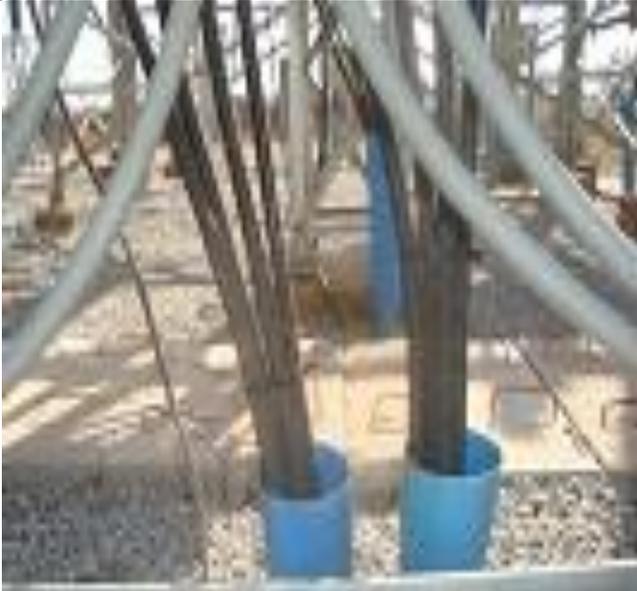
Substation Switchyard	Cable PVC pipes were not properly covered. This will allow ingress of water/reptiles/rodents to the control room through the PVC pipes.

The PVC pipes should be plugged/properly covered.
	Substation Switchyard	Cables were seen exposed under the control panel in the switch yard along with the cable duct. This is unsafe as reptiles and rodents can gain access to the control room through the exposed cable ducts

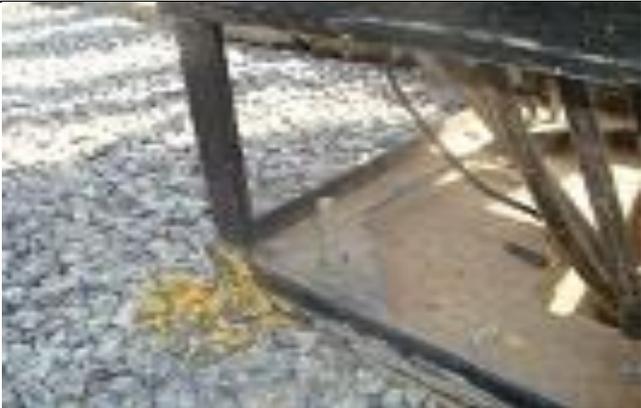
<p>Substation Switchyard</p>	<p>No nuts on the bolt to hold the panel firmly in place. During strong windstorms the panel could be displaced causing a serious electrical accident.</p>

<p>Bolts and nuts must be used to firmly hold the panel in place.</p>
	<p>Substation Switchyard</p>	<p>Most bolts and nuts used in the gantry were seen rusted.</p>

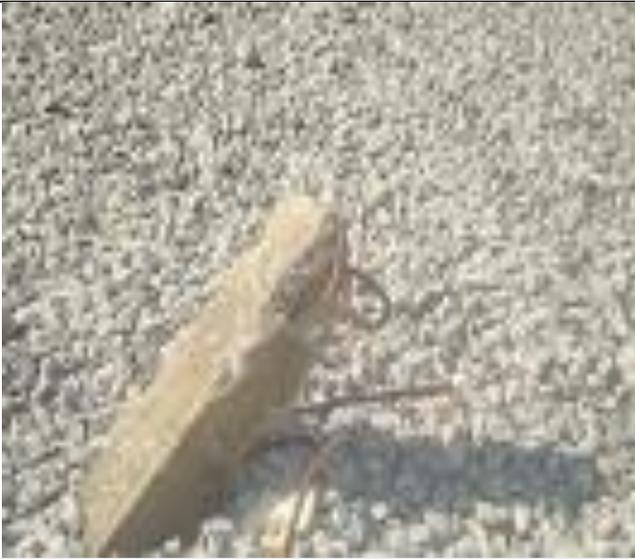
<p>Substation Switchyard</p>	<p>Unused concrete pillar was seen in the substation switch yard. This is dangerous and unsafe as it can result in trip accident during inspection and maintenance.</p>

<p>Unused concrete pillar must be removed from the substation switch yard to avoid operators getting injured during maintenance.</p>
	<p>Control room</p>	<p>Insufficient clearance observed between the wall and the panels. This is unsafe especially during switching operation.</p>

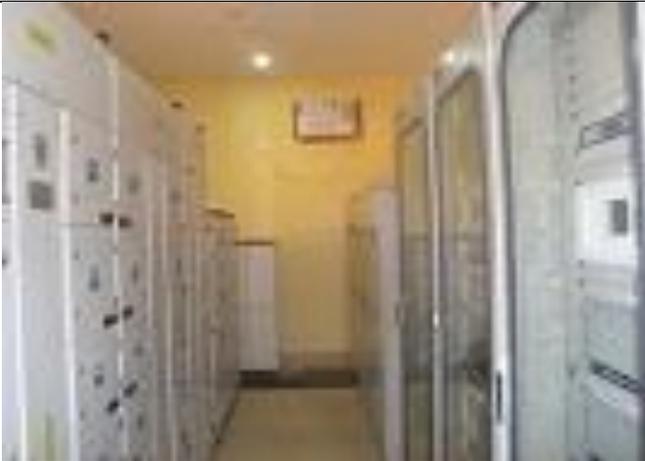
Control room	Not enough work safe area was observed. This is unsafe for the operators during switching operation.

Enough work safe area must be provided.

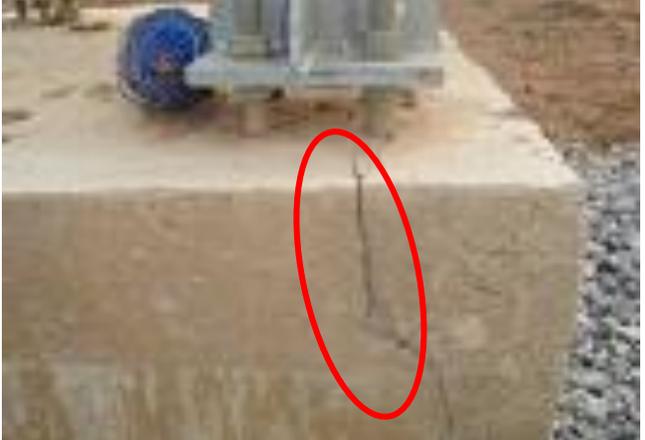
Substation Switchyard	Cracked concrete pillar for one of the gantry was observed.

Concrete pillar must be reconstructed.

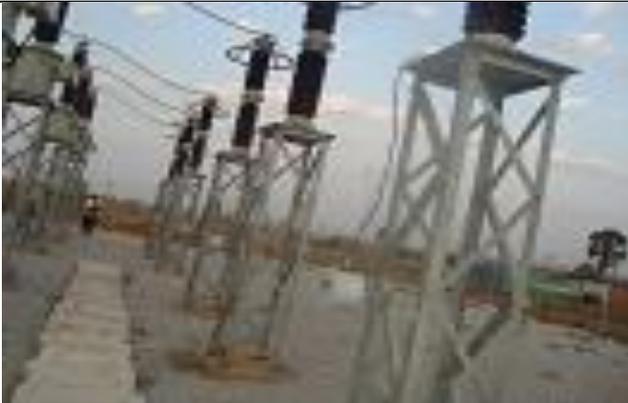
Substation Switchyard	Lightning arrestors were seen not earthed.

Lightning arrestors must be properly earthed with earth resistance value of less than 2 Ohms.
--	-----------------------	--	---	---
