# **NIGERIAN ELECTRICITY MANAGEMENT SERVICES AGENCY (NEMSA)**

## **NEMSA INSPECTION REPORT**

**38 MEGAWATT DUAL - FUEL FIRED TURBINE INDEPENDENT POWER PLANT, KALAMBAINA ROAD, SOKOTO**

## NEMSA INSPECTION REPORT ON 38MW SOKOTO INDEPENDENT POWER PLANT

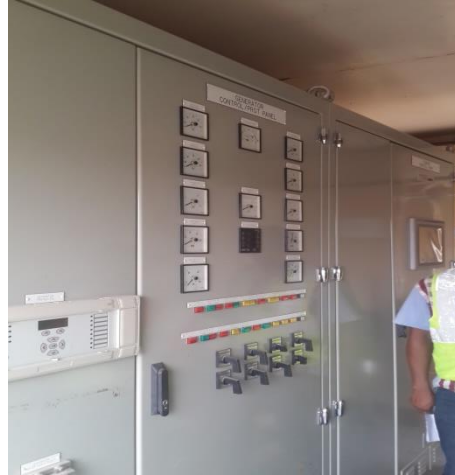
<b>S/ N</b>	<b>PROJECT DESCRIPTION</b>	<b>OBSERVATIONS</b>	<b>PICTORIAL PRESENTATION ITEMS</b>	<b>OF</b>	<b>RECOMMENDATION</b>
1a	<b>control room</b>	The control room at the Power Plant was seen without Air conditioners working thereby subjecting the panel instrumentation to high ambient temperatures.

i. Air-conditioners should be constantly provided in the control room for adequate cooling of the control panel equipment.
1b		ii. Insulation mats were not laid in front of the Power plant control panels.

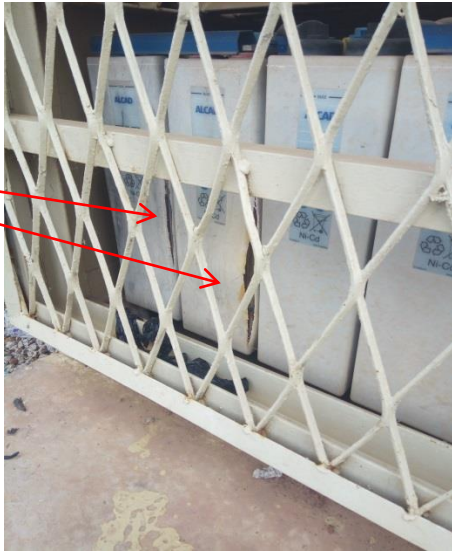
- i. Several damaged and swollen batteries were seen at the lower level of the battery bank located just outside the control room at the power plant. This could have occurred as a result of direct exposure

<p>iii. Danger signs should be fitted at the entrance gate of the control room and around the turbine skid.</p>
2a.	<p><b>Battery bank:</b></p>	<p>i. The lower battery arrangement in the battery bank at the power plant was seen with several damage and swollen batteries. This occurred as a result of inadequate ventilation and lack of cooling facilities in the battery bank.</p>

<p>i. All the damaged and swollen batteries in the battery bank should be replaced with functional ones and adequate ventilation and cooling system should be provided.</p>

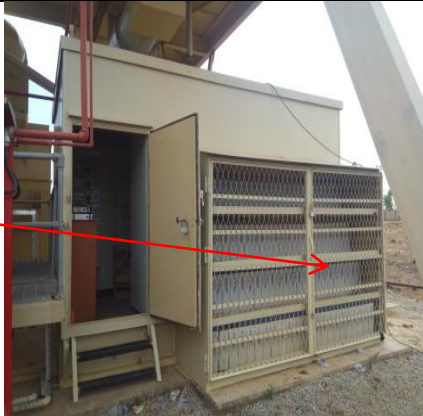
- ii. The battery bank at the power plant is of wet cells type, exposed to rain water during rainy season. The battery bank should be kept in a more spacious shaded/room having enough cooling system and should not be exposed to rain water.
- iii. No changeover switching system between the AC and DC panels.

ii. The battery bank should be kept in a spacious shed/room having enough cooling system and should not be expose to rain water.
2c		iii. No interlocked changeover between the AC and DC panels.

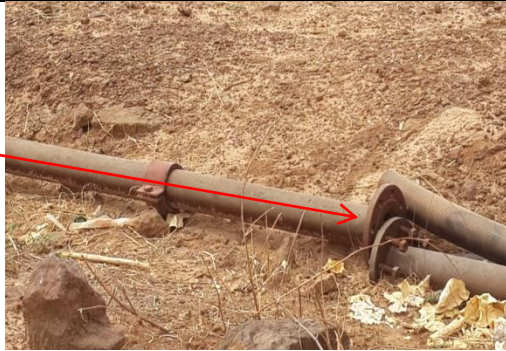
- viii. The fuel supply pipe from the main storage was seen open and unflanged. This fuel pipe as seen can allow some reptiles to enter inside the pipe causing fuel supply challenges. The pipe open end should be blocked using a blind flange.
- ix. Cables at the generating plant, the circuit breaker and the dummy load side were not labeled for proper identification. This could cause confusion during fault tracing. All cables should be properly and adequately labeled.

<p>ii. The pipe open end should be blocked using a blind flange temporarily until completion of the piping works.</p> <p>iii. The pipes should also be flushed through prior to being put into use.</p>
3c		<p>iii. The pipes were seen not well protected against corrosion.</p>

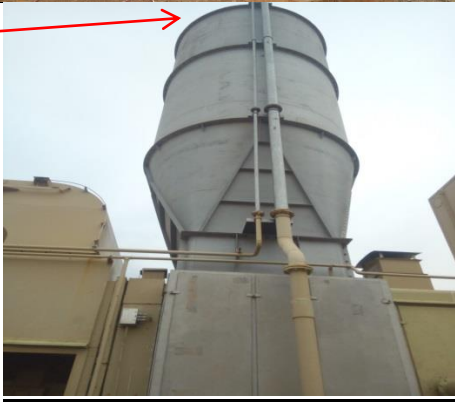
<p>iv. There should be adequate arrangement to protect the fuel supply pipes against corrosion.</p>
4a	<b>Generating plant.</b>	<p>i. No lightning protection installed at the highest point of the turbine exhaust stack.</p>

<p>i. Lightning protection (arrestors) should be provided at the highest points of the exhaust stack.</p>

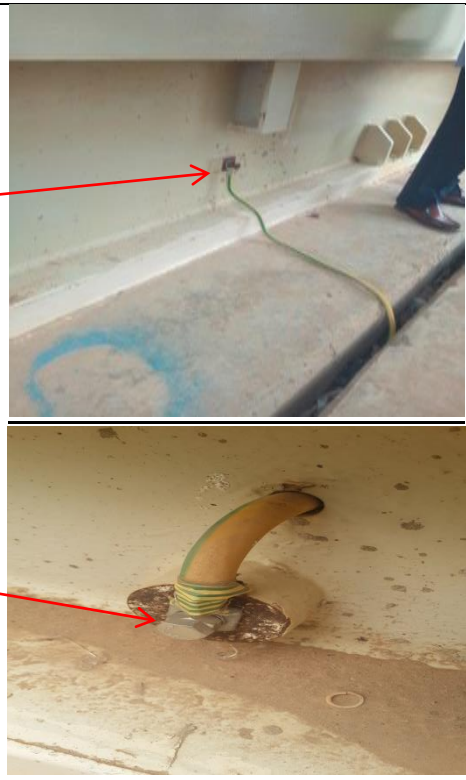
- iii. Some of the earthing points at the power plant area were seen corroded. All corroded earthen points should be checked and replaced with good ones.

<p>ii. Earth shielding wire should be provided from the switchyard to the exhaust stack to form a protection shield from lightning for the entire station.</p>
4c		<p>iii. Some of the earthing points at the power plant turbine skid area were seen corroded.</p>

<p>iii. All corroded earthing points should be checked, cleaned, re-terminated /replaced with good contacts.</p>

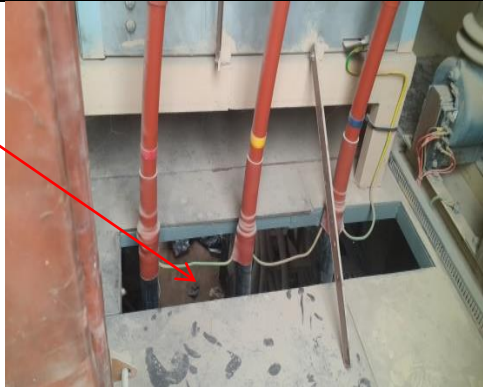
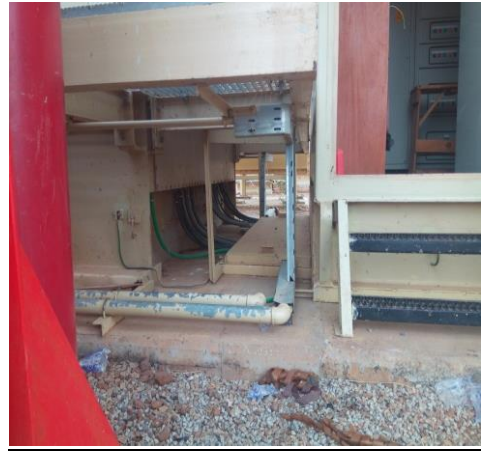
4d		iv. A sign of termite dumps were seen at the power plant area.		iv. The termite dumps should be destroyed/checked and fumigated.
4e		v. Cable ducts were well sealed/covered with a sealing compound to prevent ingress of water and access to rodents. However, the entry points of the cables to the LV panel of the power plant and the circuit breaker were not covered. This could become an access route for rodents/reptiles to enter into the turbine and destroy cables or cause bridging of live wires.

v. The entry point of the cables should be covered to prevent rodents from entering into the turbine/control panels and damaging the cables or bridging live circuits.

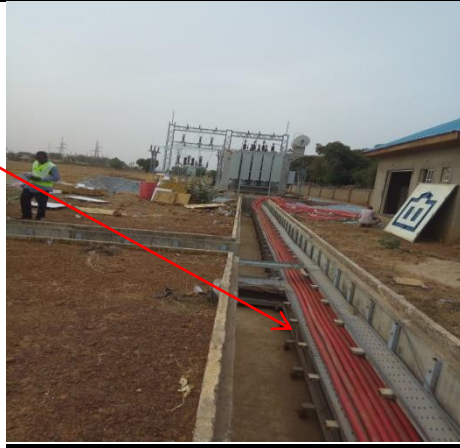
- vi. The cable tray was not earthed and could cause electric shocks to personnel. The cable tray should be properly earthed.

4f		vi. The cable tray was not earthed.

vi. The cable tray should be properly earthed.
4g		vii. The connected plate at the exhaust pipe was seen corroded.

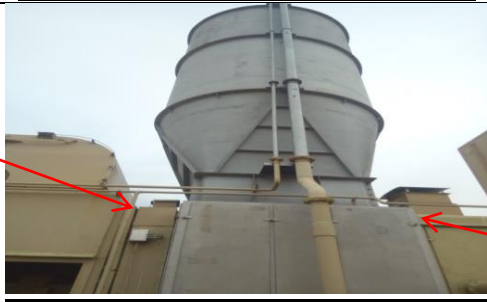
- vii. The connected plate at the exhaust pipe was seen corroded. The corroded plate at the exhaust pipe should be replaced with non-corroding plate.

vii. The corroded plate at the exhaust pipe should be replaced with non-corrodible plate.
4h		viii. Cables at the generating plant, the circuit breaker and the dummy load were not labeled for proper identification. This could cause difficulties during maintenance/fault tracing.

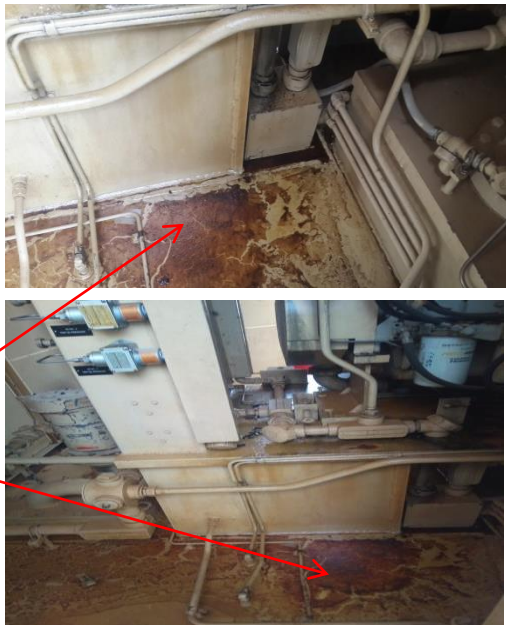
- x. Oil leakages/ spillage were seen within the vicinity of the Black Start generator. This could be sign of a major leakage and could also cause fire. The oil leakages should be checked and stopped.
- xi. From the markings on the body, the cables connecting the auxiliary transformer and the turbine appear to be LV cable for both the HV and LV side of the transformer. The cables ratings/nomenclature should be checked/confirmed or replaced with appropriately sized cables for 11kV.
- xii. Gravelling of the generating plant and switchyard area, fencing of the active area of the generating plant and slabs covering for the cable trenches between the generating plant and the switchyard control area was not done. These should be completed before commissioning of the power plant.

4i		<p>ix. Oil leakages/ spillage were seen at the black starting generator area within the turbine skid. This could be a source of fire and degradation of the blackstart generation performance.</p>

<p>ix. The oil leakages should be checked, identified and remedied.</p>
4j		<p>x. The cables connecting the auxiliary transformer has 1000V engraved on the outer insulation. These cables are used for both the HV and LV side of the transformer.</p>

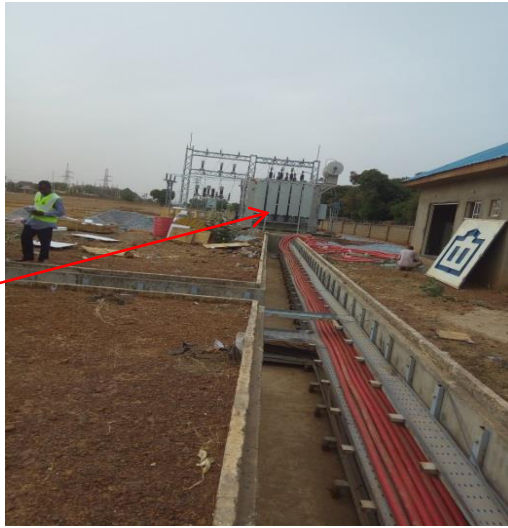
- i. The 11kV cables outgoing from the generating plant to the substation were yet to be connected to the transformer. The 11kV cables should be connected to the transformer and properly terminated with appropriate cable lugs.
- ii. At the time of our visit the contractor was replacing CTs and VTs that were found having lower ratings at the switchyard. All CTs and VTs should be checked properly to ensure they are in

S/ N	PROJECT DESCRIPTION	OBSERVATIONS	PICTORIAL PRESENTATION OF ITEMS	RECOMMENDATION
1a	33kV Switchyard	i. The 11kV cables from the generating plant were laid on cable trays inside the cable trenches. However, the cables were yet to be connected and terminated at the main 50MVA 11/33kV step-up transformer.

i. The 11kV cables should be connected to the transformer.
1b		ii. At the 33kV switchyard, the contractor was seen replacing CTs that are of lower rating.

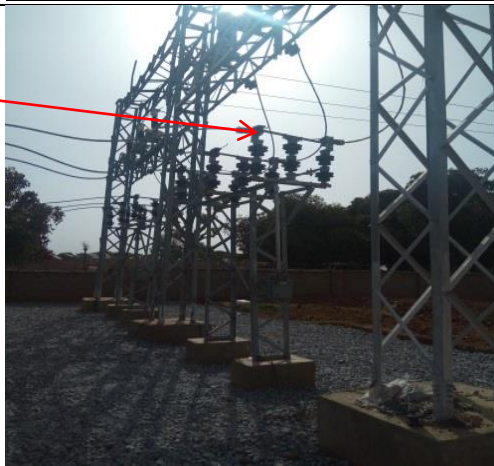
iii. The transformer bus bar isolator should be installed.
1d		iv. The evacuation line isolator was seen without an earth switch.

iv. Earthing switch should be provided at the evacuation line isolator.

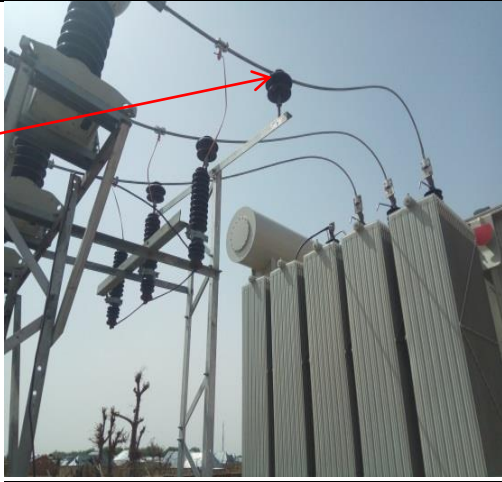
- v. The pot insulators supporting the conductors at the secondary side of the step-up 50MVA 11/33kV transformer were of 22kV ratings. The pot insulators should be replaced with those of 33kV ratings.

v. The pot insulators should be replaced with appropriately sized and rated 33kV insulators.
1f		vi. The gantry support structures for the bus bar were not on the same height level, and this created an imbalance between the support structures. The middle support structure was higher than the remaining two by the sides.

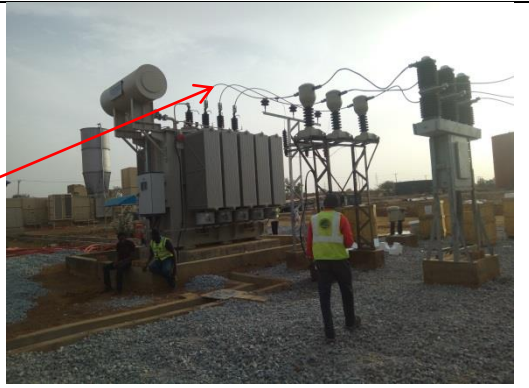
- viii. The jumper connection from the step up transformer to the transformer isolator has a big curvature that can allow rain water to follow the conductor down to bolt and nuts, this can cause corrosion. This curvature should be reduced to avoid rain water from running down the bolt and nuts.

vii. Additional bus bar should be provided at the switchyard for flexibility purpose.
1h		viii. The jumper conductor from the step up transformer to the current transformer (CT) isolator has a big curve- out that can allow rain water to follow

the conductor down to bolt and nuts, accumulate in the clamps and cause corrosion.		enters the clamp by creating a loop.
1i		ix. The lightning arrester used was not of the right specification. The counter type lightning arrester counting the number of lightning arresters falling on the equipment should be used.

viii. This curve-out should be reduced to avoid rain water from running down to bolt and nuts. The installation should be done in such a way that rain water will be discharged before it

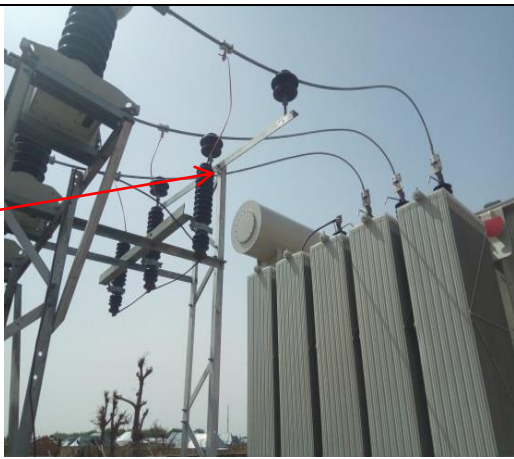
- ix. The lightning arrester used was not of the right specification. The counter type lightning arrester which records the number of lightning strikes on the equipment should be used. The lightning arrester used should be replaced with a counter-type lightning arrester.

ix. The lightning arrester used should be replaced with the counter type lightning arrester.

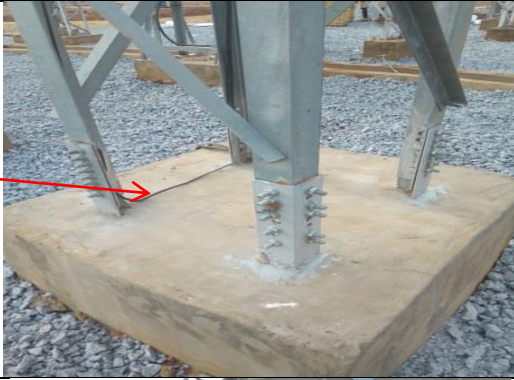
1j		x. We observed that the earth conductors used on some gantry support structures were undersized.

x. An earth conductor size of 70mm <sup>2</sup> should be used to earth each support structure.
1k		xi. No silica gel at the step up transformer.

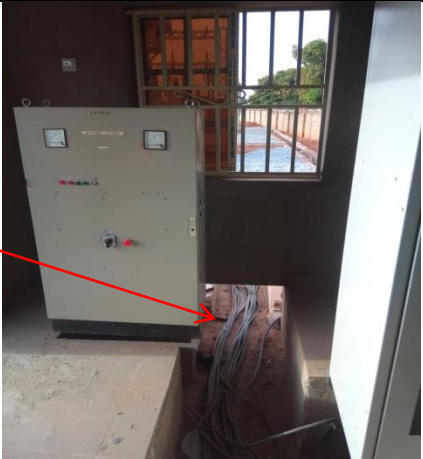
- xi. We observed that the earth conductor used at the rectifier was undersize. An earth conductor of 70mm<sup>2</sup> should be used at the rectifier.

3a	<b>Switchyard Control room</b>	i. We observed that the earth conductor used at the rectifier in the control room and some gantries was undersize.

i. An earth conductor size of 70mm <sup>2</sup> should be used at the rectifier.
3b		ii. The metal door frames at the control room were not earthed.

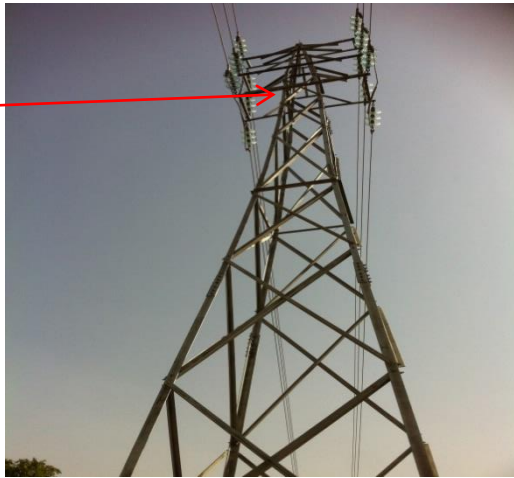
S/N	PROJECT DESCRIPTION	OBSERVATIONS	PICTORIAL PRESENTATION OF ITEMS	RECOMMENDATION
1a	33kV overhead Lines	i. The tips/cage of the first tower was seen tilted/twisted.

i. The tilted cage of the first tower should be checked and amended.
1b		ii. The second tower was not designed for an angle, but it is now used as an angle tower due to the change in the entry point to the transmission

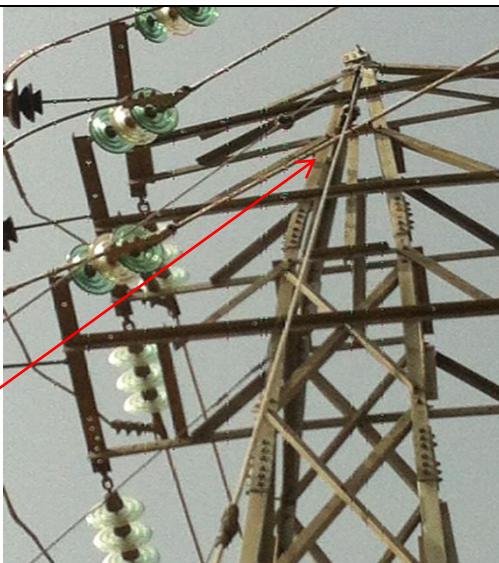
- iii. The stay wires used were not properly erected; they were already touching the live conductors. Also, the stay insulators provided were 11kV and so are undersize. The stay wires should be properly erected, relocated away from the live conductor and replace the undersize stay insulators with appropriate size stay insulators.

1c		iii. The stay wires used were not properly installed as they were touching the live conductors. Also, the stay insulators used were undersized/under-rated.

<p>iii. The stay wires should be properly positioned, erected and relocated away from the live conductor.</p> <p>iv. Also, the undersize stay insulators should be replaced with appropriate size stay insulators.</p>

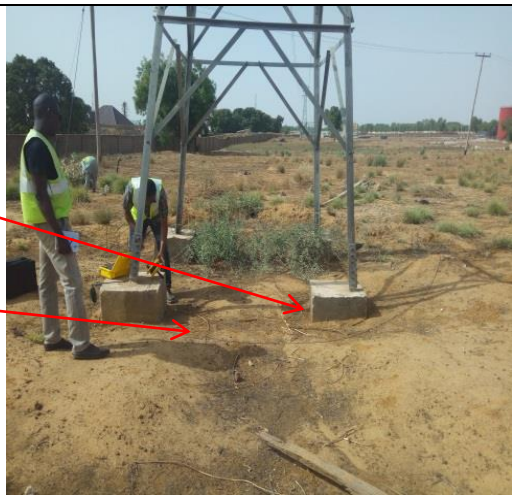
- v. The base of the second tower was seen exposed to flooding of water during rainy season. This could submerge the funnels and degrade the strength of the tower leg foundations. The tower base should be covered with laterite to avoid flooding during rainy season.

<p>vi. All bent cross-arms observed should be replaced with good ones.</p>
1e		<p>vii. The base of the second tower was seen not properly sand filled and thus exposed to retention of water during rainy season, while the two legs B &amp; C were seen buckled out.</p>

<p>vi. The tower base should be covered with laterite to avoid flooding and retention of water during rainy season, while the buckled legs B &amp; C should be checked and amended.</p>

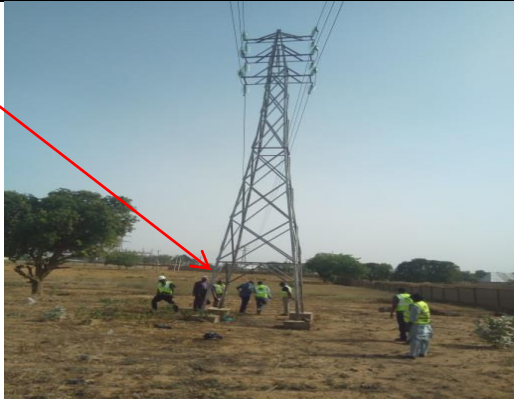
- ix. Legs B and C of the first tower were seen buckled. The buckled legs of the first tower should be checked and amended.
- x. The clearance between the new SIPP overhead line and the existing 33kV overhead line was inadequate. The clearance between the SIPP and the existing 33kV overhead line should be checked and improved upon to within specified values.

1i		xi. Legs B and C of the first tower were seen buckled.

x. The buckled legs of the first tower should be checked and amended.
1j		xi. The line crossing between the SIPP overhead line and the existing 33kV overhead line has inadequate clearance.

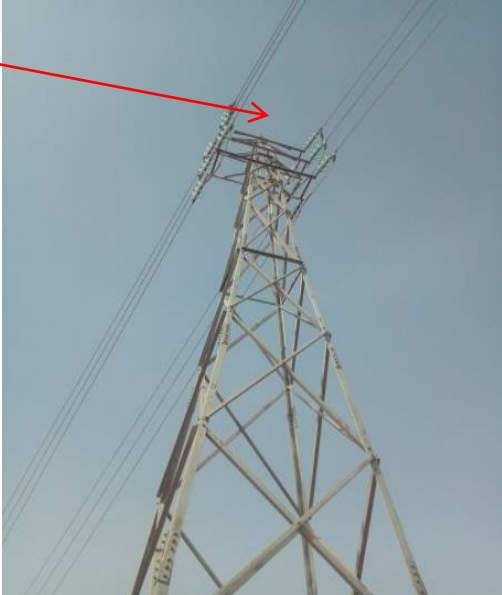
xii. Earth shielding wires and vibration dampers should be provided from the power plant to the TCN substation.
1l		xiii. No communication links or sky wire between the TCN substation and the power plant.

xiv. Communication links or sky wire should be provided between the TCN substation and the power plant.

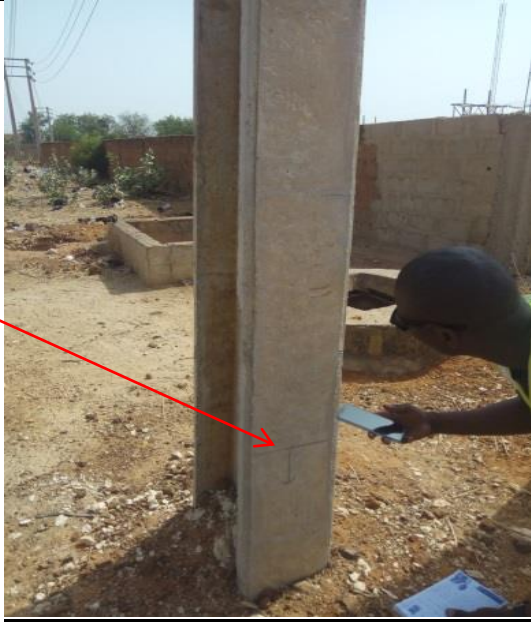
S/ N	PROJECT DESCRIPTION	OBSERVATIONS	PICTORIAL PRESENTATION OF ITEMS	RECOMMENDATION
1a	Concrete Poles	i. The lines have mixed support structures, i.e., lattice towers (two) and concrete poles. The poles were not planted to the required planting depth as the poles foundation markings were visible. (See arrow).

i. All poles should be planted to the marked planting depth on the pole boot.
1b		ii. No pole numbering, danger signs and anti-climbing devices on all the concrete poles inspected.

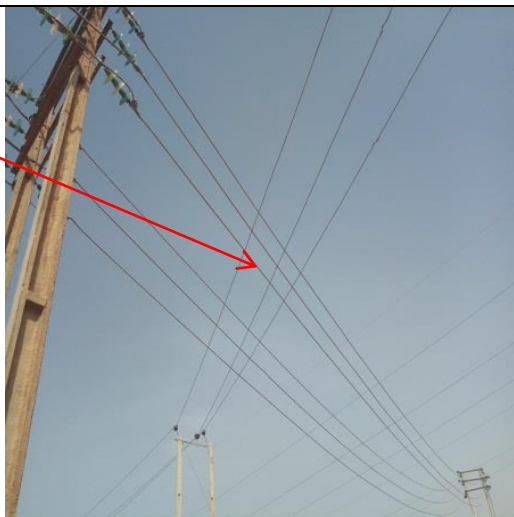
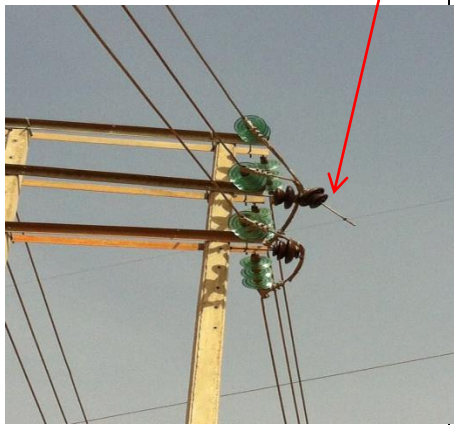
<p>iii. The conductor kink on the yellow phase should be checked and removed, or the conductor span replaced.</p>
1d		<p>iv. The red and yellow phases on the second section pole were seen touching each other due to a detached pilot insulator.</p>

<p>iv. The pilot insulator should be checked and tied back.</p>

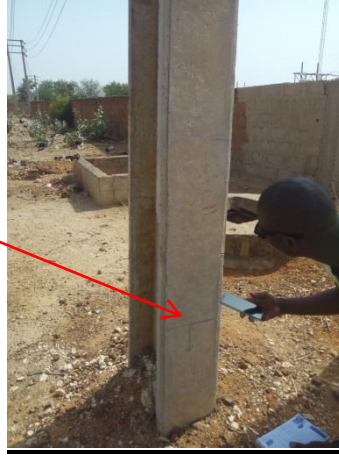
- vii. The fourth concrete pole was a three-pole structure; the jumpers of circuit two on it were not connected properly. A crack was seen on one of the concrete poles. The jumper connection of circuit two and the crack seen on one of the poles should be checked and corrected.

vii. The channel iron should be earthed and adequate ground clearance should be provided on the line networks of both the second and the third pole.
1g		viii. The fourth concrete pole was a three pole structure, the jumpers of circuit two on it was not connected properly and cracks were seen on one of the concrete poles.

vii. The jumper connection of circuit two and the cracks seen on one of the poles should be checked and corrected.

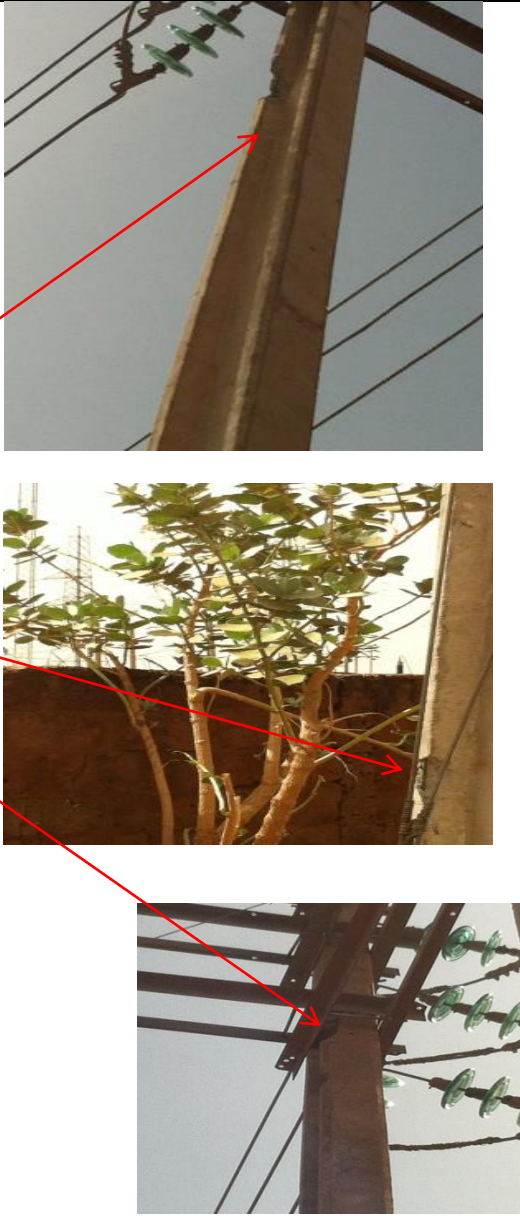
<p>xi. Many of the concrete poles were seen cracked. These are likely to cause line instability. They may break and disrupt power supply.</p>

<p>x. All cracked poles with exposed reinforcement should be replaced for stability of the line and for safety of lives and property.</p>
--	--	---	--	---

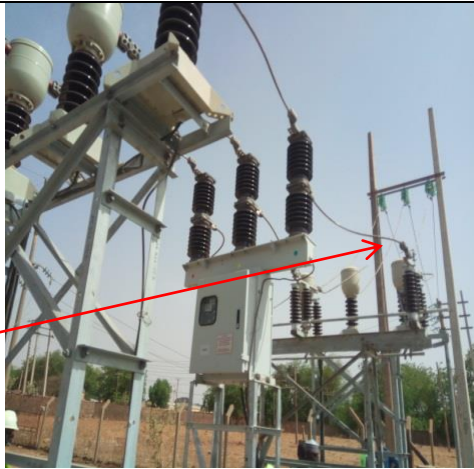
- i. Only one of the circuits was observed terminated on a makeshift connecting bay of a double concrete pole, instead of terminating the whole two circuits on one bay. A corridor for a connecting bay should be provided by TCN to terminate the second circuit.

<b>S/ N</b>	<b>PROJECT DESCRIPTION</b>	<b>OBSERVATIONS</b>	<b>PICTORIAL PRESENTATION OF ITEMS</b>	<b>RECOMMENDATION</b>
1a	<b>TCN Substation</b>	i. Only one of the double circuit SIPP line was terminated at the TCN substation on a bay of double concrete pole, instead of terminating the whole two circuits on proper gantries. No proper provision has been made for the interconnection of the second circuit

i. A corridor for a connecting bay should be provided by TCN to terminate the second circuit.

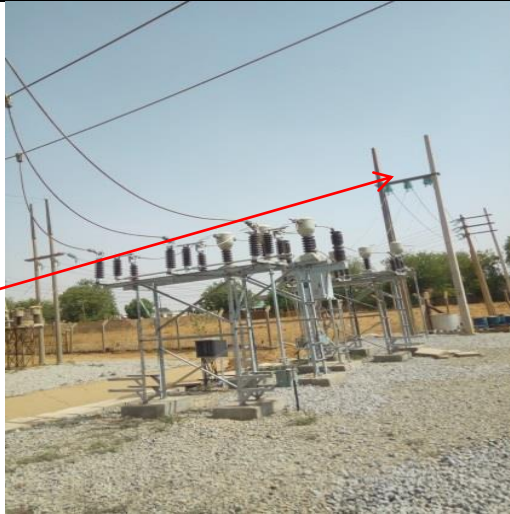
1b		<p>ii. At the connecting bay, the channel iron of the connecting bay was not earthed. Also, the jumpers between the outer Red and Blue phases were almost touching the concrete pole, as there was inadequate clearance.</p>

<p>ii. The Channel iron of the connecting bay should be earthed, while the jumpers of the outer phases that are almost touching the concrete pole should be checked and corrected.</p>
1c		<p>iii. There was no lightning arrestor at the connecting bay of the incoming SIPP 33kV feeder lines to the TCN substation. Also, all the gantry supports for the</p>

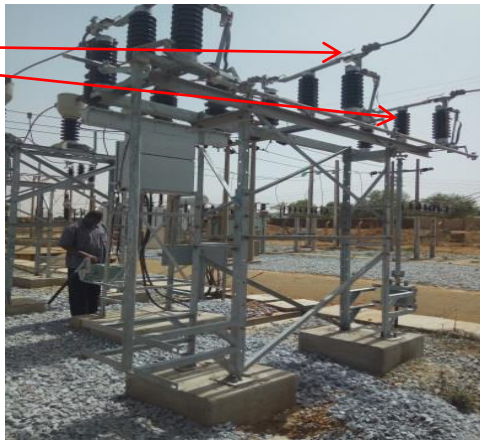
- iv. There was no interlock between the isolator and isolator earthing switch. This is a serious hazard that could lead to short circuit, explosion, fire and electrocution. Therefore, it is of utmost

iv. At least a mechanical interlock should be provided between the incoming isolator and the earthing switch. This is a very major safety hazard that can result in electrical accident, explosion and fire.

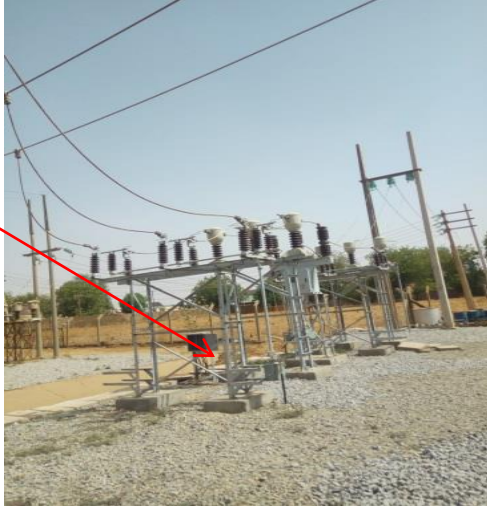
1e		<p>v. The control boxes of line isolator and bus bar isolator were yet to be installed.</p>

<p>v. The control boxes of line and bus bar isolators should be installed immediately.</p>

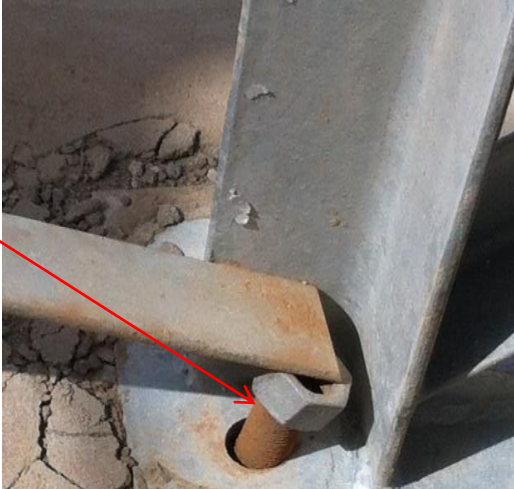
- vii. Loose and corroded nuts were seen on the gantries. These could eventually wear out causing the gantries to fall. The loose nuts on the gantries should be tightened, while the corroded nuts should be replaced with galvanized ones.

vi. The Red and blue phases which were wrongly tagged should be properly traced, identified and corrected.
1g		vii. Loose and corroded nuts were seen on the gantries.

vii. The loose nuts on the gantries should be tightened while the corroded nuts should be replaced with galvanized types.

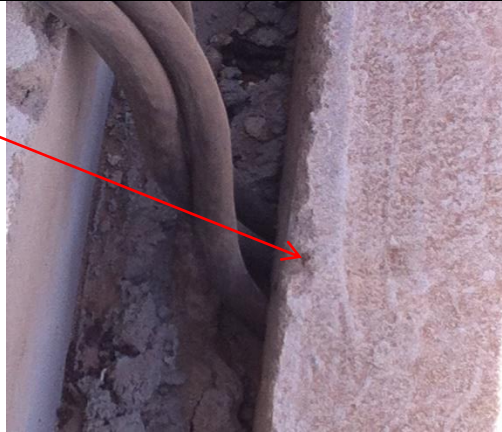
- viii. Concrete slabs were observed placed on the control cable, coming from the circuit breaker at the TCN switchyard. This would injure the cable insulation and lead to premature failure of the cables. The concrete slabs should be lifted off the cables completely.

1h		<p>viii. Concrete slabs were observed placed on the control cables, coming from the circuit breaker at the TCN switchyard. This would further injure the cable insulation and degrade the cable.</p>

<p>viii. The concrete slabs that were fouling on the control cables from the circuit breaker at TCN switchyard should be removed to avoid injury on the cable insulations.</p>
