ELECTRICITY MANAGEMENT SERVICES LIMITED

INSPECTION REPORT OF ONITSHA – ASABA 330KV TRANSMISSION LINE, ASABA 330/132/33 KV SUBSTATION AND ASABA 132/33 KV SUBSTATION

NDPHC letter No NIPP/TRX/2119 dated 9th February, 2015 on the above subject matter refers, please. The Inspection/Test of Onitsha – Asaba 330KV (SC) OHTL with the associated Asaba 330/132/33KV substation and Asaba 132/33 KV substation was carried out between 11th and 14th February, 2015. The following persons were present for the exercise;

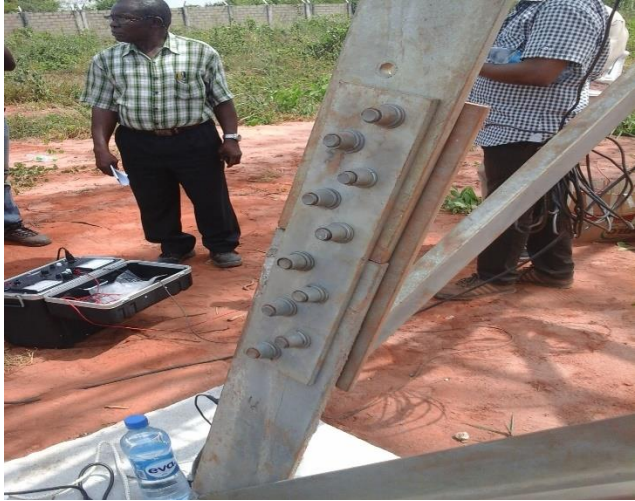
S/NO.	PROJECT AREA	OBSERVATION	PICTORIAL ILLUSTRATIONS	RECOMMENDATIONS
1.	Tower structures and Foundations	The 330KV SC Onitsha – Asaba OHTL was seen supported on towers made of galvanized steel lattice structure. Each of the tower legs was firmly erected on rectangular concrete foundation (bases). Anti-vandals (specially made) bolts and nuts were used for fixing the tower members to prevent easy removal by vandals. Also the step bolts used for the erection of the tower were still in position at the time of our inspection visit

<ol style="list-style-type: none">i. In order to prevent easy climbing access by vandals, all the step bolts below the anti-climbing devices should be removed from position as advisedii. All tower location within visible erosion prone areas along the entire

transmission route length, should be provided with erosion control measures

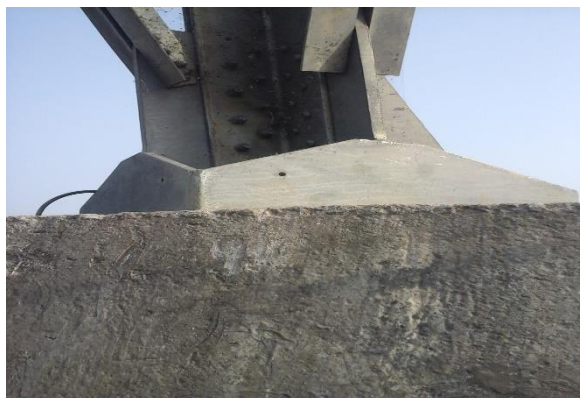
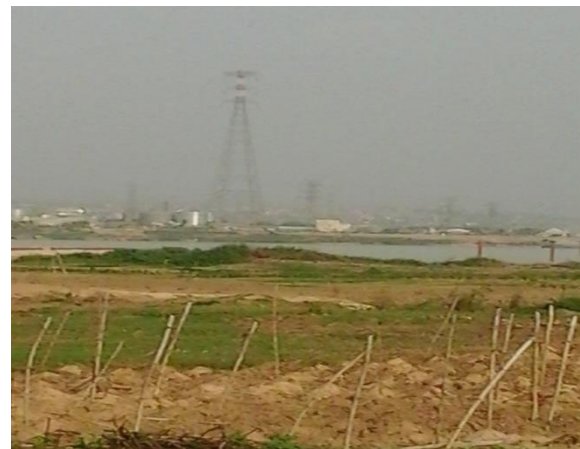
The following were also observed;

i. The towers at River Niger crossing and swampy areas, were erected on pile foundations.

ii. The tower legs bucket of the river crossing towers have the tendency of retaining water when the holes provided for draining trapped water are blocked by debris.

iii. No tower was erected within the River Niger channel. However, the two towers used for crossing the river are of 187 metres high, which is adequate for the line clearance to the river during high tides.

iv. Four types of designs were employed for the towers between Onitsha – Asaba substation (Dextron Towers, Special River Crossing Towers, KAC Towers and the existing Towers).

iii. The TCN maintenance crew should be adequately informed on the possibility of water retention at the tower legs bucket of the river crossing towers, to ensure that the drainage holes are free of debris.

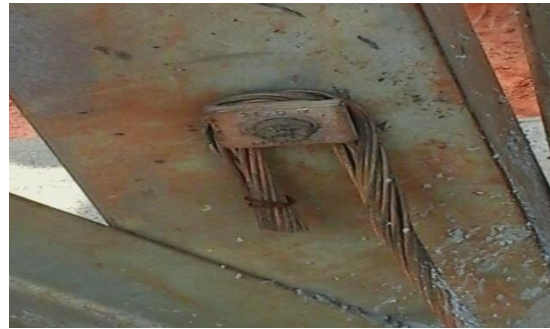
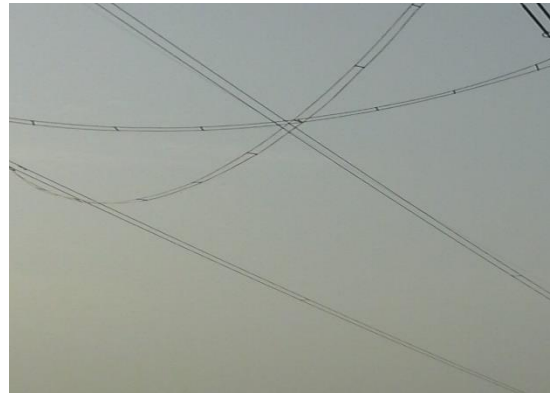
2. Materials of line conductors, Earth conductors and other The materials employed for the line conductors are aluminum conductor steel reinforced (ACSR) of code name "Bisson" having a cross-sectional area of 463mm² each

of the double conductors and 826mm² for the single conductor provided for the river crossing. The earth conductor for the towers were of galvanized steel type. The following were also observed;

- i. The Earth conductor connection to the tower legs were done using clamps at some towers. This may not give the necessary/proper contacts.
- ii. The red and blue phases of the OHTL were interchanged (transposed) along the line at Agbor Village in order to have the correct phase sequence at entry point of the Asaba 330/132/33KV substation

i. The connection of the earth conductors to the some of the tower legs should be done

via the appropriate cable locks.

- ii. The contractor should ensure that adequate clearance is achieved at the red and blue phases interchange around the line at Agbor Village near the river bank.

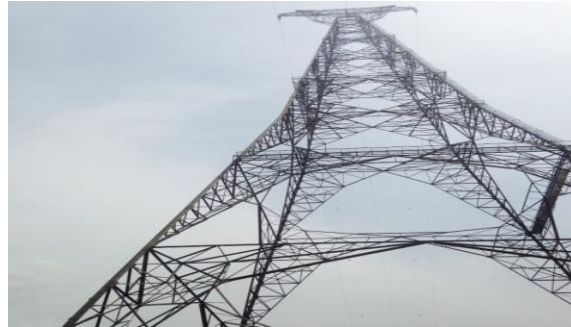
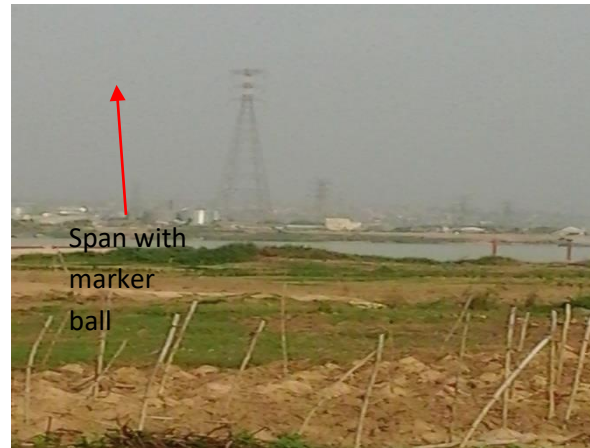
Anti-climbing devices, danger plates and number plates have not been provided/fitted on all the towers from Onitsha to Asaba. Also, Aerial identification plates were not provided on the towers. However, it was noticed that the phase identification plate has been fitted on the tower within the Asaba substation.

i. Considering the existence of low flying aircrafts, aerial marker balls were provided on the transmission lines at river crossings only.

i. Anti-climbing devices, danger plates, number plates and aerial number plates should be provided and fitted on all the towers from Onitsha – Asaba.

ii. Phase identification plates should be fitted on all towers.

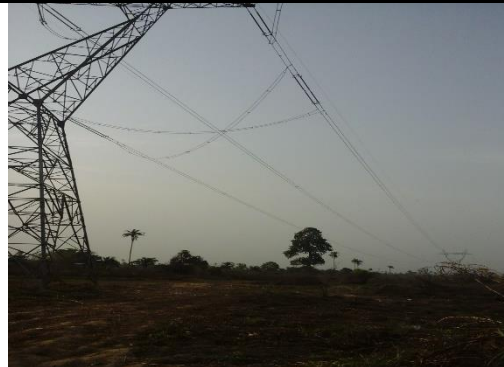
4. OHTL Stabilization Facilities From thorough inspections and checks, insulators, spacers, vibration dampers and corona rings were provided and properly erected except we noticed that arcing horns are missing on most towers.

Arching horns should be installed.

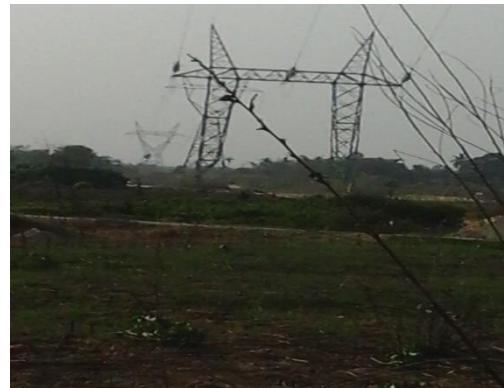
5. 330KV OHTL Status The tensioning of the 330KV OHTL was observed uniformly executed and the towers properly aligned. Tests were carried out on the OHTL to ensure continuity and clearances. See Appendix IV

Ensure that the tower legs of the towers within the swampy areas are further protected by bitumen coating up to a certain height above the chimneys.

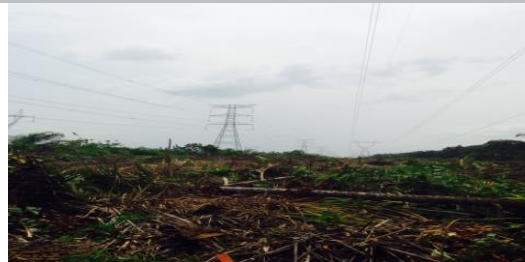
6. Line Trace and Access Road The terrain traversed by the 330KV SC OHTL is a difficult one with heavy vegetation and swampy areas.

The line trace should be properly and adequately maintained and secured.

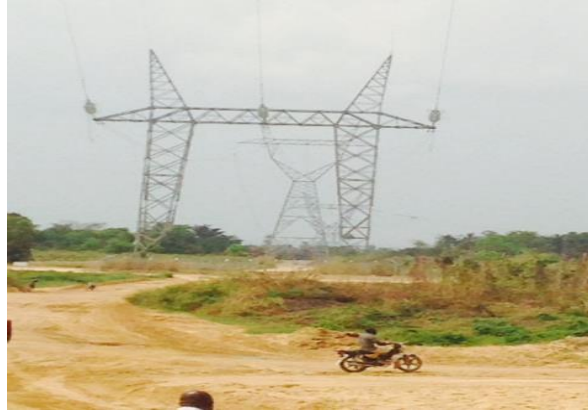
motorable access earth road along the OHTL route. The contractor ensured the access road route did not pass directly under the towers to prevent possible drive through by motorists. In some cases, the tower bases were fenced to avoid direct access to motorist.

The fence around the towers should be effectively earthed.

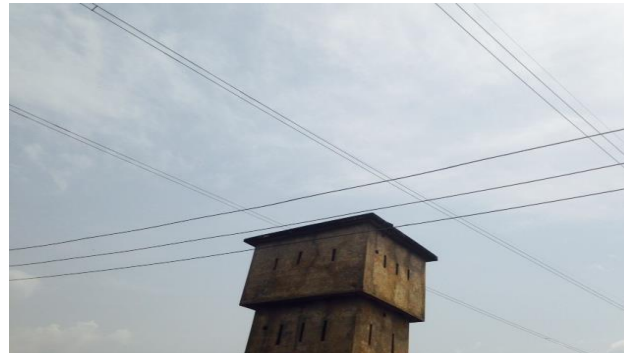
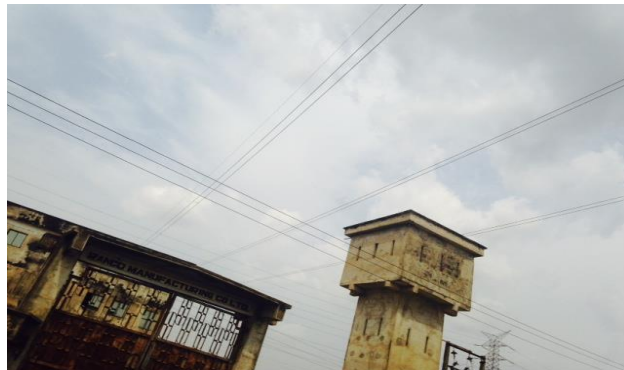
7. 330KV OHTL Crossings Observations also revealed that there were no railway lines crossings along the trace of the 330KV SC OHTL. However, the line crosses River Niger, existing 33KV, 11KV and 0.415KV OH lines at many locations, as well as some major roads. At all these crossings, statutory safety clearances were maintained throughout the lines route. Other observations are;

- i. The 330KV OHTL passes over a building within Ranco Manufacturing Co Ltd. Onitsha, with a clearance of about 5.7 metres.

- i. All existing structures within the right of way of the transmission line should be demolished.
- ii. The contractor should liaise with the respective distribution companies to ensure that all channel irons of the 33/11KV lines at the crossings of the 330KV OHTL are appropriately earthed.

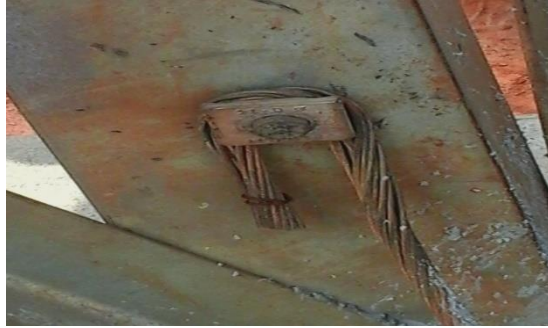
8. Earthing System/Earth Tests Carried out Two methods of earthing system in addition to the grounding sky wire were adopted. Namely;
- Counterpoise earthing

- Individual tower legs earthing

In both cases, physical earth connection to the tower legs was seen and visible. The results of the random earth resistance measurement tests for the tower legs were as recorded in appendix I & II

The contractor should carry out further earthing improvements for all earthing resistance above 10 Ω

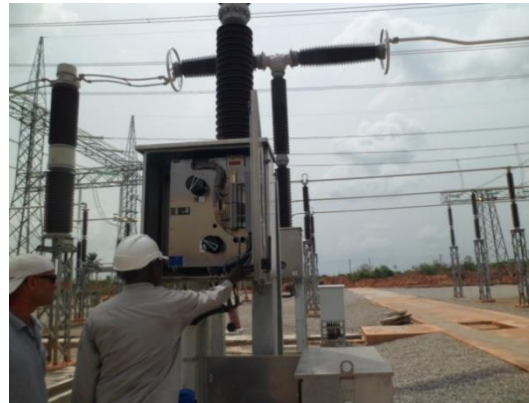
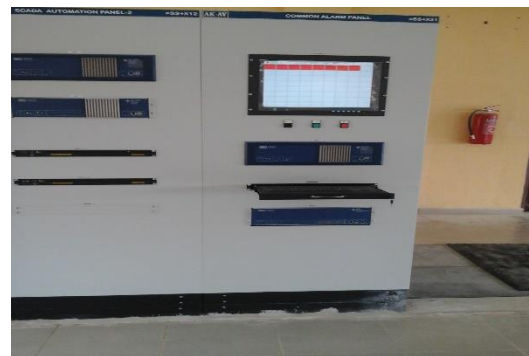
1. Asaba 1 x 150 MVA, 330/132/33KV Substation Ak-Ay Elektrik Co Ltd. Pre-commissioning engineers have proved the integrity of the Asaba 1 x 150 MVA, 330/132/33KV substation by executing and demonstrating the following functional tests in our presence (EMSL engineers) where practicable;
 - i. Remote/manual and automatic operations of all isolators and circuit breakers
 - ii. Alarms response to failures of various components of the protection equipment such as breaker trip coil failure, loss of SF6, motor and heating MCB failure, etc. were demonstrated
 - iii. Relay injection simulation test to verify differential,

overcurrent and earth fault protection schemes were not demonstrated

- iv. Tripping of circuit breakers in response to actuation of Bucholz relay and transformer pressure release valves were not demonstrated

- i. The alarms response to actuated failures of some of the components of the protection equipment did not respond. We recommend that the contractor should ensure that the system is properly adjusted for appropriate alarm responses to failures of sensitive components of the protective equipment.
- ii. The provision of a spare transformer in

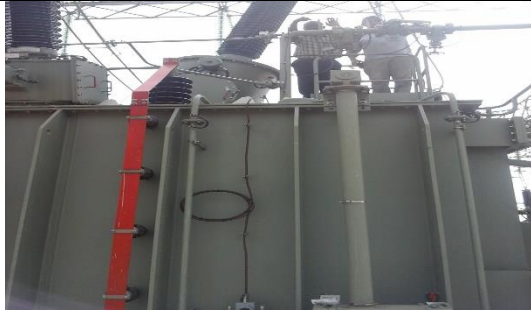
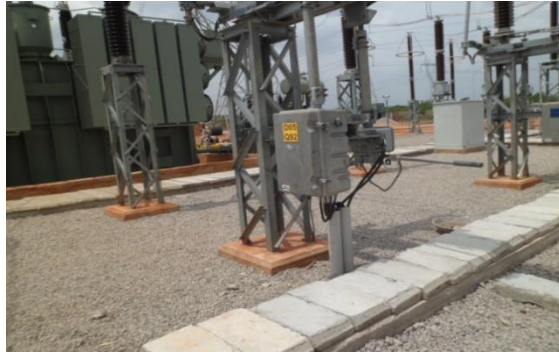
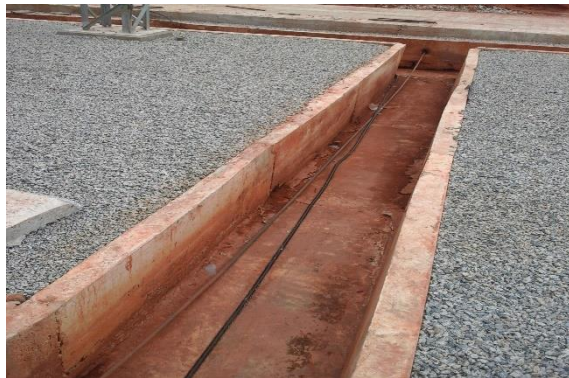
- i. The switchyard equipment (CT, VT, CVT etc.) and gantries are of high quality and well laid.
- ii. At the time of our inspection visit, covering of cable trenches/ducts were still on-going.
- iii. The fence of the active area of the substation is yet to be erected.

this very important substation cannot be overemphasized. Therefore, the available 1 x 150 MVA, 330/132/33 KV transformer already at the site should be installed.

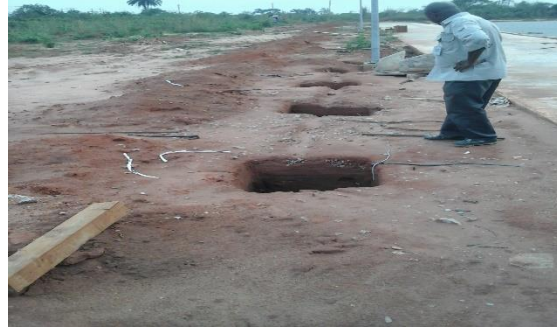
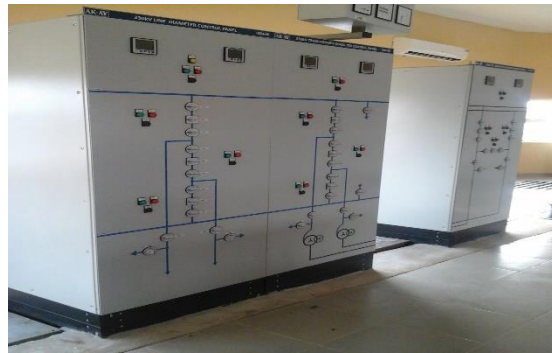
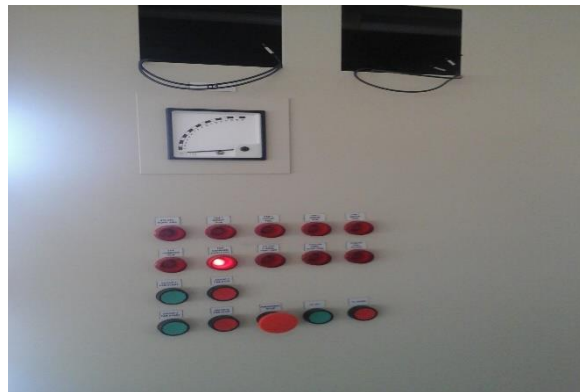
- However, the gravelling of the substation has been completed.
- iv. No insulation rubber mats provided for all the panels in the control room
 - v. The contractor did not demonstrate the operation of the changeover switch/interlock between the station's 415V supply and the standby generator supply
 - vi. There were no indications for the 1 x 150 MVA transformer oil and winding temperatures on the control panel. Also, the indicators supplied were not compatible with the panels; however, the contractor assured that the indicating

- iii. The erection of the active area fence should be completed and earthed.
- iv. Contractor to provide insulated rubber mats on all control panel floors
- v. Generator, main supply, changeover/interlock operation should be demonstrated prior to handing over the substation
- vi. Appropriate means of monitoring transformer windings temperatures should be installed in the

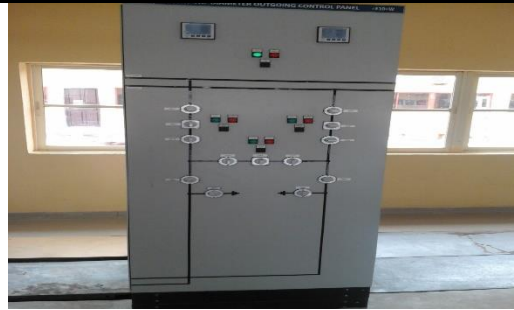
vii. meters have been ordered and is awaiting delivery. The control panel labels were not adequately labelled.

vii. control room The labelling in the control room should be consistent and explicit

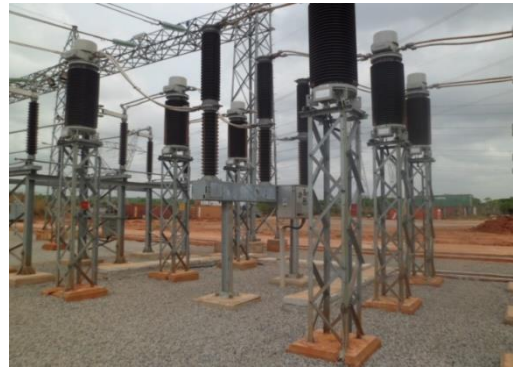
viii. The 18/19 nos and 8/9 nos of disc insulators per string used at the 330 KV and 132 KV side of the substation respectively are not adequate for the necessary clearance between the gantries and the lines.

viii. Disc insulator strings of 20/21 nos and 10/11 nos should be employed for 330 KV and 132 KV side of the substation respectively.

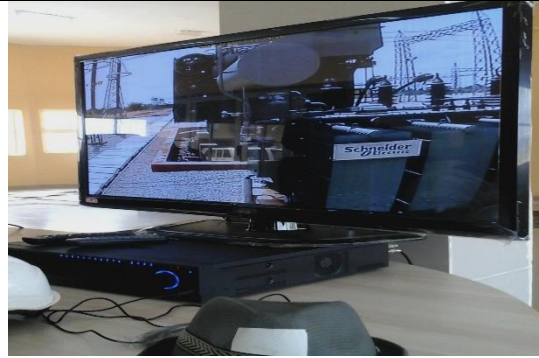
-
- xi. The CCTV cameras have been installed for the entire switchyard instead of the thermal cameras recommended in the RFP

- erected.
- xi. The open cable trenches should be covered with concrete slabs of adequate bearing strength
- xii. Thermal cameras that indicate hot spots within the switchyard during operations should be installed in addition to the CCTV cameras.
- xiii. The contractor should provide adequate firefighting equipment/devices to be placed at strategic locations within the substation yard/control rooms

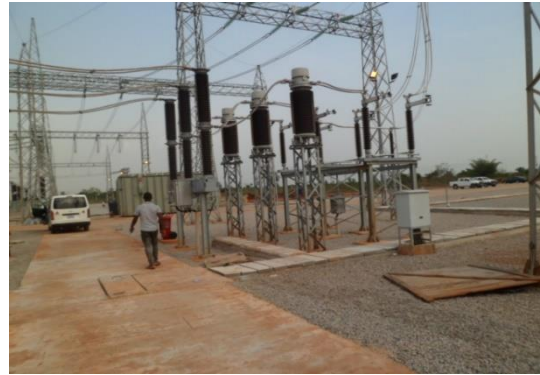
- xii. The firefighting equipment/devices provided for the substations are not adequate.

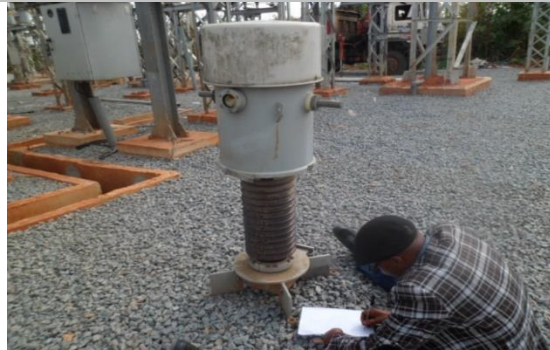
| <p>1. Asaba

2 X 60 MVA
132/33KV
Substation</p> | <p>At the time of our inspection visit, the 2 x 60 MVA, 132/33KV substations was under construction. The necessary inspections of the substation was therefore not carried out</p> |

The contractor should expedite the construction of the substation and EMSL informed for inspection/testing and certification of the project before commissioning.

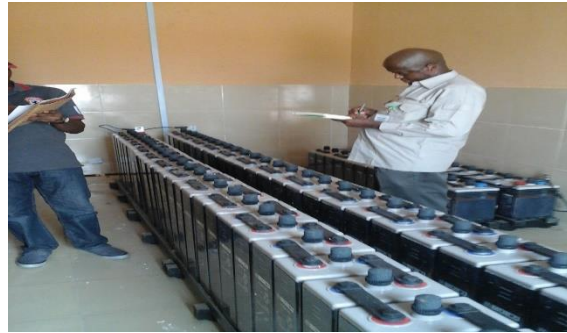
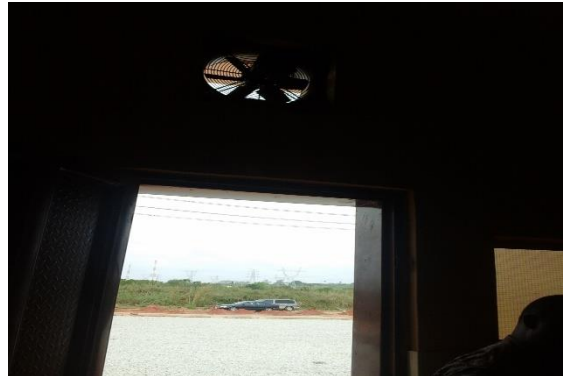
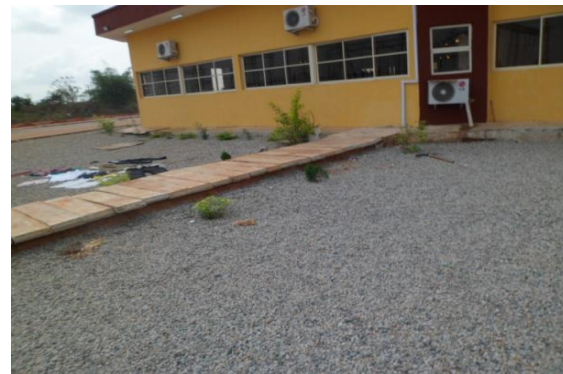
- i. The Asaba – Benin axis of the 330 KV SC OHTL was under construction at the time of our inspection visit.
- ii. The metal doors of the control rooms are not earthed
- iii. No eye wash basin had been installed in the battery room at the time of our visit.
- iv. During the introduction meeting before the commencement of our inspection exercise, the NIPP project manager informed the meeting that out of the 50 Km Asaba – Benin 330 KV SC OHTL, 31.7 Km had been completed. The highlights of the meeting is attached as appendix III

- i. To enable the continuation of the construction of the 330 KV SC OHTL along Asaba – Benin axis, adequate isolation of the line should be carried out at the Asaba substation and the nearest sectional tower to ensure safety of personnel during the construction.
- ii. The frames of all metal doors of the control room should be earthed
- iii. The eye wash hand basin should be safely positioned and installed in the

battery room,
to make it
readily
available in an
emergency.
