ELECTRICITY MANAGEMENT SERVICES LIMITED

REPORT ON INSPECTION AND TESTING OF STANDARD METALLURGICAL COMPANY (SMC) 15MW GAS TURBINE GENERATOR AND 132KV SUBSTATION, GBARA VILLAGE, SAGAMU, OGUN STATE ON 5TH & 6TH MARCH, 2015

RE: CONSTRUCTION OF 132KV OHTL AND ASSOCIATED SUBSTATION FOR THE CONNECTION OF SMC TO NATIONAL GRID

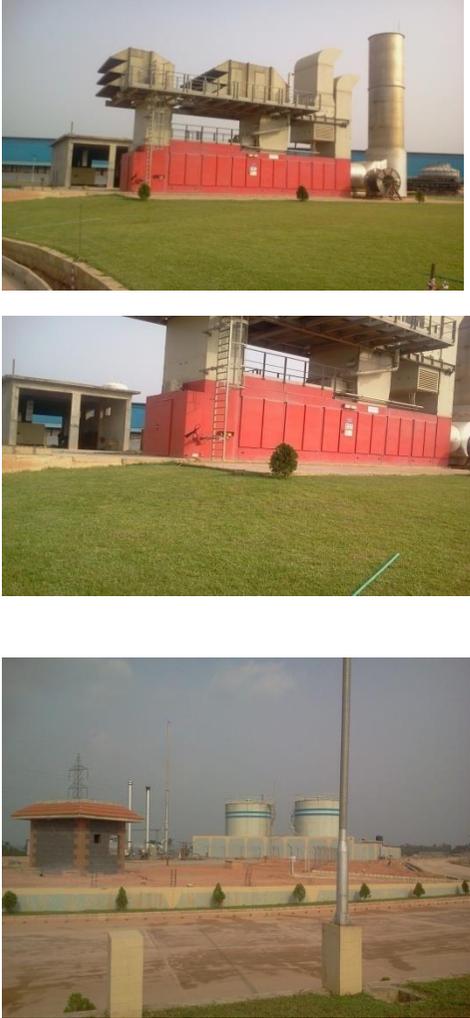
S/NO	PROJECT AREA	OBSERVATIONS	PICTORIAL VIEW OF ITEM	RECOMMENDATION
1.	GENERATING STATION	<p>There was one number Caterpillar (Turbomach) 15MW gas fired turbine engine generating plant, encased below with a sound proof cabin, and projecting upwards with specially designed ventilators and exhaust chimneys. However, detailed technical data and specifications of the plant were not made available to the inspecting team, but was promised to be sent afterwards.</p> <p>The Power Plant is centrally situated with adequate provision for space. Generator area was surrounded by well landscaped green area.</p>

<p>It is recommended that the generation area be guarded with dwarf mesh fence and danger notices to prevent unauthorized entry. Soft and hard copies of generators technical specifications should be presented to the inspecting team for proper confirmation of equipment data and for documentations.</p> <p>Commendable Layout and installation.</p>

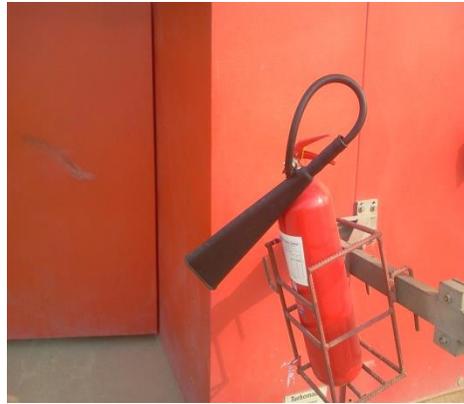
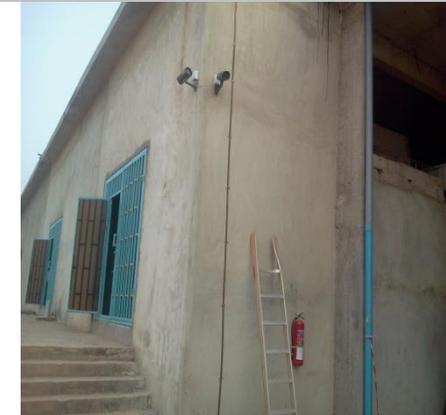
The generated voltage from the generators and other technical data were to be furnished to the inspecting team in due course. However, obvious provision for future expansion has been made in the Power Station and substation areas.

Exposed fire extinguishers should be shaded from the direct effect of rainfall and sunshine, as well as accumulation of dust.

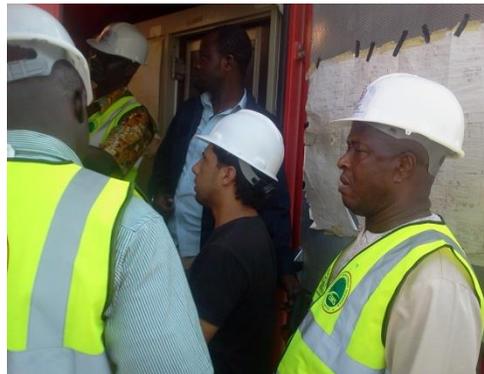
Gas turbine monitor/control room was a small cubicle built inside the lower cabin and manned by one operator that had to be locked in the enclosure.

It is recommended that individual monitoring and confinement in such sensitive area should be avoided, notwithstanding the three shifts of work in place. Alternatively, a transparent opening could be created to enable the visibility of the operator from outside without opening the door.

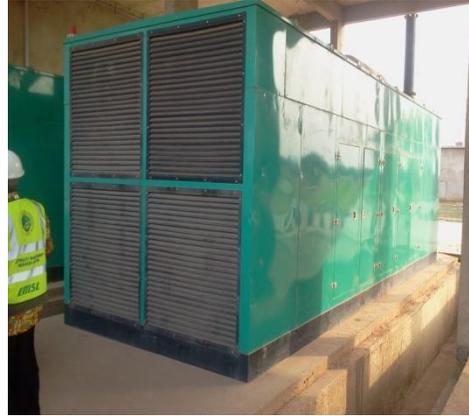
There were also two numbers (diesel fired) standby private generating plants of 1250KVA capacity each.

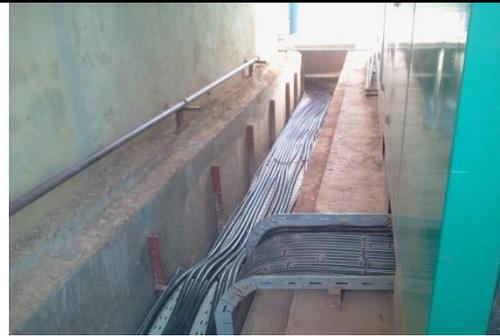
The two numbers private generating plants' house was not completely enclosed enough to prevent unauthorized entry. Besides, the cable trenches and trays were exposed to danger.

Sufficient barricade should be put in place to forewarn unauthorized persons about inherent dangers around high voltage environments. Concrete slabs of appropriate sizes should be constructed and cable tray covers to cover up the places for the safety of all.

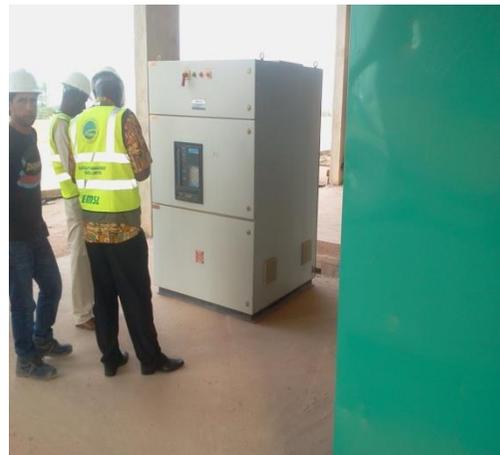
There were no insulation mats provided at the floor of the generator control panels.

Provision of insulation mats of appropriate sizes, rating and quality is recommended for all high, medium and low voltage control panels.

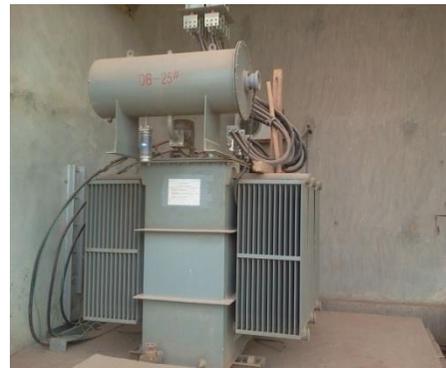
The installed 3.15MVA11/0.415KV, transformer was not properly protected with either wire mesh (as was the case for the 500Kva, 11/0.415kv distribution transformer and the

R.M.U. shown below) or other sufficient barriers.

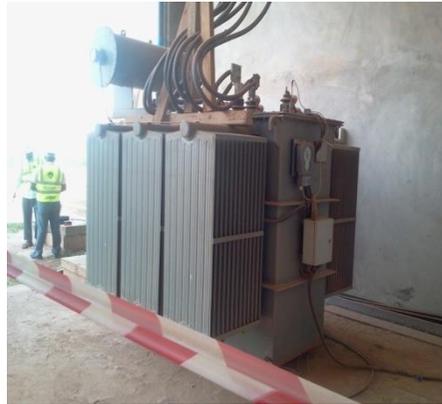
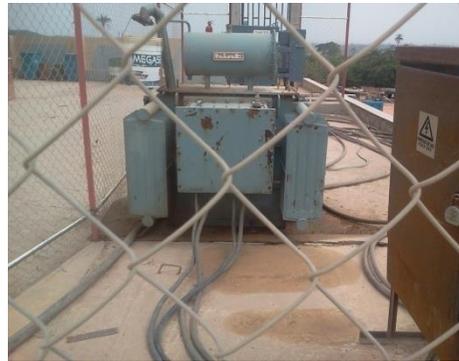
It was also observed that undersized cables were used for terminations on the low voltage side.

The capacity of the MVA transformer requires that a more proactive safety approach should be adopted to forestall unforeseen bad situations that may arise otherwise.

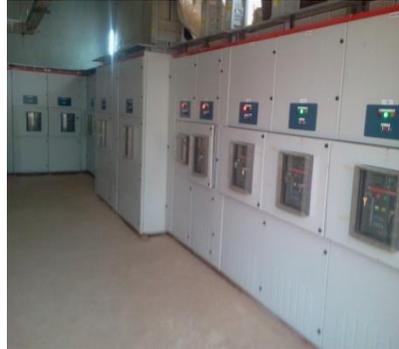
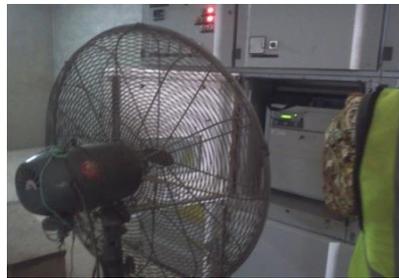
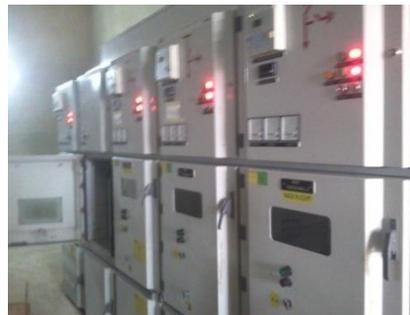
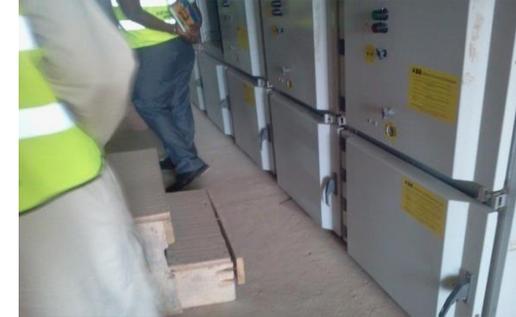
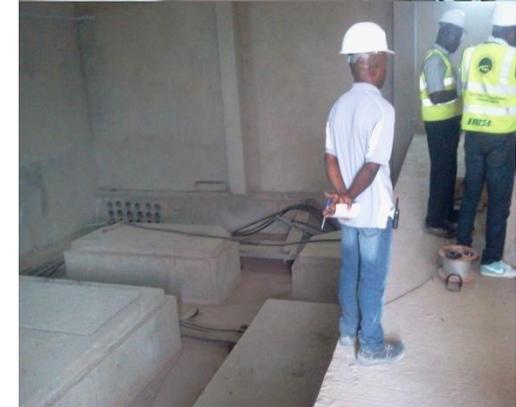
The control rooms were spacious and sufficiently illuminated. However there were no air conditioning facilities, no proper ventilation and there were no insulation mats in place as at the time of this inspection. There was no provision of hand rails or other barriers that could prevent falling off from the pavement elevation created inside and outside of the control room. Use of standing fan was observed as the cooling device for the control panel busbars.

Functional tests carried out to determine the effectiveness of the circuit breakers and other switchgear control systems were confirmed to be in proper operational condition except that the limit switches of

The worker captured in the pictorial above can easily slip over into the ditch behind him, hence the need for adequate barriers/rails to guard possible slippage.

two isolators in the 132KV substation need to be rechecked for proper alignment. Moreover, the support structure for isolator was observed to have cracked.

Provision of recommended safety measures would secure both lives and installed infrastructure.

Defective materials and construction work should be addressed as required by regulation.

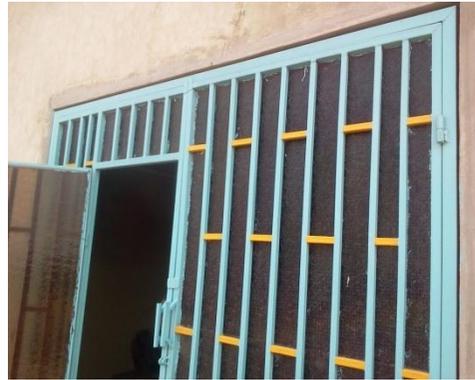
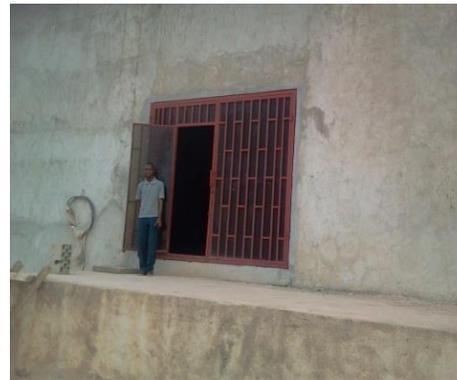
The MV and HV room entrances were not so designated for easy identification, except for the blue coloured (with yellow stripes) metal barrier for the LV room and red coloured entrance for the MV room.

**Boldly written “MV CONTROL ROOM’
DANGER! KEEP OFF** with danger signs at the entrance shall serve.

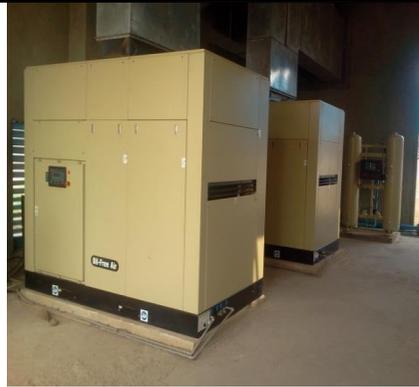
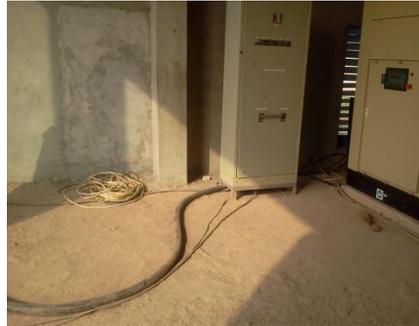
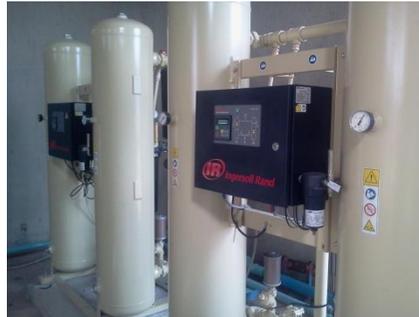
The air compressors and the compressed air receivers/surge vessels were well installed and identified.

Electrical supply cables were not channeled through appropriate ducts thereby exposing some high voltage cables to possible abrasions from continuously stepping upon them.

Appropriate barricade should be provided to block already existing thoroughfare across the air compressor room.

All air receivers/vessels must be hydrostatically tested with labels on the body showing SWP, Test pressure and Date of last test.

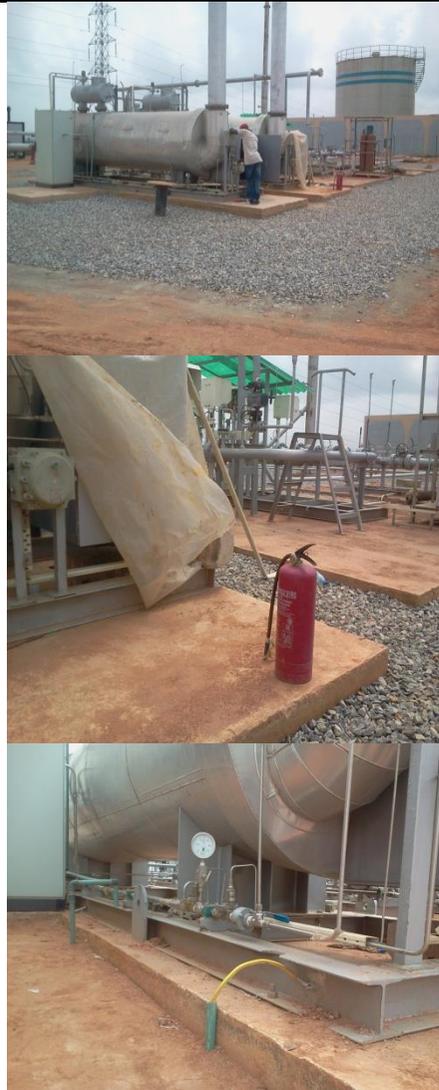
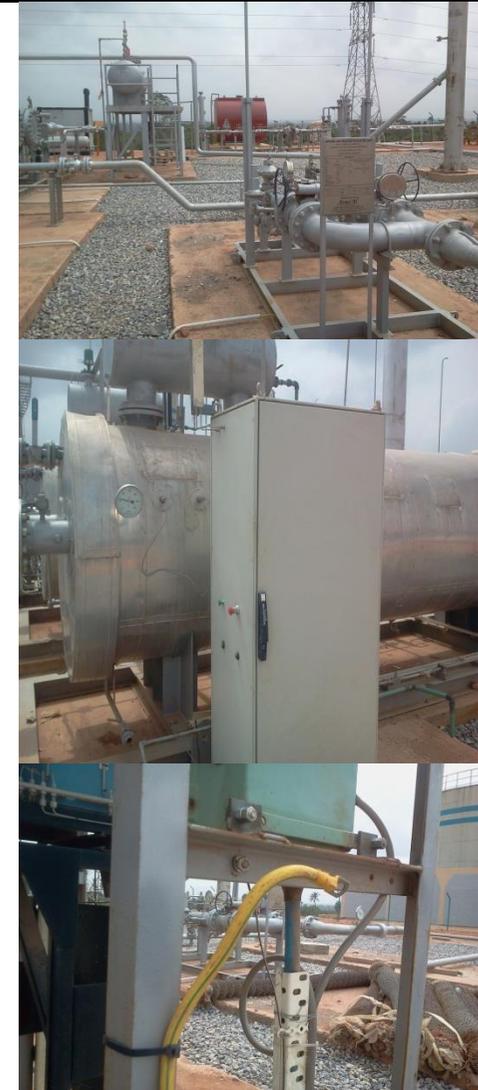
The gas plant area was spacious enough with adequate granites and fire extinguishing facilities provided. Earthing terminals were also identified to be properly terminated except at one separate chamber where the terminal cable lug was flying unconnected.

Fire extinguishers were sighted to be exposed to direct adverse effect of rainfall , sunlight and dust.

The gas plant environment was not barricaded from unauthorized entry and tamper.

All exposed fire extinguishers should be shaded. Terminate flying earthing cable lugs and barricade the entire gas plant arena from unauthorized entry/tamper.

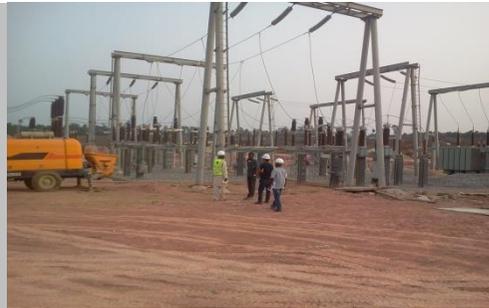
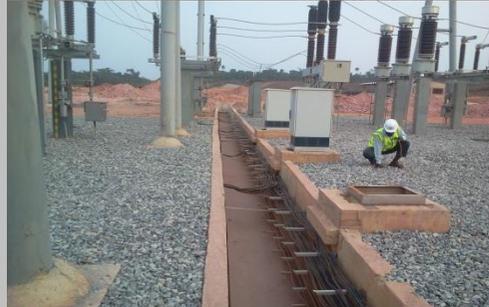
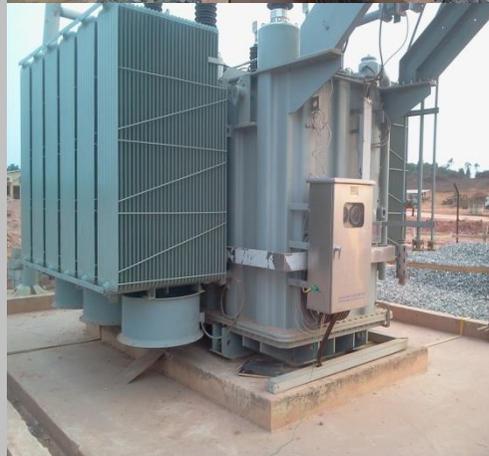
Most areas of the substation construction work were ongoing. Open cable trenches were yet to be covered with slabs.

Covering concrete slabs should be provided to close up all ditches, trenches or ducts as required.

Entire substation arena including power transformers should be properly fenced off with adequate danger notices.

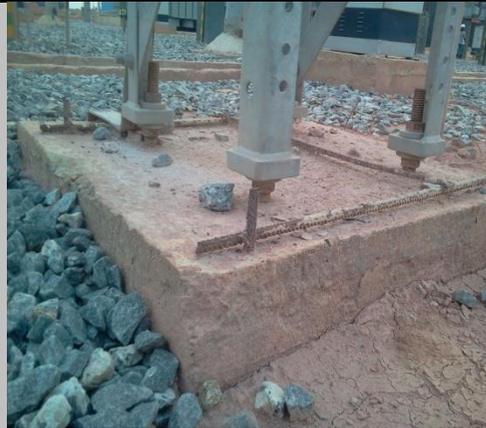
Some gantry basement foundation in the substation were found to be suspended on bolts rather than on concrete structure.

The overall weighty of the gantry structure can tilt the affected gantries out of balance thereby resulting in major construction defects.

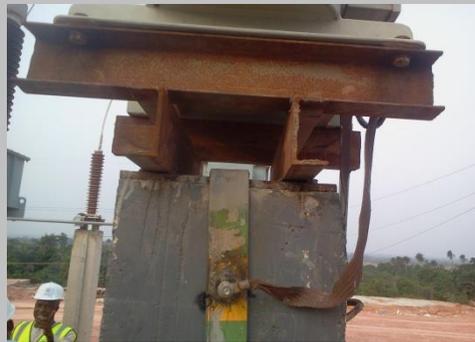
Some metal channels used in the substation construction work were found to be rusting including some bolts and nuts.

Use of galvanized bolts and nuts and galvanized steel channels is recommended.

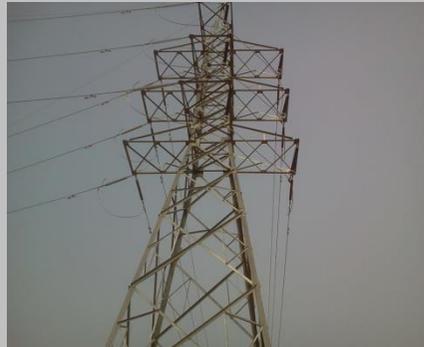
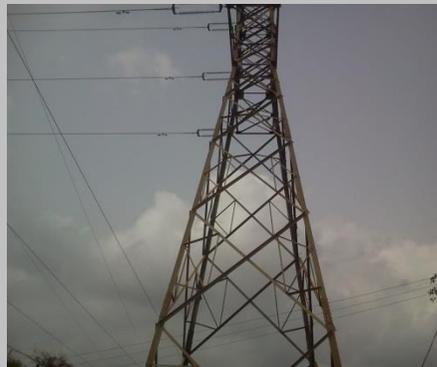
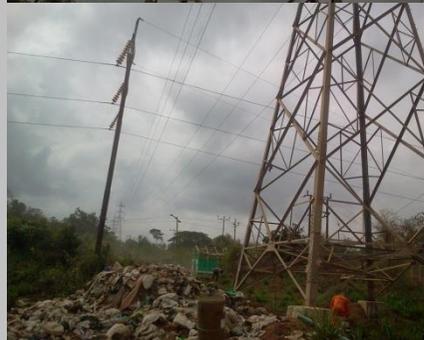
There were no anticlimbing devices, no phase identification notices, no danger notices, no external earthing of the tower legs. Tower number six and some others were observed to be too close to the access road. Careless drivers have the tendency to crash into the towers.

Reflexive caution signs should be installed on the towers affected. Use of anti climbing devices, phase identification signs, and danger notices are required by regulation for all transmission tower installations.

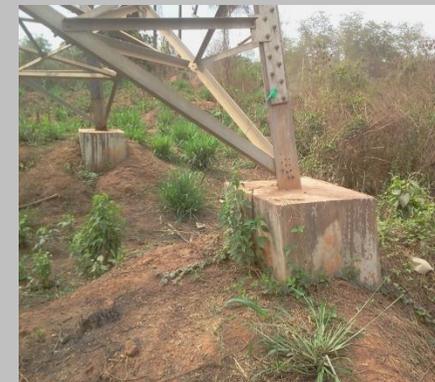
The existing 132KV network to which the proposed 132KV transmission substation

is to be connected was observed to be too low and does not possess the regulation standard height. It was observed to be lower than existing 11KV network along the same axis. Station to the air compressor section, transformer substation structures and control panel rooms, tower structures and all associated ancillaries and they were found to be within specified values except at tower numbers 3, 5, and 7 where the values were between 2.04 and 3.37 ohms. All measured earth resistance values are tabulated in appendix 2 below.

Reconstruction of the existing 132KV Ikorodu/Sagamu lines is strongly recommended in order to avert potential future hazards.

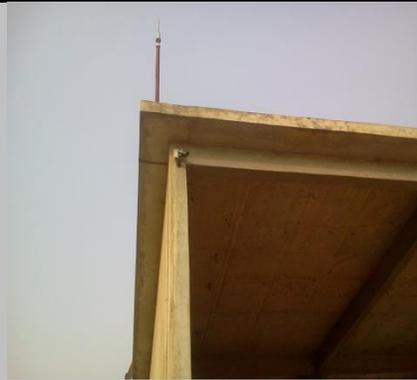
The entire substation and generator environment was well protected from lightning using sky wire in the substation and spikes covering the entire factory perimeter.

The turn-in turn-out sky wire should be in form of a mesh to cover the entire region designed to be protected.
