### **INSPECTION REPORT OF 915MW TRANSCORP POWER STATION AT UGHELLI, DELTA STATE**

The Inspection and Evaluation of the 915MW Transcorp Power Station was carried out on Tuesday 14<sup>th</sup> March 2017 with the following in attendance:

**Plant Detail:** Client - **Transcorp Power Limited, Ughelli, Delta State**

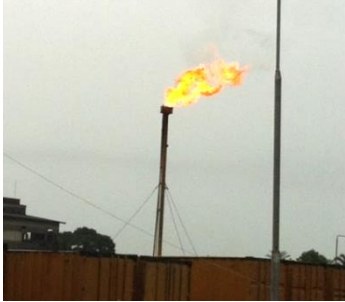
| | | <p><b>7. Bleed excess natural gas from Utorogu and Ughelli East Gas Plants are flared for safety.</b></p> | | |

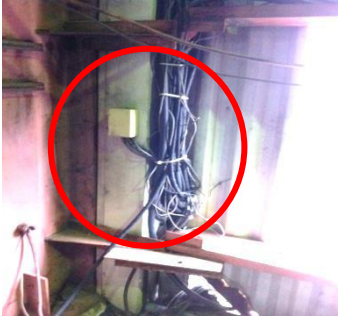
| 2. | <p><b>Delta II &amp; III Turbines Building Areas</b></p> | <p><b>1. Cables not properly laid on cable trays were seen in the Delta II &amp; III turbine building areas; some of the cables were seen just bunched together on the building stanchions/steel structures.</b></p> | <p><b>Cables tied untidily on turbine building steel structure</b></p> | <p><b>1. Use proper cable trays or cable ducts as discussed with your team of engineers.</b></p> |

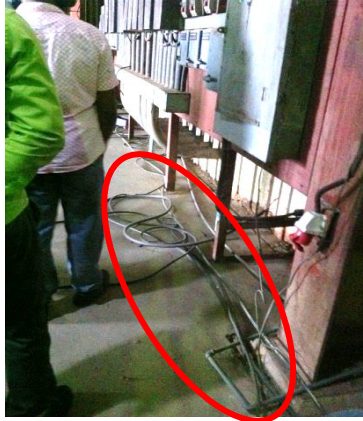
| | | <p>3. Some cables were seen running on the bare turbine room floor. This is unsafe.</p> | <p>Live cables lying loosely on the floor in Delta III turbine areas</p> | <p>3. Cables lying loosely on the floor should be properly run on cable trays, ducts or pipes to avoid accidental damage and possible tripping of personnel by the cables.</p> |

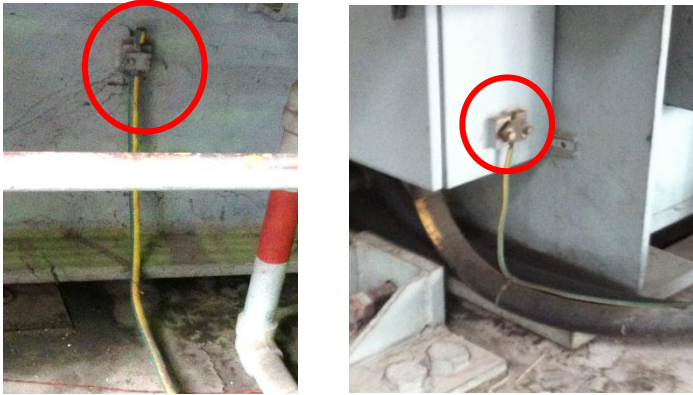
| | | <p>4(i) Good earthing of the turbine and alternator base frames using appropriately rated earth conductors were seen in place.<br/>4(ii) However, some earthing points were seen covered/coated with paint thereby reducing the contact connections and this has negative effect on earthing effectiveness.</p> | <p>The turbine frames and control panels were well earthed</p> | <p>4 (i) The earthing on all the turbines, alternators, transformers, panels, etc must be checked at least twice a year to ensure that their earthing resistance values are below 2 Ohms.<br/>4 (ii) The earthing points should be checked for proper contact/ingress. The ones with ingress should be disconnected, cleaned, greased &amp; reconnected for proper contact.</p> |

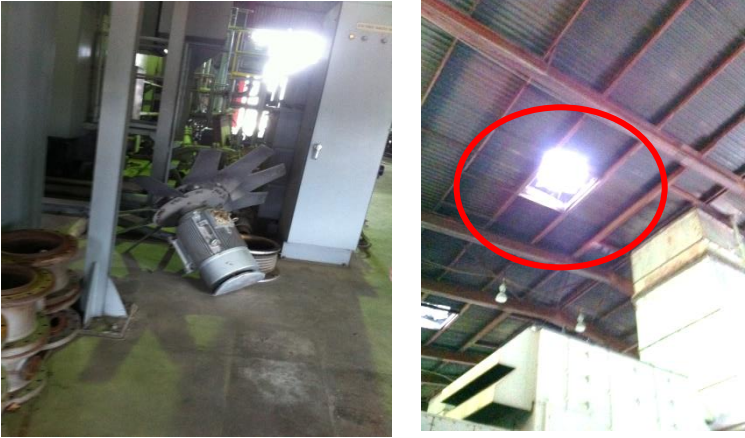
| | | <p>5. Some sections of the Delta II &amp; III turbine areas were observed very hot as some of the extractor fans were either not in position or were not working.</p> | <p style="text-align: center;"><b>Missing Roof extractor fans</b></p> | <p>5. All missing or faulty roof extractor fans should be replaced/made operational.</p> |

1. Access doors to turbine areas not closed presumably because of absence of roof extractor fans in some areas of Delta II & III.
2. Loose cables, broken earth continuity conductor, exposed terminals all constitute unsafe conditions.

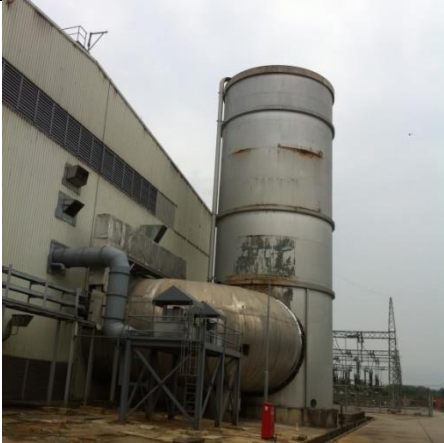
| | | <p>6. Appropriate lightning protection Faraday spikes were seen on the exhaust stacks of Delta IV turbines and around the power station.</p> <p>7. Other lightning arrestors seen around the power station providing adequate protection against lightning strikes.</p> | <p style="text-align: center;"><b>Typical exhaust stack of the Frame 9E GTGs</b></p> | <p>6. Earthing of lightning arrestors should be checked regularly to ensure earth continuity and earthing resistance of less than 2 Ohms.</p> |

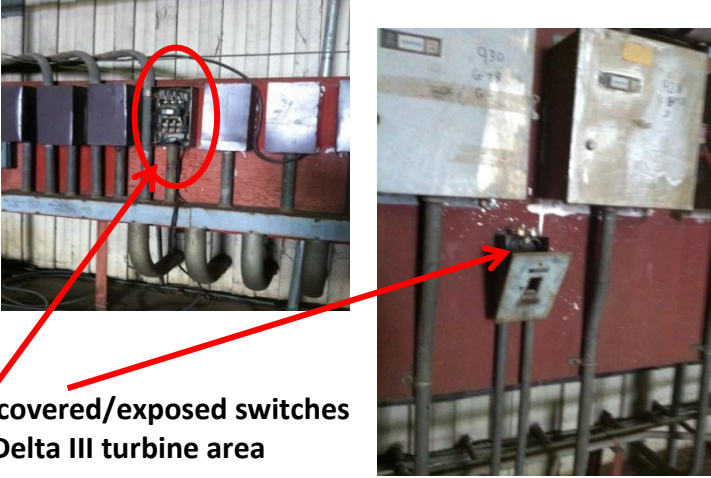
| | | <p>8 (i). Some main/control switches were seen without covers or inadequately covered.</p> <p>8(ii). Control switches were not adequately labeled / identified.</p> | <p>Uncovered/exposed switches in Delta III turbine area</p> | <p>8(i). All exposed electrical switches must be covered.</p> <p>8(ii). Control switches should be appropriately labeled for ease of identification by operatives/technical personnel.</p> |

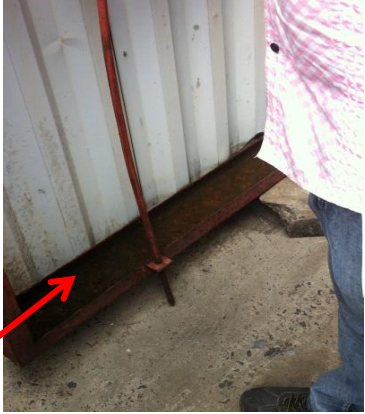
| . | | <p>9. Rain water seen collecting on the channel iron used to brace the turbine building doors. This could lead to rusting of the channel iron, and can also be a receptacle for festering mosquitoes.</p> | <p>Water collection on door channel iron could be a habitat for mosquitoes</p> | <p>9. At least one (1) hole should be drilled on the channel iron to drain off water and prevent future gathering of water on it.</p> |

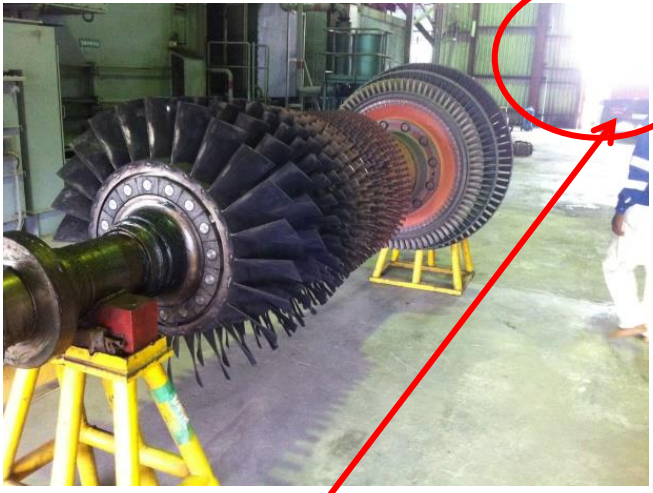
| | | <p>10. Most of the main access doors to the turbines were open and without barriers. This could give access to unauthorized persons to enter the turbine areas and cause expensive damage to the rotor and other turbine parts.</p> | <p>Wide open doors give free access to turbine areas</p> | <p>10. Appropriate barriers to be provided to prevent accidental entry to turbine areas.</p> <p>11. Gates made with wire mesh can be provided if the doors must be open especially in areas where roof extractor fans are missing and the turbine area is hot.</p> |

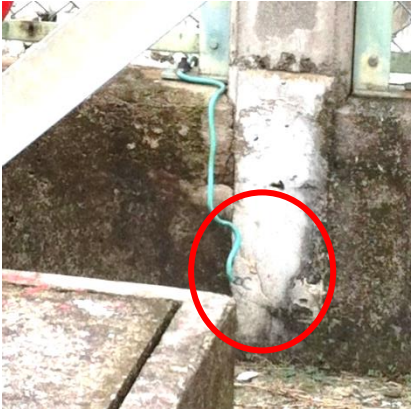
| <p>3.</p> | <p><b>EARTHING SYSTEM</b></p> | <p>1. An earth continuity conductor was seen not properly terminated at Delta IV by the Station Transformer II.</p> <p>2. Painting was seen on some of the earthing points.</p> <p>3. The earth pit points were properly covered.</p> | <p>Dangling earth continuity conductor.</p> | <p>1. The hanging earth conductors should be clamped properly to the gantries leg to ensure earth continuity.</p> <p>2. All paint deposits on earthing points should be scraped of and the area of contacts properly cleaned, retightened for better contact and greased to prevent corrosion.</p> |

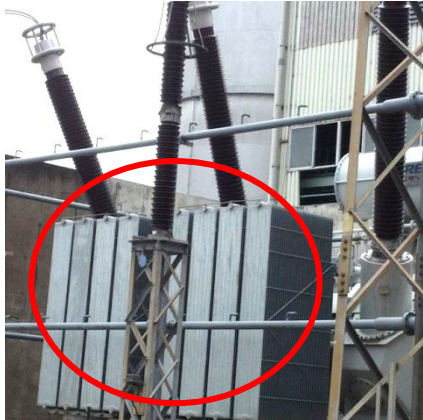
| 4. | STATION TRANSFORMERS | <p>1. It was observed that the Delta IV Turbine No. 1 station transformer area was not fully protected with a fence. This was considered to be work-in-progress and should have been provided with temporary barrier and Danger Signs.</p> <p>2. The gantries carrying the fire hydrant pipes around the station transformers were seen not earthed.</p> | <p>Station transformer area of 115MW GTG not guarded.</p> | <p>1. The protective wire mesh fence should be restored and appropriate Danger Signs installed.</p> <p>2. Mesh protection around the station transformer should be earthed appropriately.</p> <p>3. The gantries/columns carrying the fire hydrant pipes around the station transformers should be adequately earthed.</p> |

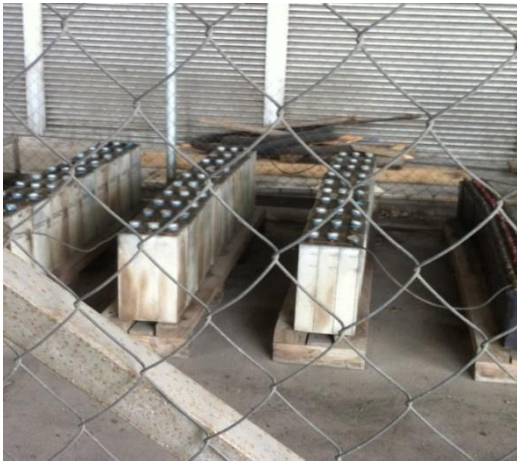
| 5. | BATTERY ROOM | <p>1. No Eye-Wash facility seen installed nearby</p> <p>2. Battery area was seen to be well ventilated and protected from access by unauthorized persons.</p> | <p>Battery compartment</p> | <p>1. Eye wash bay should be established close to the battery area..</p> <p>2. Lighting should be improved upon generally and all lighting points should be functional.</p> <p>3. Metallic gate and the wire mesh should be adequately earthed.</p> |

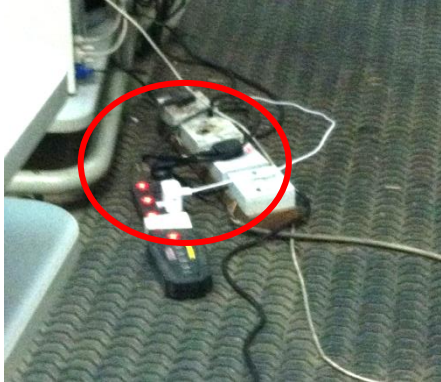
| | | <p><b>8. Extension socket outlets seen on control room floor.</b></p> | <p><b>Heavily-loaded Extension socket could be a source of Fire</b></p> | |

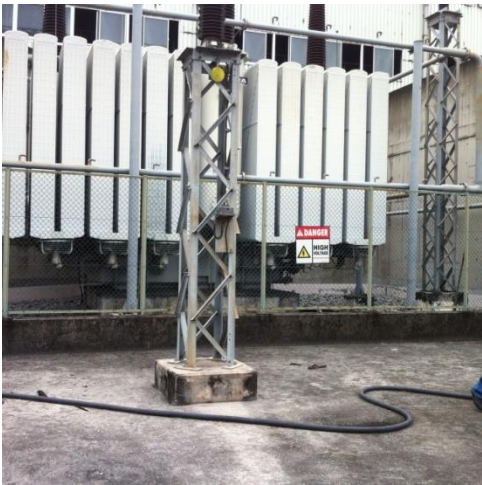
| <p><b>7.</b></p> | <p><b>SAFETY EQUIPMENT/ SIGNS</b></p> | <ol style="list-style-type: none"> <li><b>1. Danger / Warning signs were seen available in the entire power station.</b></li> <li><b>2. Safety requirements for specific areas were seen displayed in areas such as entrance to turbine areas</b></li> <li><b>3. Fire extinguishers were available in the turbine areas and control room but not in the switch yard.</b></li> <li><b>4. Artificial respiration procedures chart not seen in the control room.</b></li> </ol> | | <ol style="list-style-type: none"> <li><b>1. Danger / Warning signs should be provided at strategic locations</b></li> <li><b>2. More fire extinguishers should be provided in the turbine areas.</b></li> <li><b>3. All unused constructional materials, equipment and tools should be moved out of the turbine areas.</b></li> <li><b>4. All constructional hanging cable strands, ropes, bolts &amp; nuts, etc, should be removed</b></li> <li><b>5. The turbine areas should be kept clean &amp; tidy always.</b></li> <li><b>6. Emergency / Artificial Respiration Charts should be provided.</b></li> </ol> |
