AREA FIELD OFFICE:		OWERRI		MONTH:	
S/N	Date of Investigation	Accident Description	Accident Type	Location	DisCo
1	29th MARCH 2019	A 56 years old woman, Mrs Chitolu Tomas was Electrocutted as the jumper wire of existing 11KV GRA feeder line spanned	ELECTROCUTION	OKPARA SQUARE, UMUAHIA, Abia state.	EEDC

Mar-19

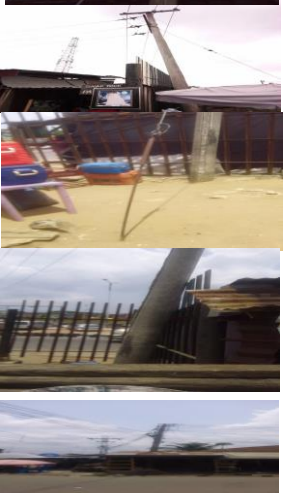
<p>ENGR. K.O. IKPO (NEMSA): KINGSLEY OGBODO (NEMSA): ENGR. OZOEZE ONYEBUCHI: ENGR. FRANCIS IWU (HEAD HSE FEDC):</p>	<p>Jumper wire cut of existing 11kV line dropping on a stay wire; energized the stay structure. The victim, Mrs Chitolu Thomas, made direct body contact with</p>

Actions Taken	Details of eye witnesses (Contacts)	Follow Up Actions (Date) & outcome	Recommendations made to eliminate surface & root causes
VISITED SITE, INVESTIGATED THE COURSE OF ACCIDENT, SENT REPORT TO APPROPRIATE AUTHORITY FOR COMPLIANCE.	On condition of anonymity, two persons, also road side traders, explained that the deceased was serving the canteen owner. The latter had finished the day's	Visited the site of accident on 29/3/2019, confirmed that the jumper line of 11KV network that snapped and fell on stay wire causing	1. Double poles to be installed at the tee off angular point. 2. Steel cross arms to be solidly earthed. 3. Whole appropriate sizes of wires to be used to replace jointed pieces used for replacement during repairs. 4.
