AREA FIELD OFFICE:		EKO		MONTH:	
S/N	Date of Investigation	Accident Description	Accident Type	Location	DisCo
1	02/12/2019	<p>The victim, MRS SAOFIYAT (Mama Ayo) 45-years old was sleeping inside a metal kiosk situated under an 11kV HT Overhead network when due to heavy rain/thunderstorm at 2:30Pm on Sunday 20th January 2019, the yellow phase conductor which was in an energized state snapped and fell on the metal kiosk thereby electrocuting the lady. She was taken to a hospital but was pronounced dead on arrival.</p>	Electrocution	5, Sofolahan Street, Itire, Mushin, Lagos.	Eko

MONTHLY RETUR**FEBRUARY**

INS ON ACCIDENT INVESTIGATED

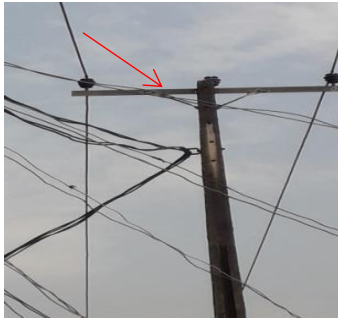
The HT Pole from which
the Yellow Phase
aluminum conductor
snapped and fell on the
metal kiosk.

Actions Taken	Details of eye witnesses (Contacts)	Follow Up Actions (Date) & outcome	Recommendations made to eliminate surface & root causes
<p>The accident was investigated</p>	<p>1. Mrs JOY OKOH (Principal Witness) a business woman who owns a retail shop opposite where the event took place. 2. MALLAM SULEIMAN (A Security man) living in the wooden shack attached to the container shop where the victim got electrocuted.</p>	<p>Nil</p>	<p>1. The entire 11kV HT-Overhead network along Sofolahan street, Itire, mushin, should be replaced with new aluminium 150mm² (ACSR) conductors as it was observed to have deteriorated, unstranded with several weak joints. 2. EKEDC should lay emphasis on proper monitoring /maintenance and rectification and replacement of aging/bad network equipments and accessories.</p>

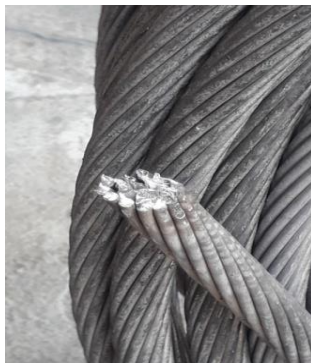
Historical Incident (If Any)	Pictures	Investigated By	Possible Root Causes
Nil		Osagie, F.O Oghenegweke, F.O MUSA, W	<p>The snapped HT-11kv overhead line aluminium conductor may be;</p> <ol style="list-style-type: none"> 1. Aging with several jointed parts. 2. Conductors may be deteriorated. 3. Conductors may be unstranded and reduced in size. 4. The conductors may be substandard.

The 150mm sq. ACSR rolled and folded from ground level

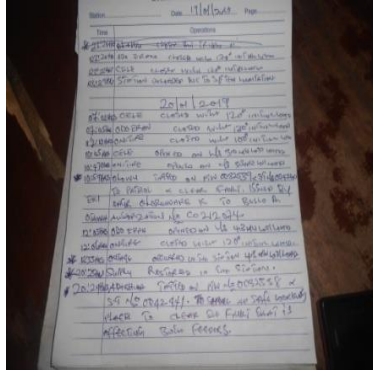
The Log book at the Itire Injection Substation indicating the time of the incident.

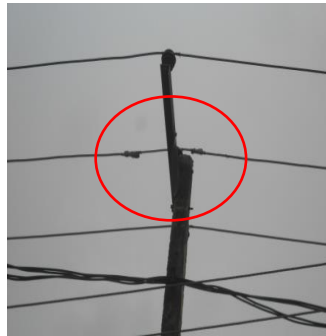
A portion of the network with several weak jointed parts.

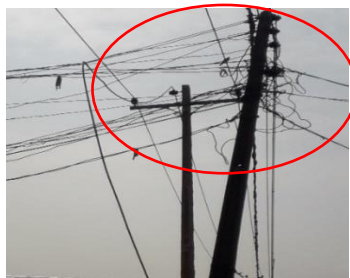
Very Rough/untidy
network with improperly
executed/weak joints at
sofolahan street, Itire
Road Mushin, Lagos
