REPORT ON INSPECTION AND TESTING OF THE PARAS ENERGY 90MW POWER
STATION AT OGIJO, OGUN STATE
26TH AND 27TH FEBRUARY 2015.

INSPECTION OF PARAS ENERGY 90 MW GENERATION POWER PLANT AND 33KV/132KV SUBSTATION IN OGIJO, OGUN STATE

ON 26TH AND 27TH FEBRUARY 2015

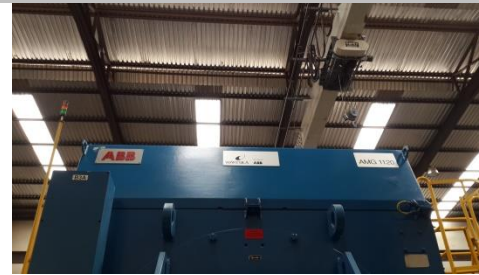
The generated voltage is 11KV from ABB alternators powered by the Wartsila 20V34SG engines. Provision for future expansion has been made in the Power Station building.

The alternators are synchronized and the output voltage is first stepped up to 33KV and subsequently again stepped up to 132KV for connection/transmission to the national grid.

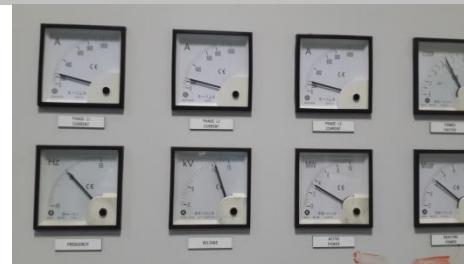
Generated voltage and frequency were at 11KV and 50 Hz respectively.

Observed load was 3.3 MW balanced on the three phases.

Grid meters have also been procured and sent to National Meter test Station Oshodi for certification.

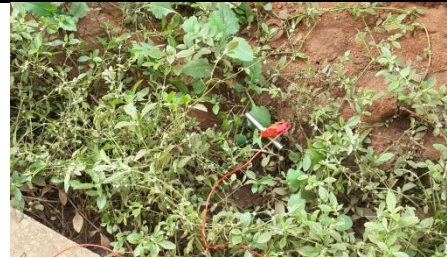
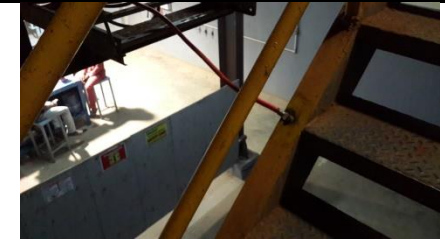
The earth resistance of all the generators were measured and found to be as in Appendix 3. However the earth resistance of the handrails and steps were high.

Two earth Megger testers were used for the readings and these correlated very well.

An improvement on the earth resistance of the handrail and steps could be achieved by connecting them to earth continuity as done in the workshop area as shown below.

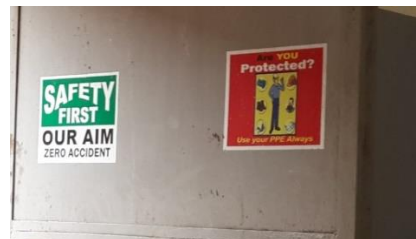
Adequate safety, warning and danger signs abound in the entire plant and this is commendable. A safety officer is also employed.

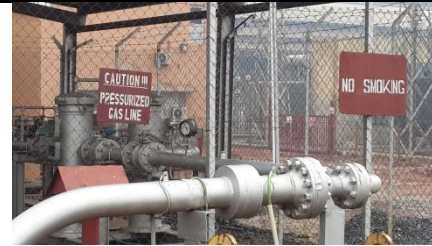
Gas leak detectors are in place both inside the generating station and gas stations.

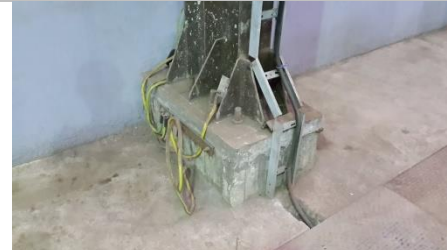
The earthing of all the generators, auxiliaries, steel structures, control panels were found adequate and within specified values.

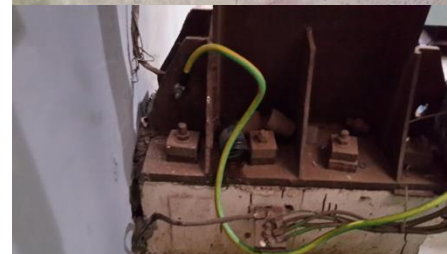
The earth continuity conductors were of adequate size with correct colour codes.

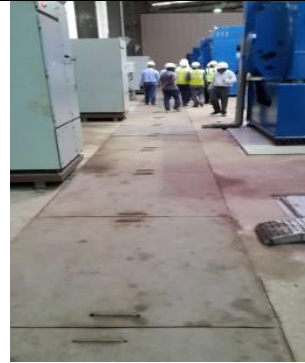
Cable ducts were adequately covered with checker plates, and the stairways and generator platforms with steel gratings.

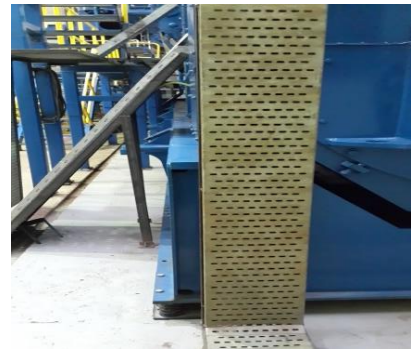
The Cable trays were all well laid out and not overloaded, and cables well strapped to the trays with plastic cable ties.

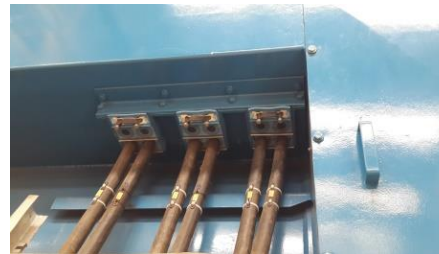
All cable entries to the generators and panels are well gland.

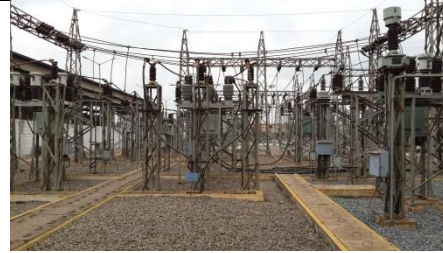
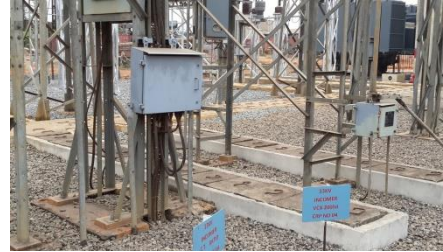
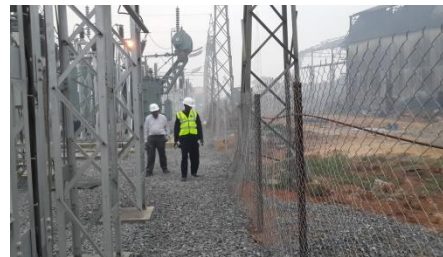
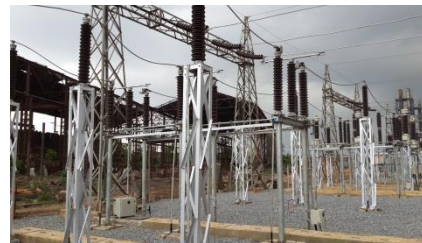
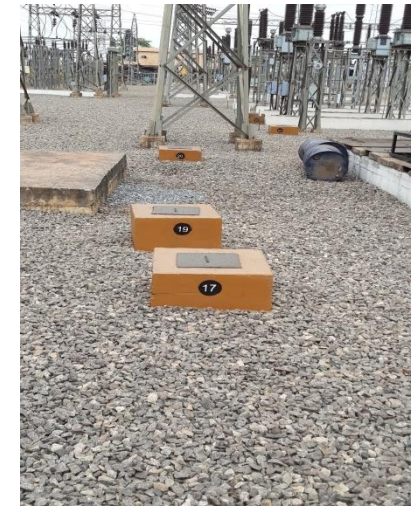
The gantries were well constructed and erected on concrete foundations. All the gantries and steel structures were of galvanized steel as per standard specifications. The entire substation grounds are well graveled.

All the equipment support structures were well labeled and earthed.

The mass earth for each unit was well constructed which ensured that all earth resistance readings were well below 1 ohm. This is highly commended.

Well-constructed and erected gantries made from galvanized steel.

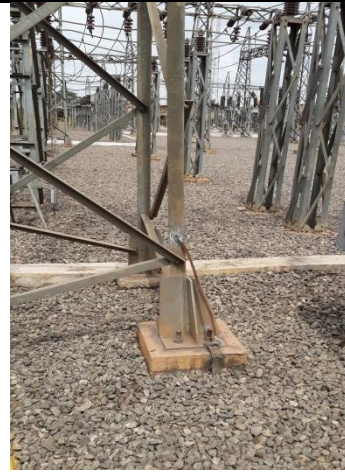
Adequate earthing of all support structures observed.

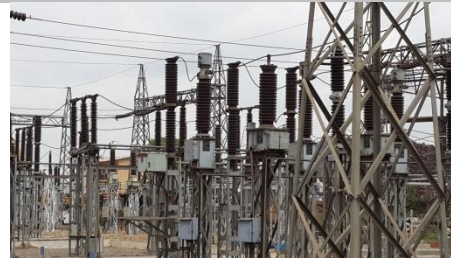
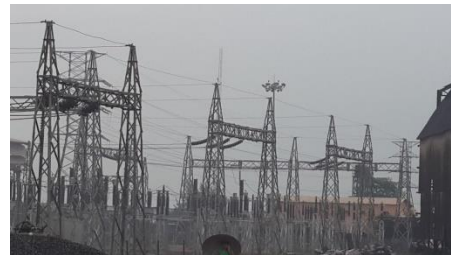
The entire substation was well protected from lightning using sky wire lattice.

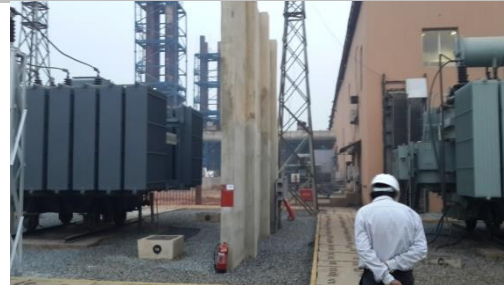
Adequate concrete separating wall put in place between transformers as standard safety requirement.

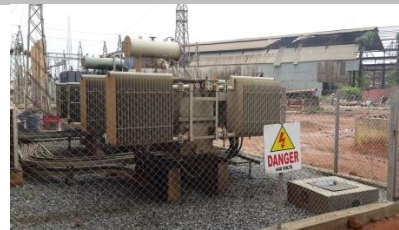
The 11/0.433KV substation is well constructed and protected with safety, warning and danger signs. Earth resistance results

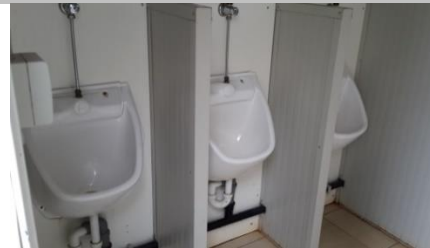
Well maintained clean toilets manned by a cleaner is commendable and indicates good staff welfare practice.

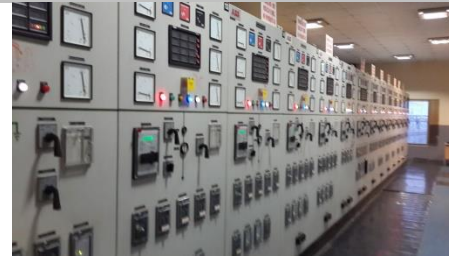
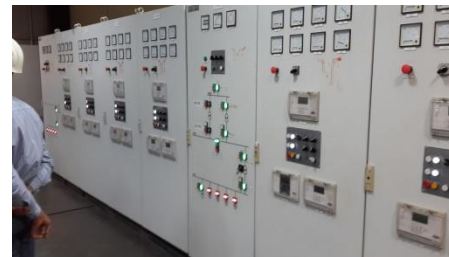
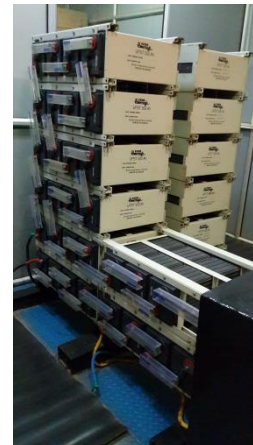
The Substation control room was very well laid out. Provision for airconditioning good. A demonstration of the capabilities of this digital substation was undertaken to determine performance of:

- Opening and closing of isolators and circuit breakers.
- Switching Interlocks.
- Flexibility of the HMI and alarm marshaling.
- Bus coupling and protection.
- Transformers switching, Tap Change panel and general circuit protection.

The Control voltage 110 Volts Battery supply and battery bank room is well laid out with state-of-the-art battery packs; no exposed conducting connections thereby assuring of safety of personnel. High voltage insulation mat is spread in front of all panels.

Distance/Remote switching and interlock protection was demonstrated. Local operations of the couplers, earthing switches, also observed,

On completion of installation works client to ensure high voltage insulation mats are laid in front of all panels. All panels must be adequately connected to an appropriate earth system.

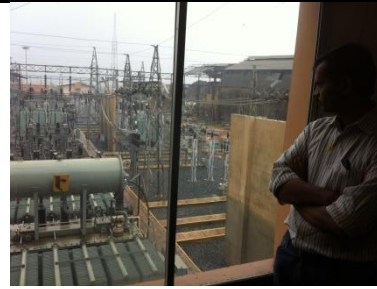
The interface between the generating station and the switchyard was demonstrated. The generating station control room was well demarcated from the substation control room and battery room. Visual contact with the 132KV substation from the control room quite adequate and makes for good operational practice.

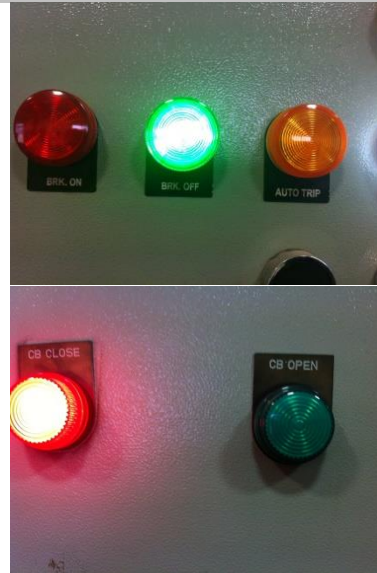
The operational indicators of the Substation Control panels show "Red" for Breaker on and "Green" for breaker off. This is standard and correct.

It is recommended that a unification to "Red" for Breaker on, and "Green" for breaker off should be made as standard.

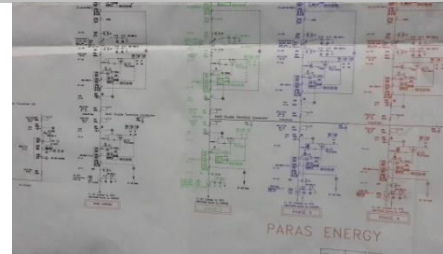
Soft and hard copies of documentation requested for by EMSL from the project team: were provided. These include, generators and transformers parameters, Relay settings and their response results; Interface drawings between generators and substation, etc. Relevant line drawings for the Turn in-Turn Out arrangements.

It is recommended that adequate risk management techniques be adopted to safeguard software, data and records by storing them at least 100 kilometres apart. Suggest replicate data and store in India, or elsewhere.

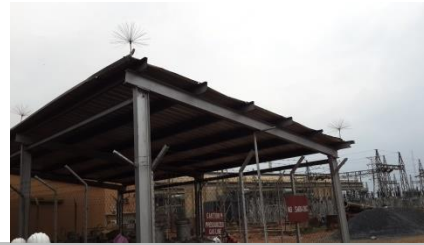
Faraday lightning rods and spikes types have been utilized as the most effective types. A radial type was seen on the steel manufacturing shop adjoining the power station.

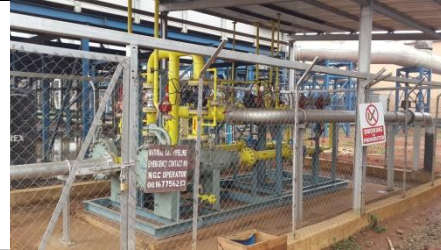
whilst that of the far side was 0.6 ohms and the wire mesh fence was between 1.29 – 2.76 ohms.

Improvement of earth resistance recommended so as to obtain values of 2 ohms and less.
