ELECTRICITY MANAGEMENT SERVICES LIMITED

INSPECTION REPORT OF JOS-MAKURDI 330KV DC OVERHEAD TRANSMISSION LINE

Your letter No NIPP/TRX/2041/2014 dated 28th November, 2014 on the above subject matter refers. Please be informed that the Inspection/Test of Makurdi – Jos 330KV (DC) OHTL with the associated Makurdi 330/132/33KV substation and 330KV line bays extension at Jos was carried out between 8th and 14th December, 2014. The following persons were present for the exercise;

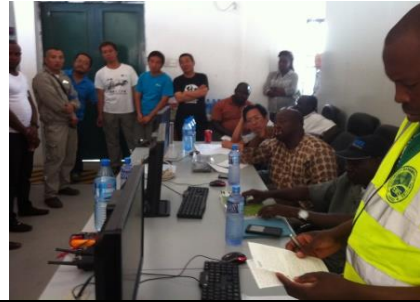
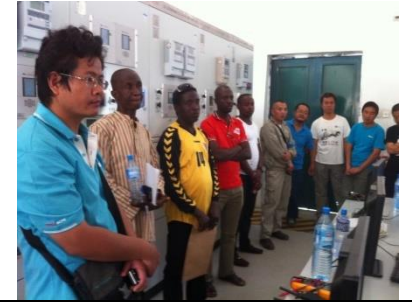
11.	General Observations	<ul style="list-style-type: none"> i. During the construction of pile foundation for tower (T33), a stream was blocked. The blockage has caused flooding around the area ii. The metal doors of the control rooms are not earthed iii. The eye wash basin installed in the battery room was not safely positioned

<ul style="list-style-type: none"> i. The blockage should be removed to enable free flow of the water since the pile foundation construction has been successfully executed ii. The frames of all metal doors of the control room should be earthed iii. The eye wash hand basin should be safely positioned to make it readily available in an emergency
------------	-------------------------	--	---	--
