# **NIGERIAN ELECTRICITY MANAGEMENT SERVICES AGENCY (NEMSA)**

## **NEMSA INSPECTION REPORT**

**38 MEGAWATT DUAL - FUEL FIRED TURBINE INDEPENDENT POWER PLANT, KALAMBAINA ROAD, SOKOTO**

## NEMSA INSPECTION REPORT ON 38MW SOKOTO INDEPENDENT POWER PLANT

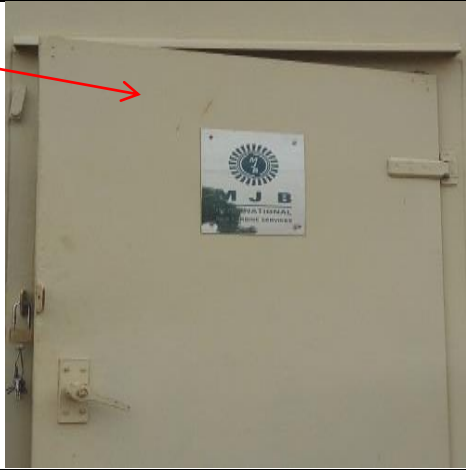
1c		<p>iii. Danger plates were not fitted at the metallic entrance gate of the control room and elsewhere around the turbine skid.</p>

<p>iii. Danger signs should be fitted at the entrance gate of the control room and around the turbine skid.</p>
2a.	<p><b>Battery bank:</b></p>	<p>i. The lower battery arrangement in the battery bank at the power plant was seen with several damage and swollen batteries. This occurred as a result of inadequate ventilation and lack of cooling facilities in the battery bank.</p>

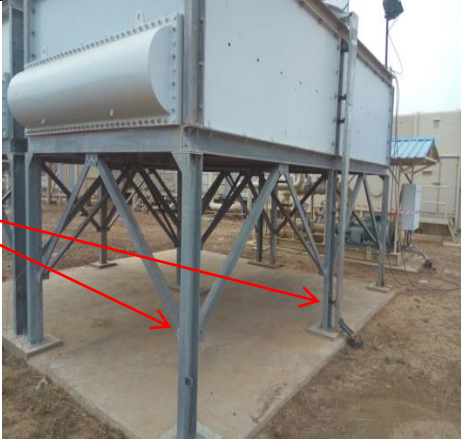
- i. Not all the supports of the Lube oil coolant platform were earthed. All the supports of the lube oil coolants platform should be earthed for safety.
- ii. The lube oil pipes were seen not well protected against corrosion. There should be adequate arrangement to protect the lube oil pipes against corrosion.

iii. There is the need to provide interlocked changeover between the AC and DC panels.
3a	<b>The lube oil coolant:</b>	i. Not all the steel supports /legs of the Lube oil coolant platform/system were earthed.

i. Diagonally opposite legs of the lube oil coolants assembly should be earthed.

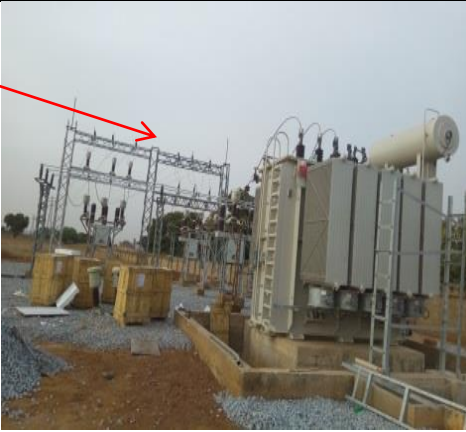
4b		<p>ii. Earth shielding wire was not provided around the switchyard up to the turbine exhaust stack to protect against lightning strikes.</p>

<p>ii. Earth shielding wire should be provided from the switchyard to the exhaust stack to form a protection shield from lightning for the entire station.</p>
4c		<p>iii. Some of the earthing points at the power plant turbine skid area were seen corroded.</p>

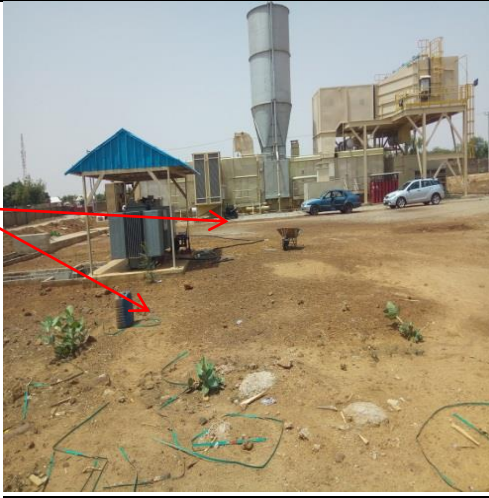
4k		xi. Gravelling of the generating plant and switchyard area, fencing of the active area of the generating plant and slabs covering for the cable trenches between the generating plant and the switchyard control area was not done.

xi. Gravelling of the generating plant and switchyard area, fencing of the active area of the generating plant and slabs covering for the cable trenches between the generating plant and the switchyard control area should be done.
		xii. A cable supplying power to an electric security lamp was seen hanging dangerously in the step ladder that leads up to the turbine filter platform

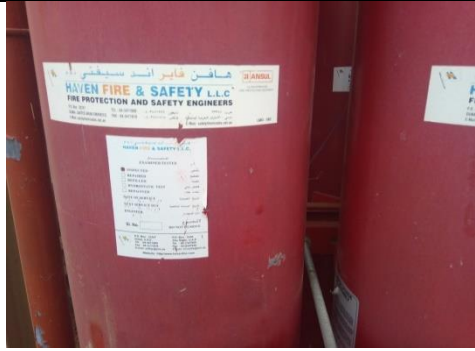
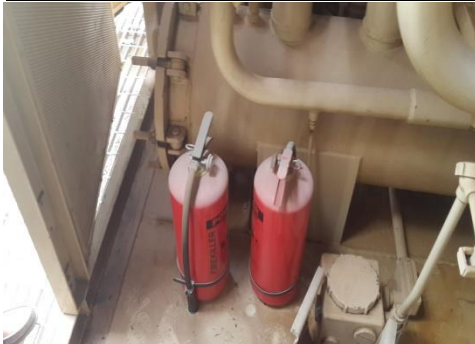
5a	<b>Fire Hydrants/ Extinguishers</b>	i. The servicing dates for the fire hydrants were not maintained.

i. The servicing dates for the fire hydrants should be maintained, while the expired fire hydrants/fire extinguishers should be replaced with functional ones.
6a	<b>Fuel Storage Vessels/Tanks</b>	i. The construction of the pure fuel tank is on-going and has reached an advanced stage at the time of our inspection visit.

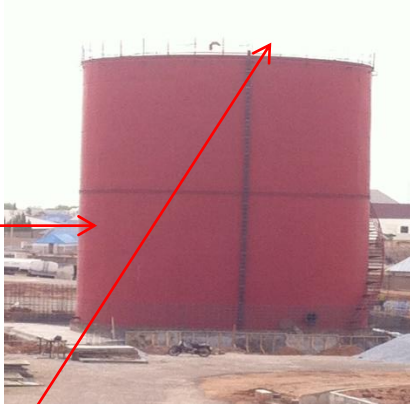
6b		<p>ii. The raw and pure fuel tanks have no proper identifications numbers.</p> <p>iii. No danger signs fitted at the fuel tanks.</p> <p>iv. No lightning arrestor at the top of the higher fuel tank for protection against lightning strikes.</p>

<p>ii. There should be proper identifications on the fuel tanks.</p> <p>iii. Danger signs should be fitted at the two tanks.</p> <p>iv. Lightning arrestor should be provided at the top of the higher tank.</p>

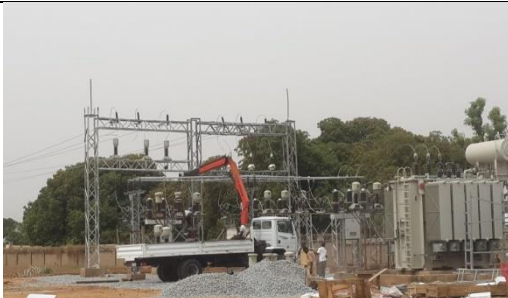
- i. The 11kV cables outgoing from the generating plant to the substation were yet to be connected to the transformer. The 11kV cables should be connected to the transformer and properly terminated with appropriate cable lugs.
- ii. At the time of our visit the contractor was replacing CTs and VTs that were found having lower ratings at the switchyard. All CTs and VTs should be checked properly to ensure they are in

i. The 11kV cables should be connected to the transformer.
1b		ii. At the 33kV switchyard, the contractor was seen replacing CTs that are of lower rating.

accordance with specifications with respect to the current and voltage ratings of the main power transformer before installation.

ii. All CTs and VTs should be in line with the current and voltage ratings of the transformer.

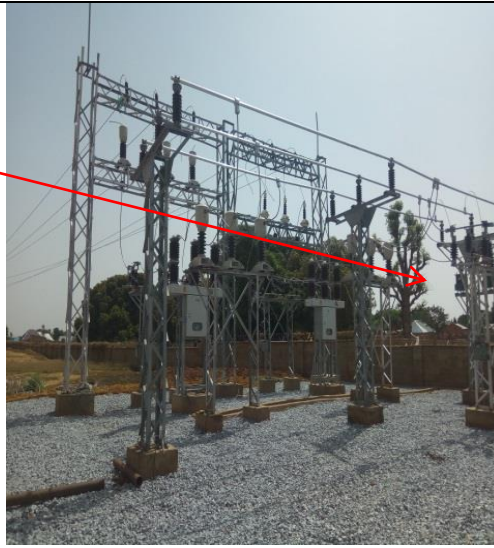
1c		iii. The transformer bus bar isolator was yet to be installed as at the time of our visit.

iii. The transformer bus bar isolator should be installed.
1d		iv. The evacuation line isolator was seen without an earth switch.

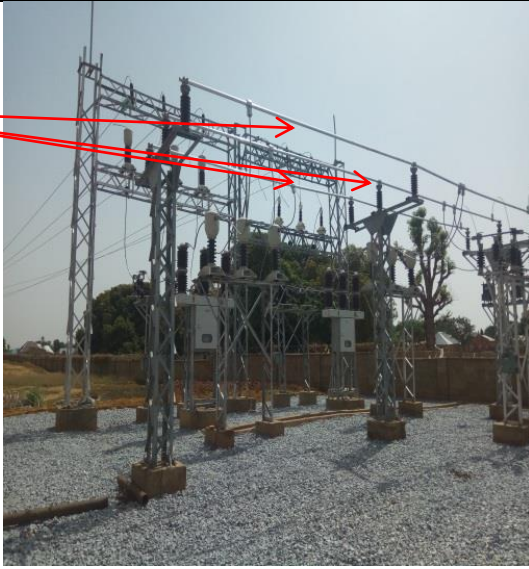
1g		vii. There was no provision for flexibility at the switchyard as Single bus bar was used as against the double bus bar seen in the switchyard control panel. Even the single bus bar provided was not sectionalized.

vii. Additional bus bar should be provided at the switchyard for flexibility purpose.
1h		viii. The jumper conductor from the step up transformer to the current transformer (CT) isolator has a big curve- out that can allow rain water to follow

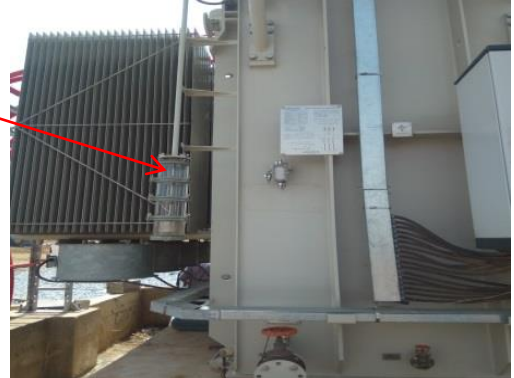
x. An earth conductor size of 70mm <sup>2</sup> should be used to earth each support structure.
1k		xi. No silica gel at the step up transformer.

xi. Silica gel should be fitted on the step up transformer.
1l		xii. The installation of some equipment within the switchyard is still on-going.

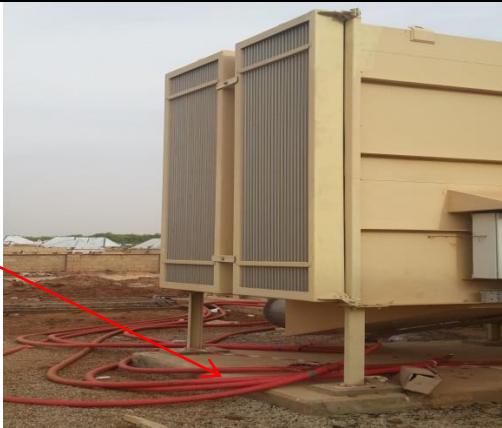
1m		xiii. Cablings and jumper terminations were still on-going at the switchyard and turbine plant ends.

xiii. The cablings and jumper terminations should be completed before the next inspection visit.
2a	<b>Switchyard battery bank</b>	<p>i. The battery bank room has no good ventilation and industrial extractor fan was not provided.</p> <p>ii. No adequate illumination in the battery bank room.</p>

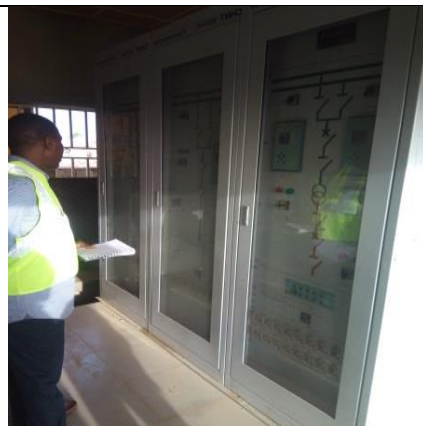
3d		iv. At the time of our visit, the contractor was seen busy fixing the lighting points at the switchyard control room.		iv. Adequate illumination is required at the switchyard control room and the switchyard itself.
3e		v. The step-up transformer oil and winding temperature indicators were not provided for in the control panel.

v. Oil and winding temperature indicators should be provided in the control panel.

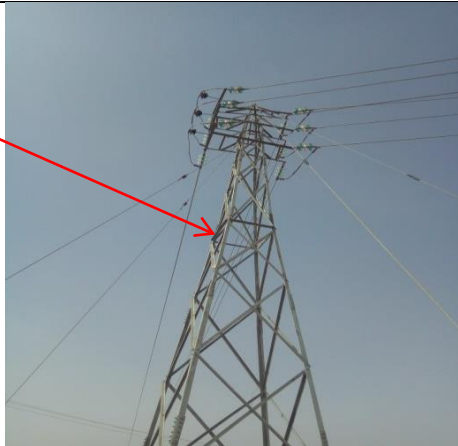
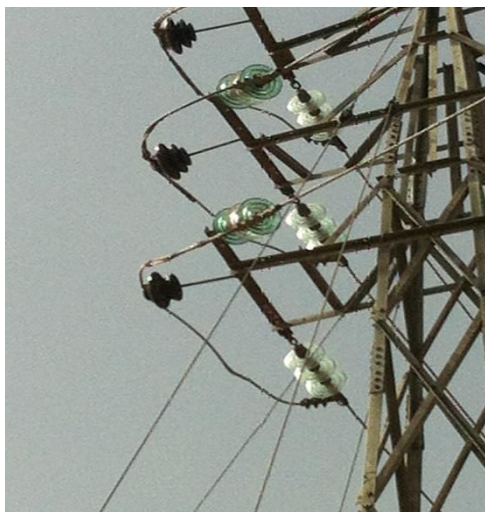
- ii. The second tower was seen not designed for an angle tower, but it is now used as an angle tower due to the change in the entry point to the transmission substation. This has caused the tower to twist creating an unstable situation where stay wires were used to stabilize the tower. Angle towers should always be constructed in accordance with designed constructional specifications and standards.

i. The tilted cage of the first tower should be checked and amended.
1b		ii. The second tower was not designed for an angle, but it is now used as an angle tower due to the change in the entry point to the transmission

substation. This has created an unstable situation where stay wires were used dangerously to stabilize the tower.

ii. Angle towers should always be constructed in accordance with designed constructional specifications and standards.

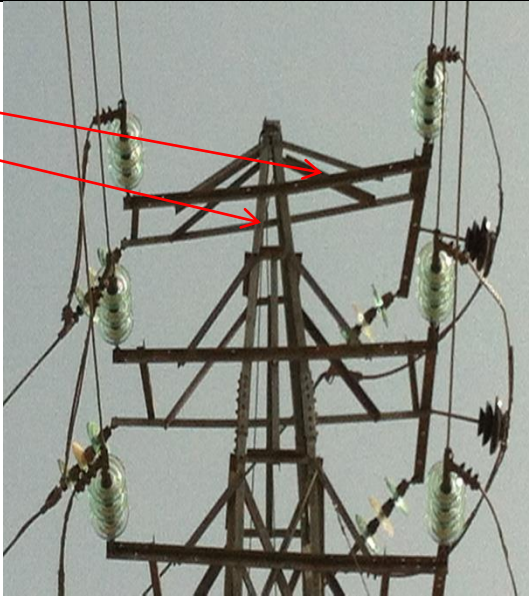
- iv. The uppermost cross-arms and the middle cross-arms of the second tower were seen bent due to excessive tension. These bent cross-arms in dangerous twist should be replaced with good ones.

1d		<p>v. The uppermost cross-arms and the middle cross-arms of the second tower was seen bent due to excessive tension.</p>

<p>vi. All bent cross-arms observed should be replaced with good ones.</p>
1e		<p>vii. The base of the second tower was seen not properly sand filled and thus exposed to retention of water during rainy season, while the two legs B &amp; C were seen buckled out.</p>

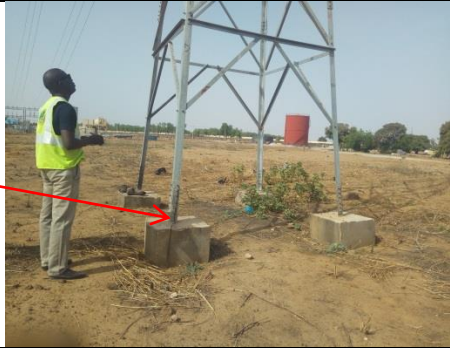
1f		vii. Not all the legs of the tower are earthed, only one leg was earthed.

viii. At least two diagonally opposite legs of the supports of each tower should be earthed.
1g		ix. No anti-climbing devices, phase identification (I.D.), tower/poles numbering plates and danger signs on both the steel towers.

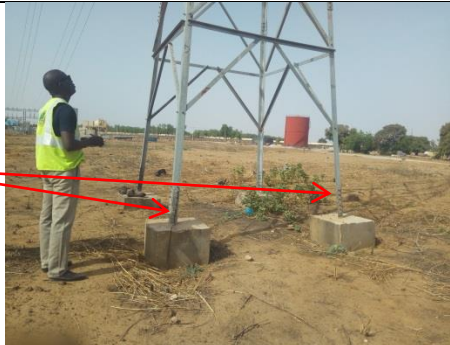
viii. Anti-climbing devices, phase identification marks, tower and poles numbering and danger signs must be installed on each tower.
1h		ix. The earth conductors used in tower legs are undersized.

x. An appropriate earth conductor size of 70mm <sup>2</sup> should be used.

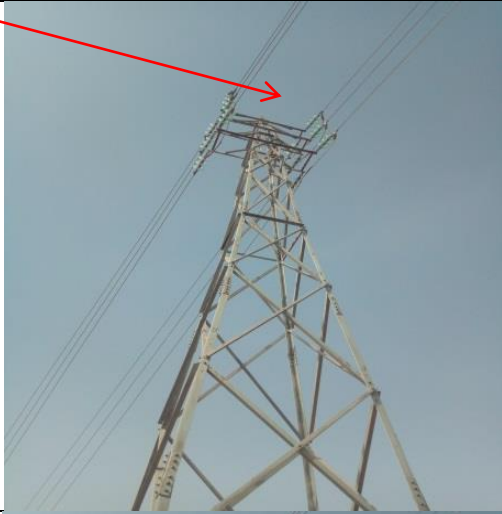
1k		xiii. The lines from the power plant to the TCN substation were not provided with vibration dampers and earth shielding wires.

xii. Earth shielding wires and vibration dampers should be provided from the power plant to the TCN substation.
1l		xiii. No communication links or sky wire between the TCN substation and the power plant.

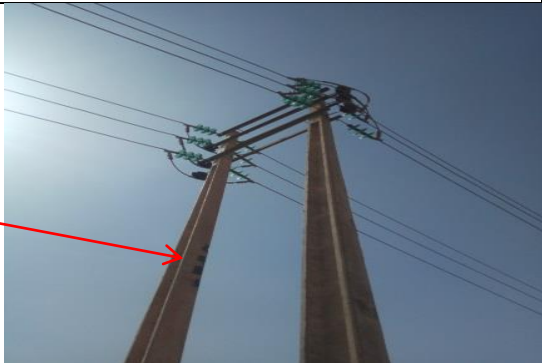
i. All poles should be planted to the marked planting depth on the pole boot.
1b		ii. No pole numbering, danger signs and anti-climbing devices on all the concrete poles inspected.

ii. All concrete poles should be numbered, while danger signs and anti-climbing devices should be fitted on each concrete pole.

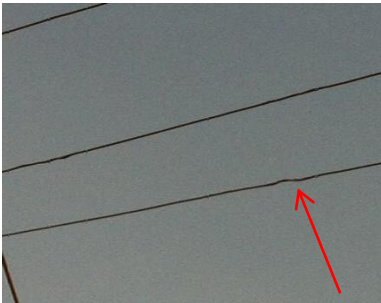
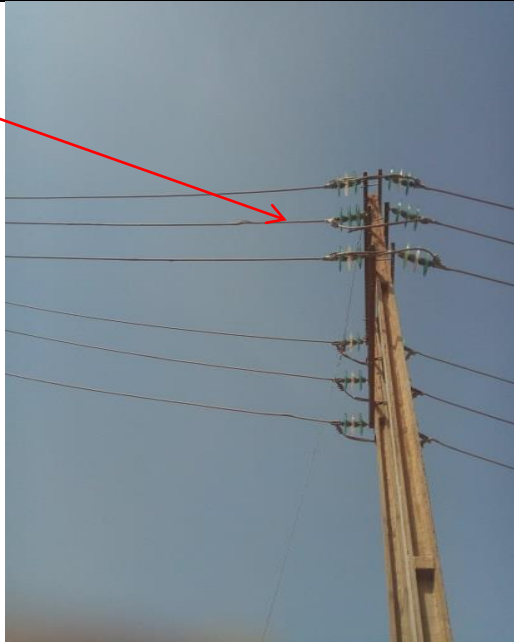
1c		<p>iii. Conductor kinks were seen on the yellow and blue phases on circuit one.</p>

<p>iii. The conductor kink on the yellow phase should be checked and removed, or the conductor span replaced.</p>
1d		<p>iv. The red and yellow phases on the second section pole were seen touching each other due to a detached pilot insulator.</p>

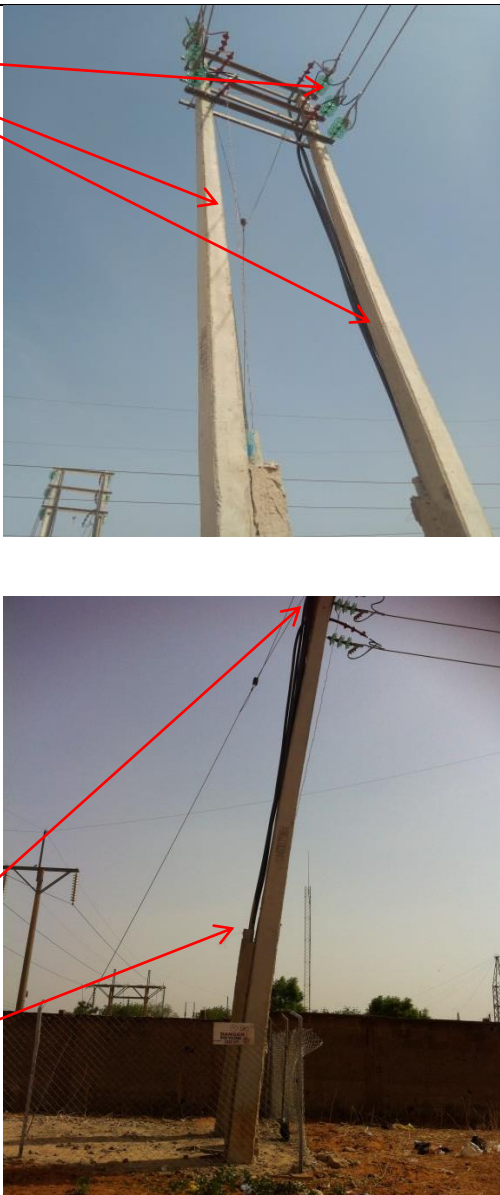
1e		<p>v. At the underground crossing of the 132kV Overhead line, one of the double poles structure was seen dangerously tilted and on the verge of collapse. It does not have adequate stay wire to support it, which has also led to extensive sagging on the line.</p> <p>vi. Also, lightning arresters were not installed on the poles.</p>

<p>v. The tilted poles should be re-erected, adequate stay wires installed and lightning arrester should be provided for the two circuits at the crossings.</p>
----	--	---	--	---

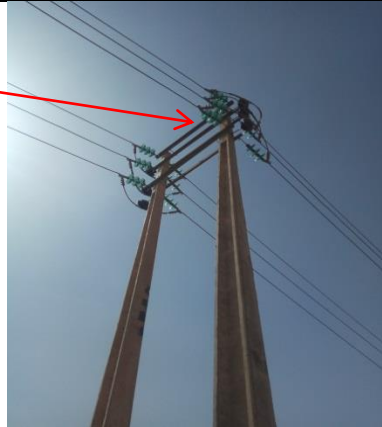
1f		vi. All channel irons on concrete poles were seen not earthed and no adequate ground clearance on the line networks between the second and the third pole.

vii. The channel iron should be earthed and adequate ground clearance should be provided on the line networks of both the second and the third pole.
1g		viii. The fourth concrete pole was a three pole structure, the jumpers of circuit two on it was not connected properly and cracks were seen on one of the concrete poles.

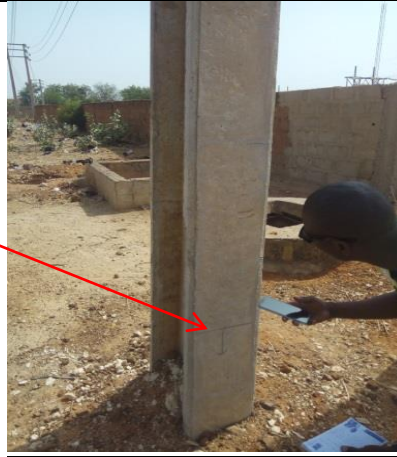
1h		viii. The sixth double pole was not planted to the planting depth and the jumpers were seen in close proximity to circuit one.

ix. The planting depth of the sixth double pole and the jumpers that are in close proximity to circuit one should be checked and amended.
1i		x. The planting depth of the three pole structure at the point of entrance to TCN substation was not adequately planted to the planting depth.

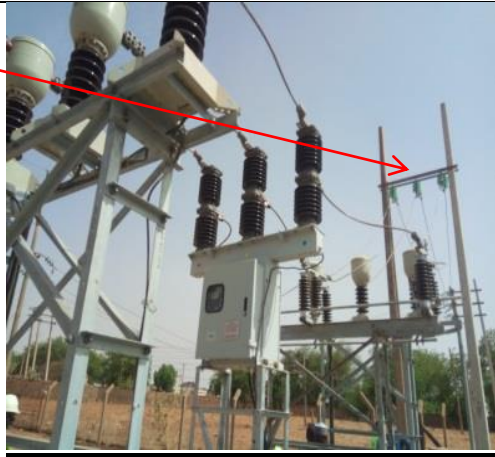
<p>ii. The Channel iron of the connecting bay should be earthed, while the jumpers of the outer phases that are almost touching the concrete pole should be checked and corrected.</p>
1c		<p>iii. There was no lightning arrestor at the connecting bay of the incoming SIPP 33kV feeder lines to the TCN substation. Also, all the gantry supports for the</p>

VT's were not earthed, while the gantry for the circuit breaker and the CT's was earthed only on one leg.		
1d		iv. There was no interlock between the main incomer isolator and its earthing switch. This is a major safety lapse that can lead to serious electrical accidents.

<p>iii. Lightning arrestor should be provided at the connecting bay, while the legs of all gantries should be earthed.</p>

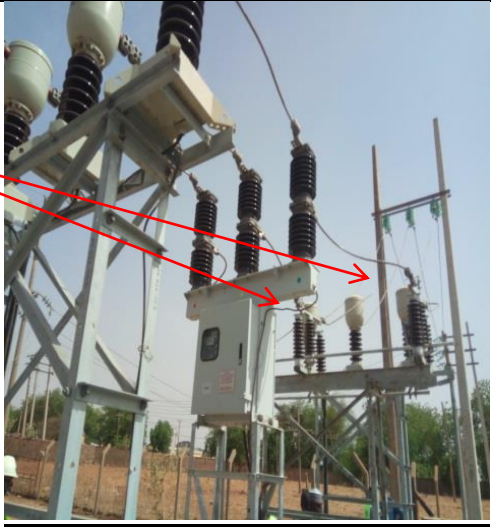
1f		vi. The phase identification marks (I.D.s) of the SIPP incoming line from the power plant were at variance with the phase identification marks on the TCN substation bus bars - (the red and blue phases were interchanged).

vi. The Red and blue phases which were wrongly tagged should be properly traced, identified and corrected.
1g		vii. Loose and corroded nuts were seen on the gantries.

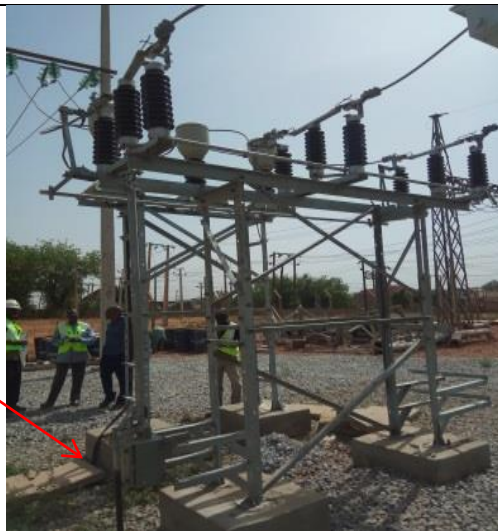
1h		<p>viii. Concrete slabs were observed placed on the control cables, coming from the circuit breaker at the TCN switchyard. This would further injure the cable insulation and degrade the cable.</p>

<p>viii. The concrete slabs that were fouling on the control cables from the circuit breaker at TCN switchyard should be removed to avoid injury on the cable insulations.</p>

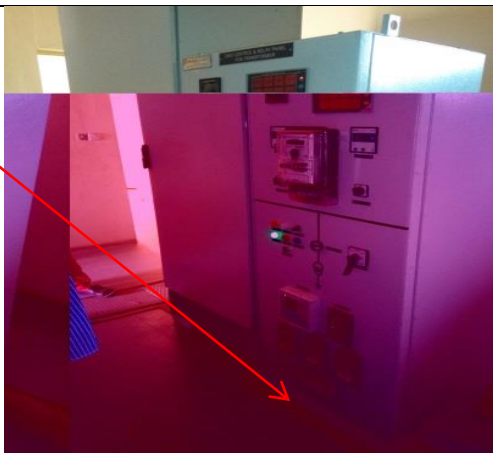
2a	<b>TCN Control room</b>	<p>i. Insulation mat was not laid in front of the control panel. This is for the safety of the operations personnel.</p>

<p>i. Appropriately rated insulation mat should be laid in front of the control panel .</p>
