ELECTRICITY MANAGEMENT SERVICES LIMITED

REPORT ON INSPECTION AND TESTING OF STANDARD METALLURGICAL COMPANY (SMC) 15MW GAS TURBINE GENERATOR AND 132KV SUBSTATION, GBARA VILLAGE, SAGAMU, OGUN STATE ON 5TH & 6TH MARCH, 2015

RE: CONSTRUCTION OF 132KV OHTL AND ASSOCIATED SUBSTATION FOR THE CONNECTION OF SMC TO NATIONAL GRID

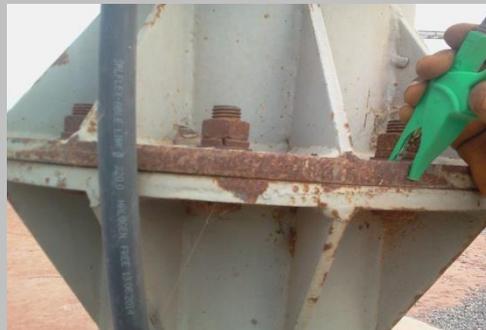
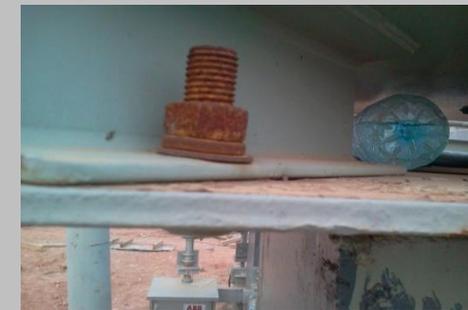
Some metal channels used in the substation construction work were found to be rusting including some bolts and nuts.

Use of galvanized bolts and nuts and galvanized steel channels is recommended.
